1 *Introduction*

1.1 Purpose and Scope of Study

This report presents observations, findings, and recommendations regarding the performance of buildings affected by the September 11 attacks on the WTC towers in New York City. This report also describes the structural and fire protection features of the affected buildings and their performance in response to the terrorist attacks. Due to the unprecedented nature, magnitude, and visibility of the terrorist attacks, this event is among the most well-documented in the media, particularly in terms of photographic images, lives affected, and the immediate responses and ensuing sequence of events. An understanding of these events must include the performance of the buildings under extreme conditions beyond building code requirements. This includes determining the probable causes of collapse and identifying lessons to be learned. Recommendations are presented for more detailed engineering studies, to complete the assessments and to produce improved guidance for building design and performance evaluation tools.

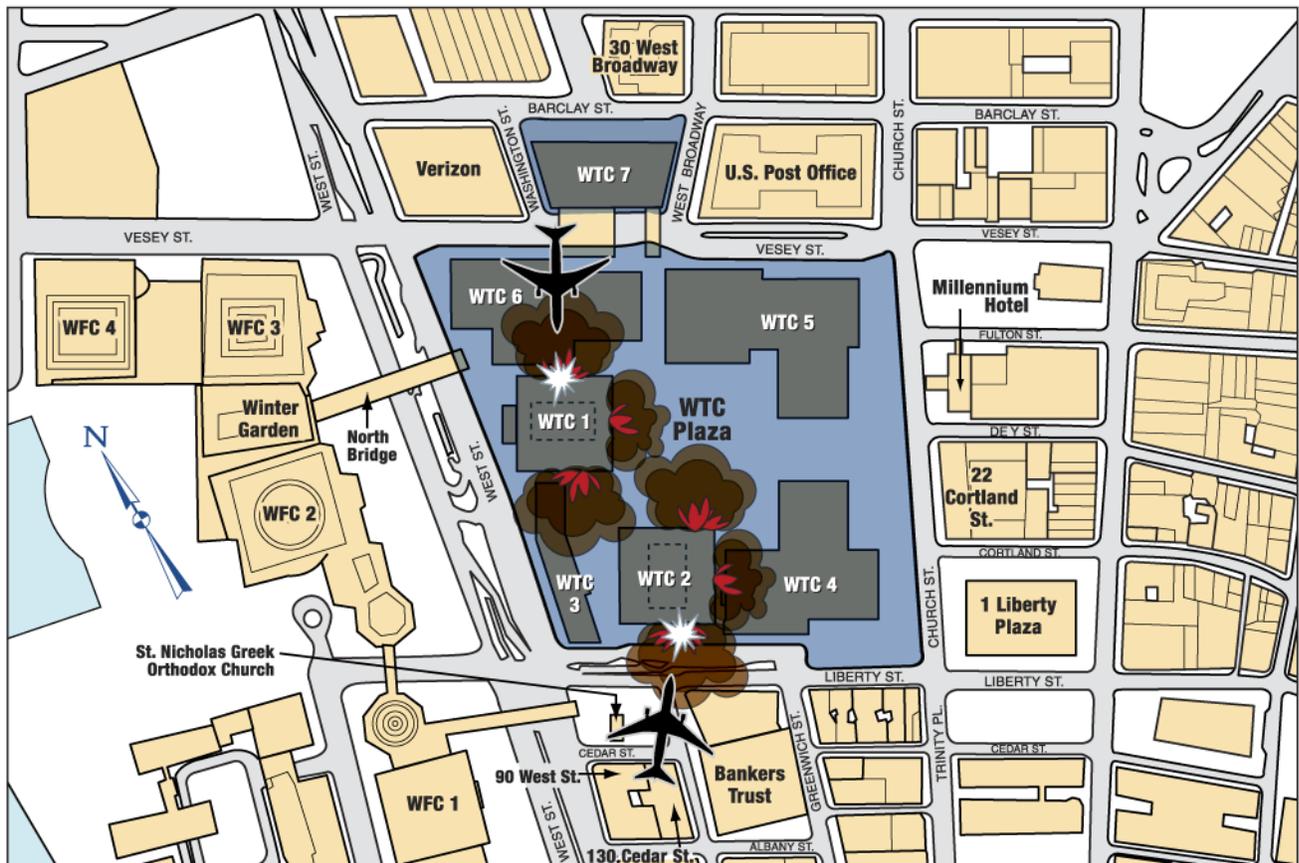
The north tower was struck between floors 94 and 98, with the impact roughly centered on the north face. The south tower was hit between floors 78 and 84 toward the east side of the south face (Figures 1-3 and 1-4). Each plane banked steeply as it was flown into the building, causing damage across multiple floors. According to Government sources, the speed of impact into the north tower was estimated to be 410 knots, or 470 miles per hour (mph), and the speed of impact into the south tower was estimated to be 510 knots, or 590 mph. As the two aircraft impacted the buildings, fireballs erupted (Figure 1-5) and jet fuel spread across the impact floors and down interior shaftways, igniting fires (Figure 1-6). The term fireball is used to describe deflagration, or ignition, of a fuel vapor cloud. As the resulting fires raged throughout the upper floors of the two WTC towers, thousands attempted to evacuate the buildings. It was estimated by the Port Authority that the population of the WTC complex on September 11, 2001, was 58,000 people. This estimate includes the PATH and MTA stations and the Concourse areas. Almost everyone in WTC 1 and WTC 2 who was below the impact areas was able to safely evacuate the buildings, due to the length of time between the impact and collapse of the individual towers.

Figure 1-3 WTC impact locations and resulting fireballs.

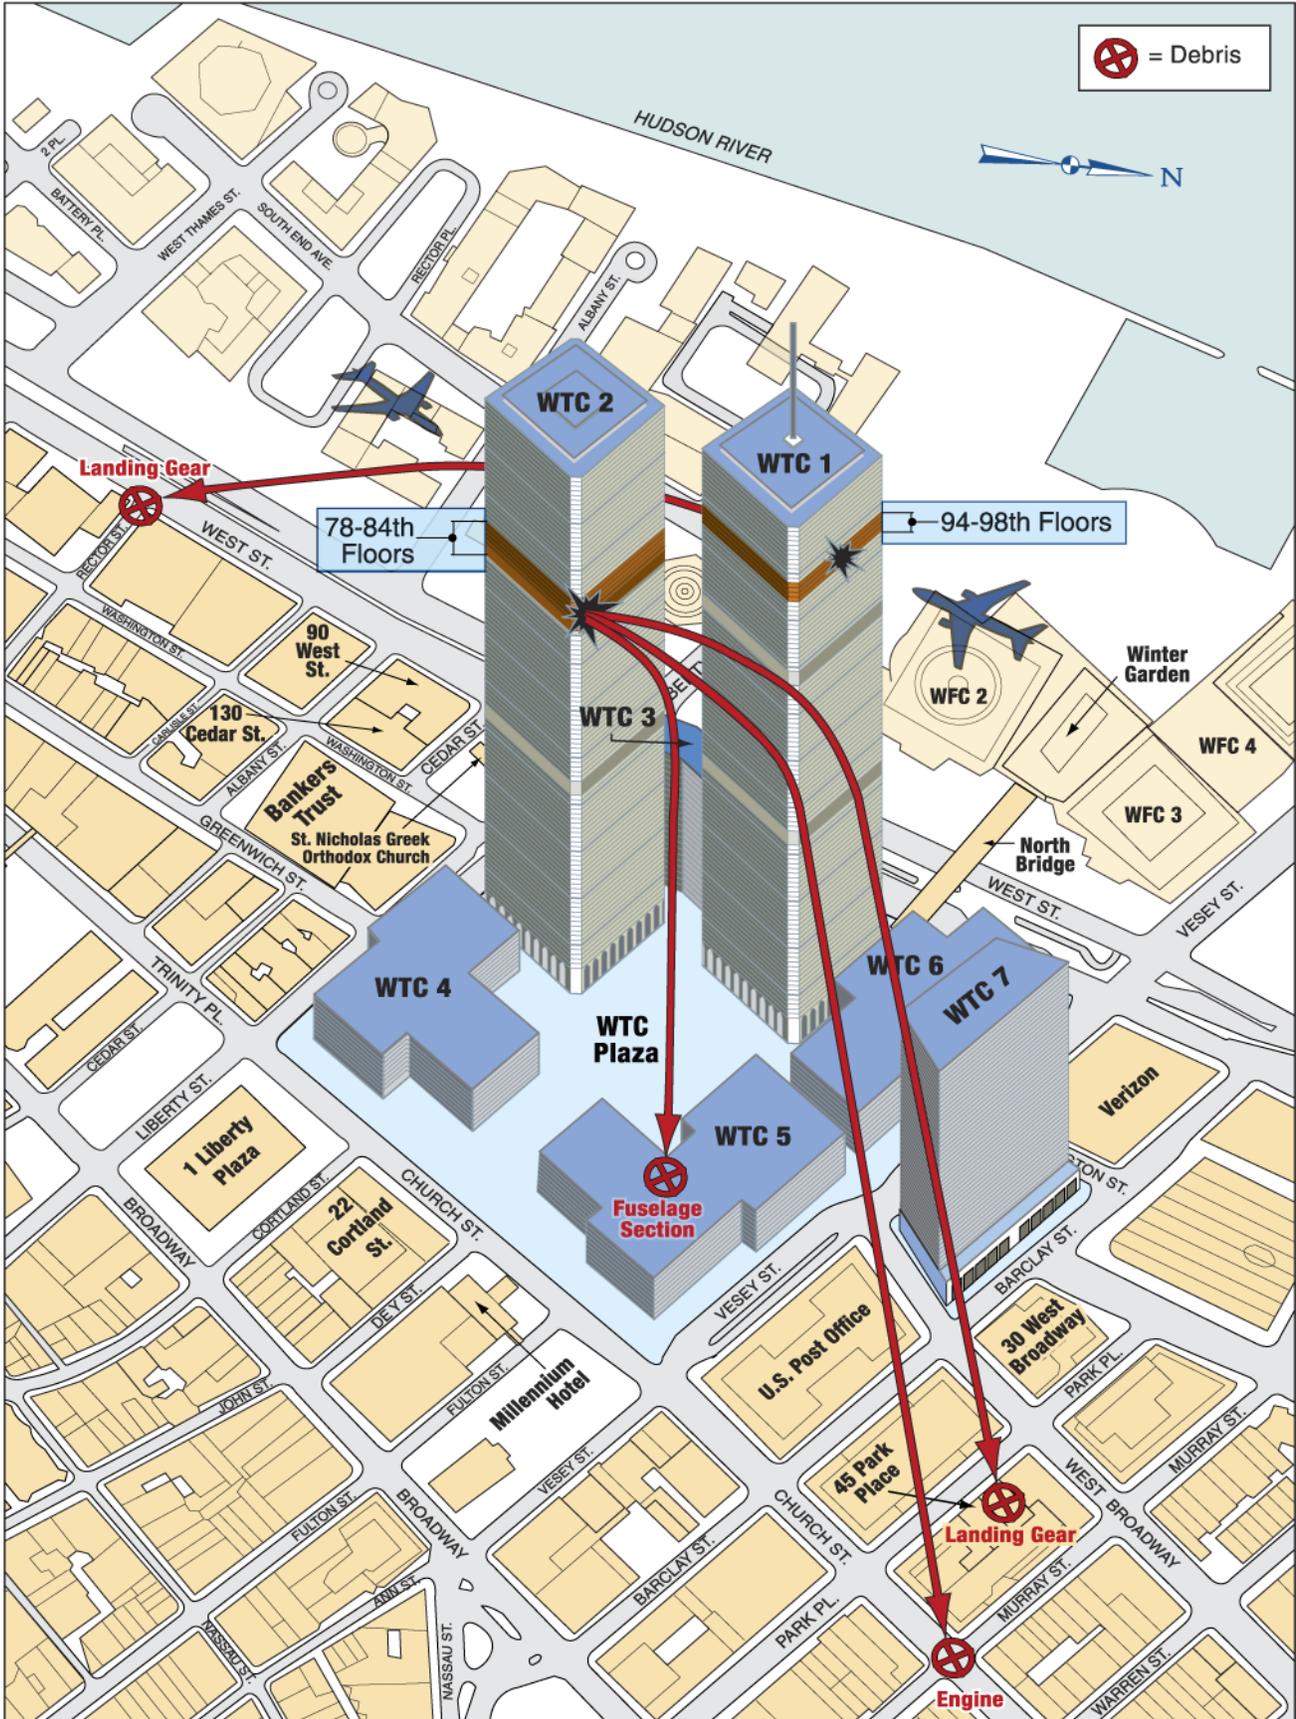
Figure 1-4 Areas of aircraft debris impact.

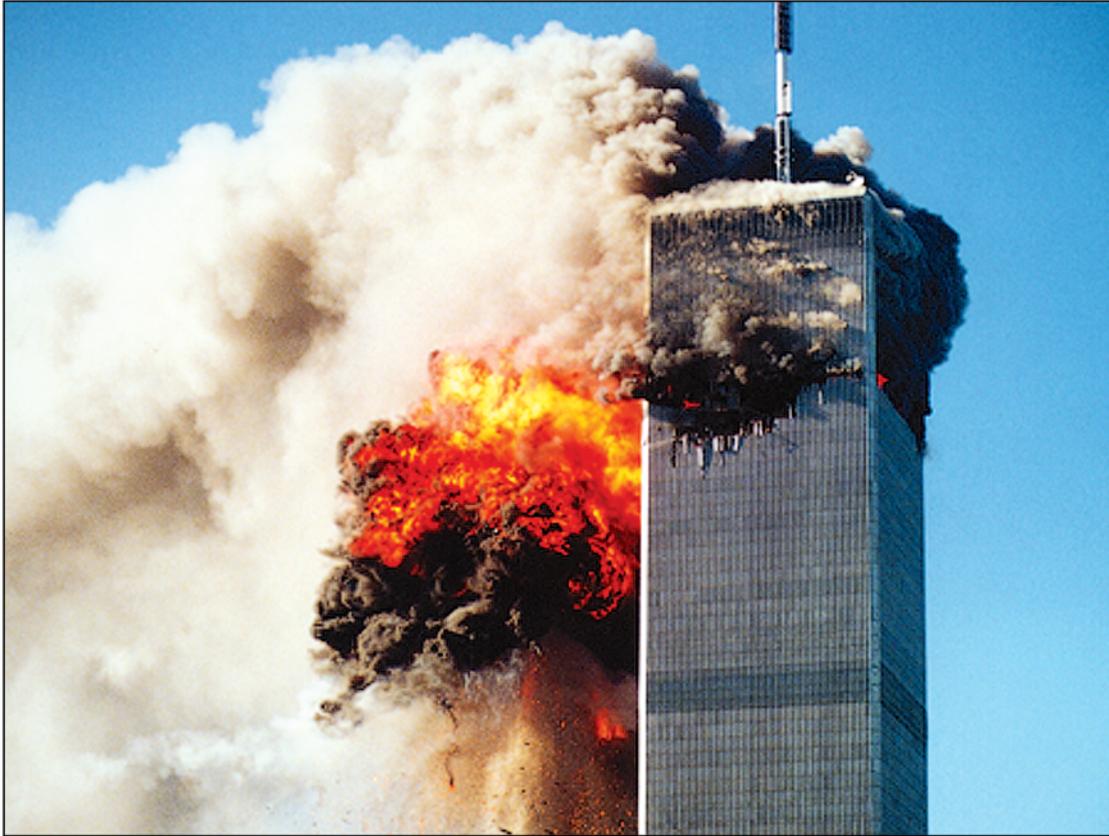
Figure 1-5 Fireball erupts on the north face of WTC 2 as United Airlines Flight 175 strikes the building.

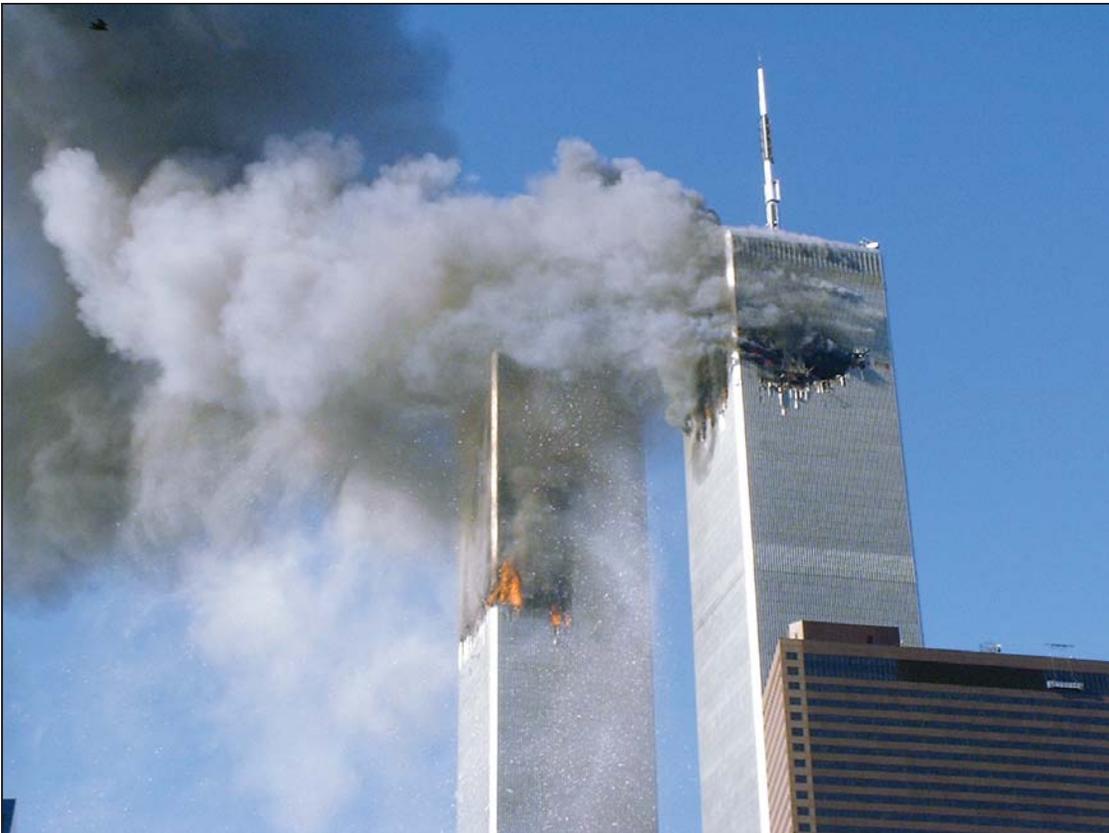
Figure 1-6 View of the north and east faces showing fire and impact damage to both towers.

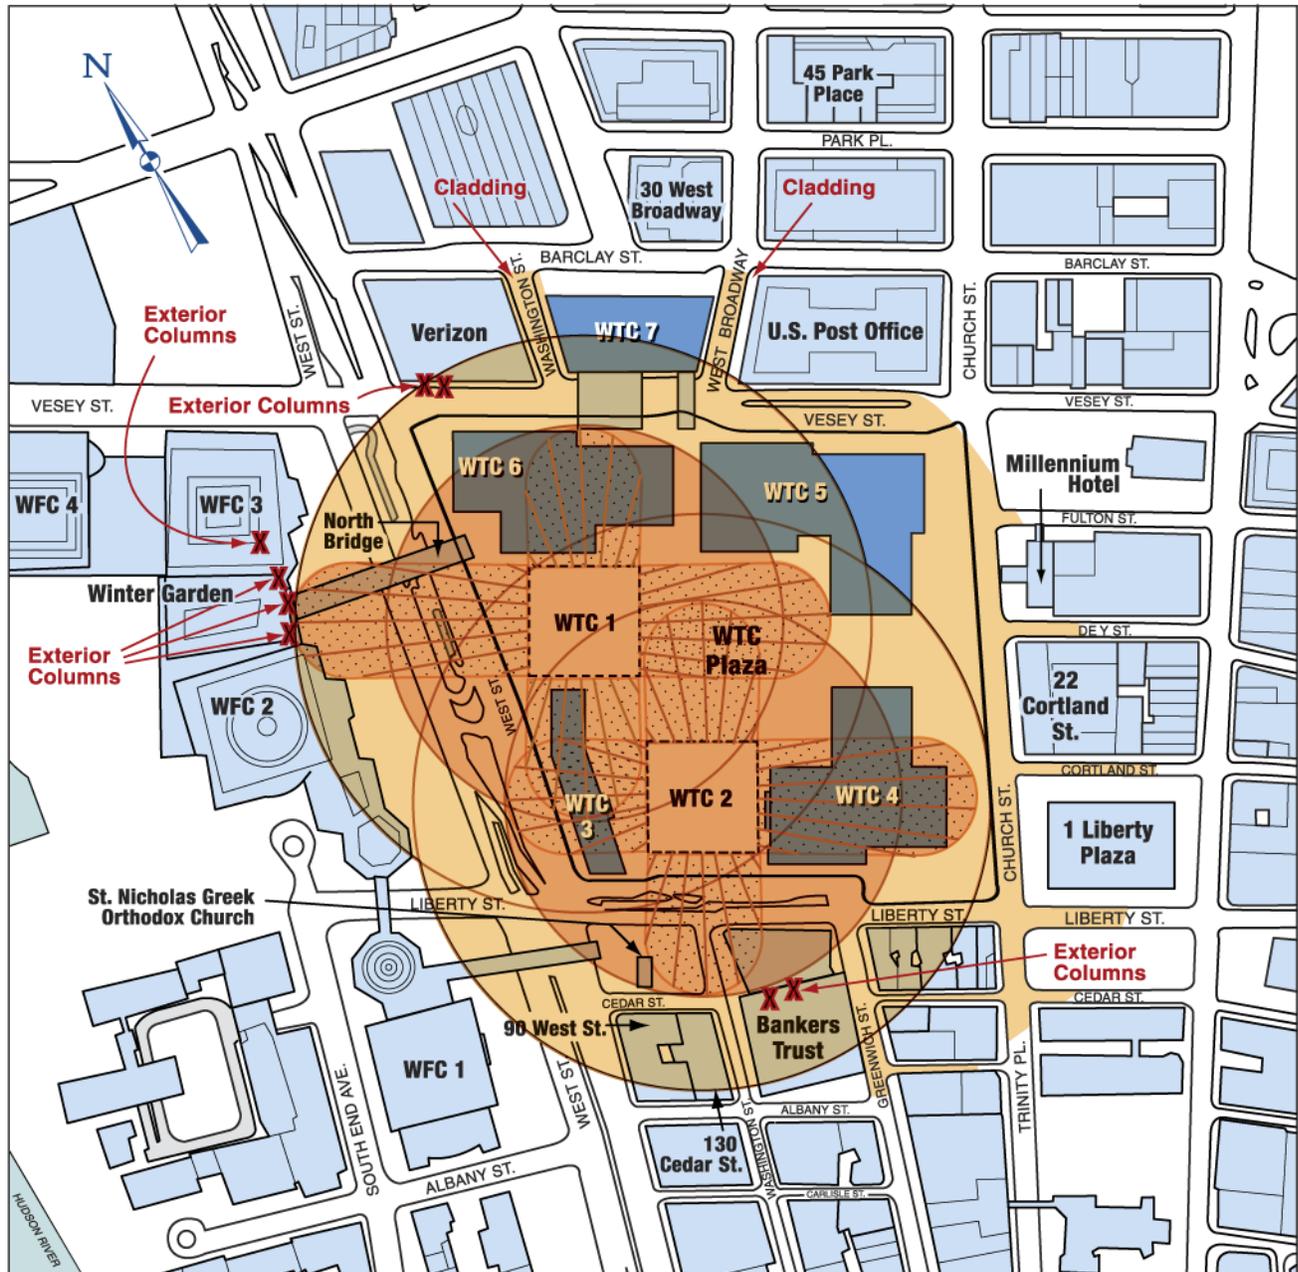
Debris from the collapsing towers, some of it still on fire, rained down on surrounding buildings, causing structural damage and starting new fires (Figure 1-7). The sudden collapse of each tower sent out air pressure waves that spread dust clouds of building materials in all directions for many blocks. The density and pressure of the dust clouds were strong enough to carry light debris and lift or move small vehicles and break windows in adjacent buildings for several blocks around the WTC site. Most of the fires went unattended as efforts were devoted to rescuing those trapped in the collapsed towers. The 22-story Marriott World Trade Center Hotel (WTC 3) was hit by a substantial amount of debris during both tower collapses. Portions of WTC 3 were severely damaged by debris from each tower collapse, but progressive collapse of the building did not occur. However, little of WTC 3 remained standing after the collapse of WTC 1. WTC 4, 5, and 6 had floor contents and furnishings burn completely and suffered significant partial collapses from debris impacts and from fire damage to their structural frames. WTC 7, a 47-story building that was part of the WTC complex, burned unattended for 7 hours before collapsing at 5:20 p.m. The falling debris also damaged water mains around the WTC site at the following locations:

Figure 1-7 Schematic depiction of areas of collapse debris impact, based on aerial photographs and documented damage. Striped areas indicate predominant locations of exterior steel columns. Inner circles indicate approximate radius of exterior steel columns and other heavy debris. Outer circles indicate approximate radius of aluminum cladding and other lighter debris. Heavy Xs show where exterior steel columns were found outside the predominate debris areas.

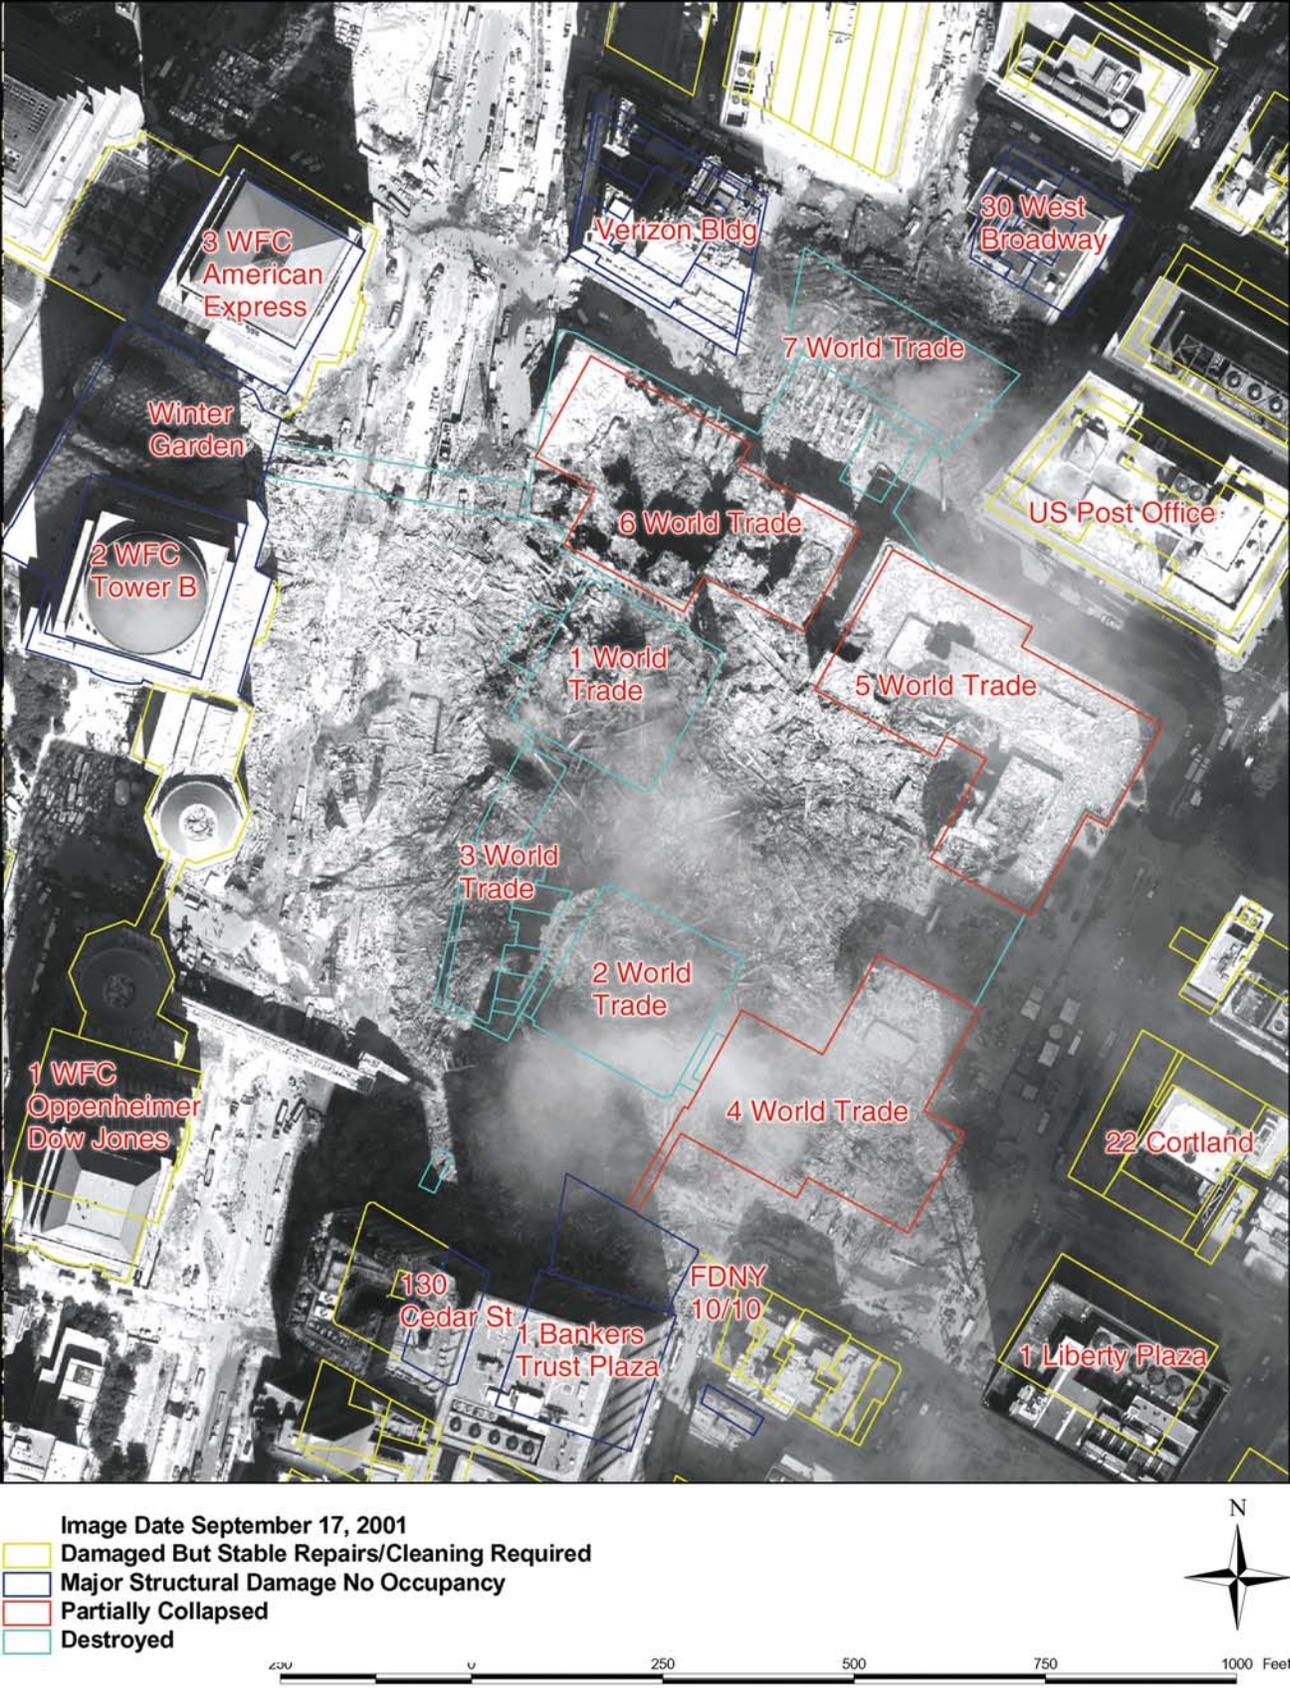
Other buildings surrounding the WTC plaza were also damaged by falling debris. A few buildings, such as the Bankers Trust building, suffered significant damage but remained standing. Many buildings had their façades and glazing damaged and their interiors blanketed with debris from the collapse of the WTC towers and WTC 7. Figures 1-9A and 1-9B are satellite images of the WTC site taken before and after the September 11 attacks, respectively.

Figure 1-9B Satellite photograph of the WTC site taken after the attacks.
