Direct Evidence for Explosions: Flying Projectiles and Widespread Impact Damage

Dr. Crockett Grabbe

University of Iowa and SeaLane Consulting

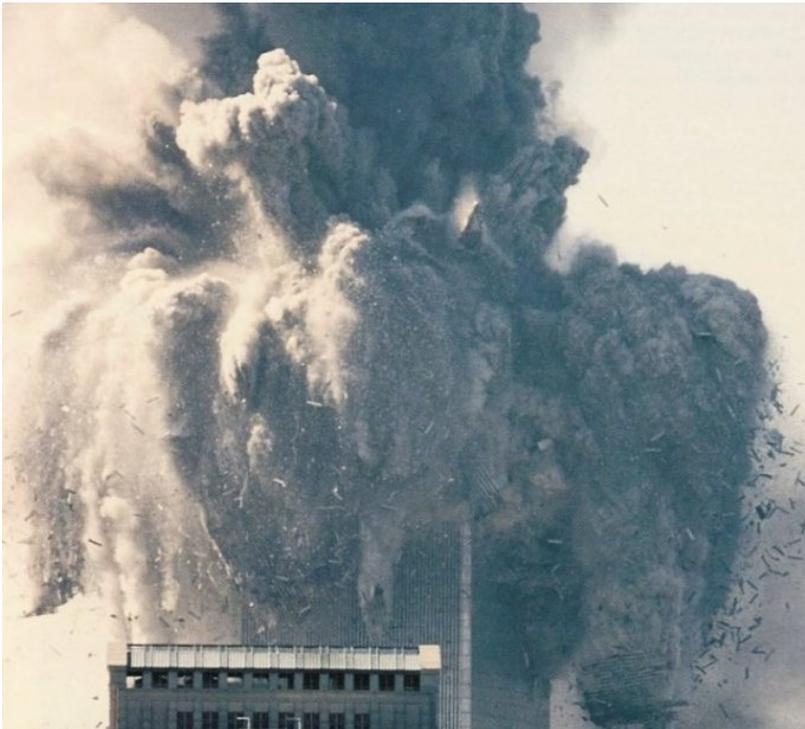
Claims have been made that there is no direct proof that explosions occurred in the World Trade Center on September 11, 2001, but there are in fact visible photographs of collapse results that provide that proof. One such photograph posted in late 2005 is shown in Figure 1, which shows the rapidly expanding cloud of the North Tower that directly exhibits explosions shattering material with hundreds of pieces of metal cladding and beams flying in the air at the edge of the dust cloud. However, there is also a whole set of photographs posted on the web which can be shown through physics calculations to graphically exhibit the direct effects of explosions in the World Trade Center towers, yet these facts have not been previously investigated.

Figure 1. Explosive dust cloud from the North Tower, which clearly shows large metal pieces like cladding and beams in the air. (After Jim Hoffman in [1].)

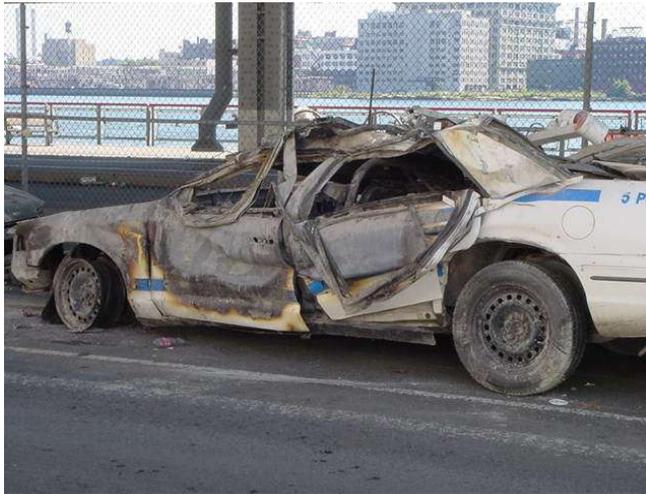
Figure 2. Vehicle damaged by World Trade Center explosions. (From [2].) Note that the uneven bending and twisting of metal, shattered windows, and swath of surface damage over a large area of metal. This combination of damage strongly suggests it was hit with force by a wide stream of debris which was apparently hot and possibly corrosive to the metal. This car was located on FDR Drive, and (reference [4]) was evidently towed to that location.

Reference [2] reports that around 1400 cars were seriously damaged like those in Figures 2 and 3. Some of the damage was because of fires started by ejections from the towers, since a number of cars were not in direct line of fire of the towers, but many were also hit at high speeds with debris. Clearly multiple explosions would be necessary to produce this damage. The damage is not likely be produced by laser directed-energy beam weapons as Judy Wood and Morgan Reynolds theorize, since the nature of destruction in that case clearly would be different: there would be evidence of melting of metal, likely burning into or through the metal, and burning of tires, but there would not be most of the surface impacts and bending and twisting of metal observed. If the tire in Figure 2 was burned off by a laser there would likely also be evidence of laser damage to the rim. Laser damage is quite inconsistent with that of the vehicle in Figure 3, which exhibits shattered windows with no melting or burning on the exterior surface or the inside seat, and corroded material in the rear.

The damage to these vehicles was most likely from being hit by a large swath of small high-speed objects of material that may have been hot and/or somewhat corrosive in nature. Many damaged vehicles, such as the one in Figure 2, show evidence of being scorched or burned by inflamed material, and both Figures 2 and 3 show possible corrosion. The windows in both vehicles were shattered, just like they were in many vehicles and in nearby buildings. It should also be noted that, similar to Figure 2, many of the vehicles clearly show damage primarily on one side or on part of the vehicle. Furthermore, photos also show shattered windows and other directed-damage in buildings for some distance from the base of the towers. This is good evidence of that the nearby vehicles and buildings were hit by "directed-energy weapons" from the tower. However, that directed energy came from the material shot out from the tower at high velocity because of explosions, rather than postulated sources like laser-beam weapons. The shattered windows and apparent impact damage in both cases provide strong evidence of being hit by material from explosives.

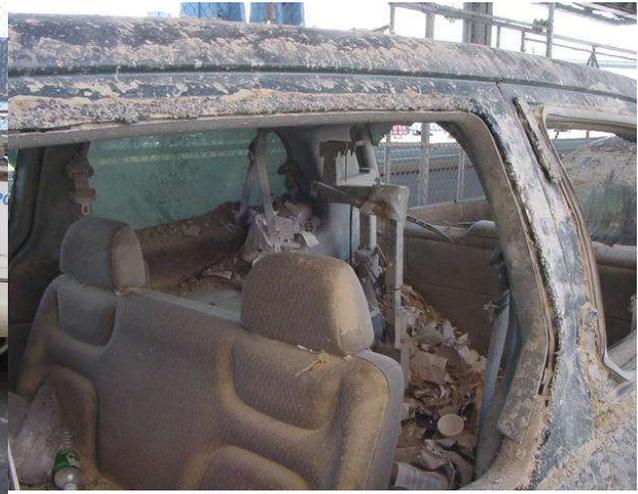
Figure 3. Vehicle damaged by World Trade Center explosions posted in reference [2]. The material caked on the exterior as well present inside the car apparently came from debris material streaming at high-speeds, shattering the windows. The seat has some projectile material on it, but was largely undamaged, probably because the car metal shielded it from any direct hit. The vehicle does not exhibit fire or heat damage.

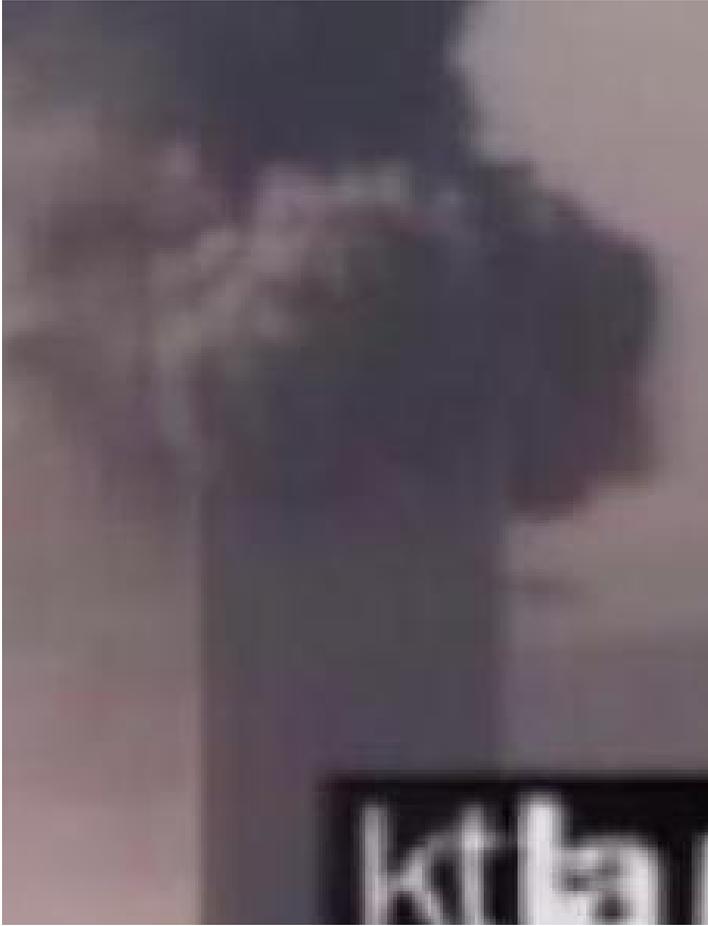
The video frame in Figure 4 of the World Trade Center North Tower taken by KTLA channel 5 news shows a "squib" -- a line of ejecting material from the tower -- right before it collapsed. Such squib ejections are driven by massive overpressure inside the building relative to the atmospheric pressure outside, and that overpressure is created by explosions. A number of squibs were observed coming from all 3 of Buildings 1, 2, and 7 a short second or 2 after each one started to collapse, and there are several websites that show photograph of them on all 3 buildings. The one displayed as Figure 4 shows ejecting material (bits of material large enough to have little air resistance) streaming out of the North Tower, which has traveled a distance from the tower in the horizontal direction, whereas the distance it has descended in the vertical direction because of gravitation pull is small.

Figure 4. Photograph from a video of the North Tower collapse by KTLA channel 5 news, which shows a streaming squib that has traveled out over 70 feet from the tower with very little descent [5].

Note the quantitative information that can be gathered from the ejection photograph in Figure 4. We can estimate that, at the front end, the ejecting plume has apparently fallen no more than roughly 3 feet (an estimate that might have up to a factor of 2 in error), whereas the horizontal distance of the front from building is about 1/3 the width of the North Tower, or about 70 feet. If we neglect air friction resistance over the length of the streamer, from fall distance $s=0.5gt^2$, where $g=32$ feet/sec² is the gravitational acceleration, we estimate 0.43 sec as the time since the front end first ejected from the building. That means that material in that squib is traveling horizontally at roughly 163 feet/sec, which means the squibs are effectively "bullets" of bits of material produced by the explosions. Since the distance fallen is quite small there may be a fairly large uncertainty in its estimate. Allowing for an error of up to a factor of 2 in the measurement of the fall distance s , the velocity could be down to 41% lower or up to 30% higher, so it could range from 100 feet/s to over 200 feet/s.

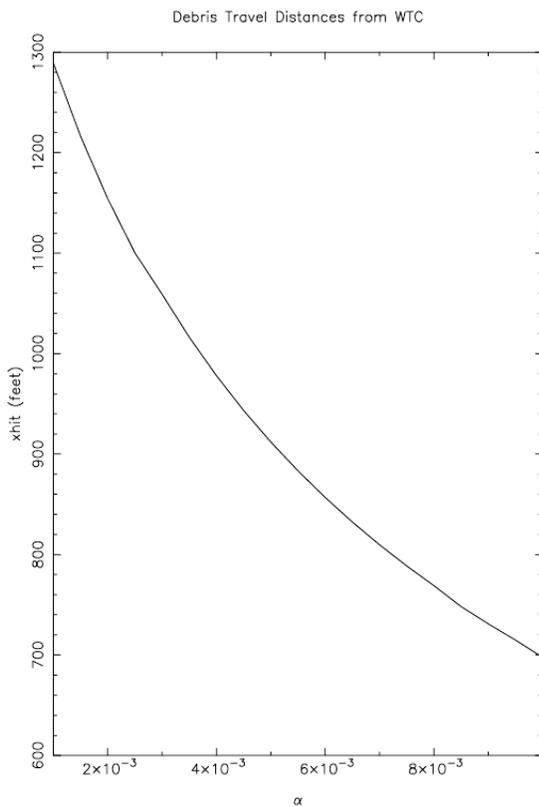
Figure 5. Graph of the horizontal distance the squib material travels from the center (x_{hit}) as a function of the air resistivity α , assuming it hits no intervening object (e.g. another building) before hitting at the ground level. The height of the squib origin in the tower is taken as 1304 feet (400 m, a feasible height for the North Tower).

Figures 5 and 6 show these high-speed squibs shot out material up to 1/4 mile or more from the towers. This ejection distance x_{hit} is not all that sensitive to the height of origin: raising or lowering the ejection height by over 800 feet changes x_{hit} by less than 500 feet for the low resistivity side, and just over 200 feet on the high resistivity side. Similarly, I found that

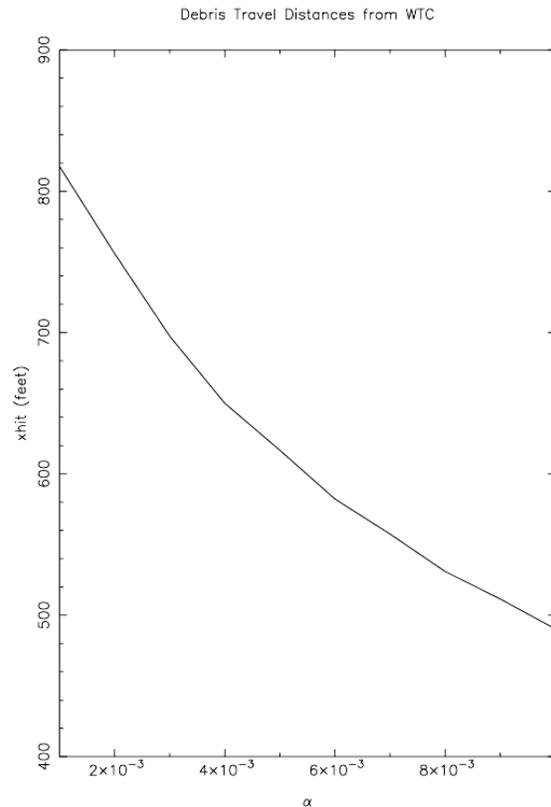
Figure 6. Graph of the distance the squib travels from the center (x_{hit}) versus of the air resistivity α of the squib. The height of the squib origin in the tower is taken as 489 feet (150 m, a feasible height on WTC7).
