#### Investigating the Mechanics of Destruction at the Twin Towers on 9/11: The Case for Propelled Demolition

#### By Wayne H. Coste, PE

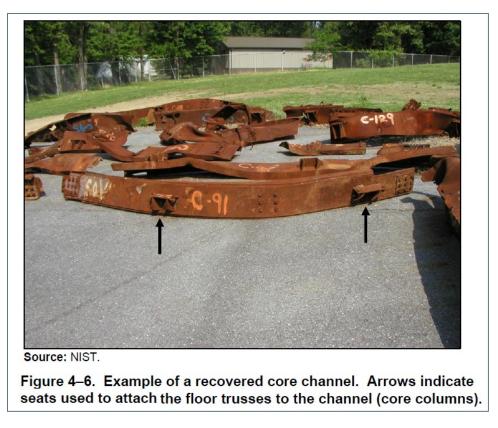
Figure 21: Truss seats from "Zone1" and/or "Zone 2" do not exhibit the downward bending observed in "Zone 3."

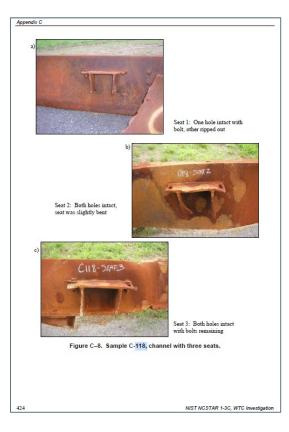
Figure 22: Truss seat connections on channel steel piece identified as NIST C-118, currently located at River Front Peace Park in Appleton, Newfoundland.

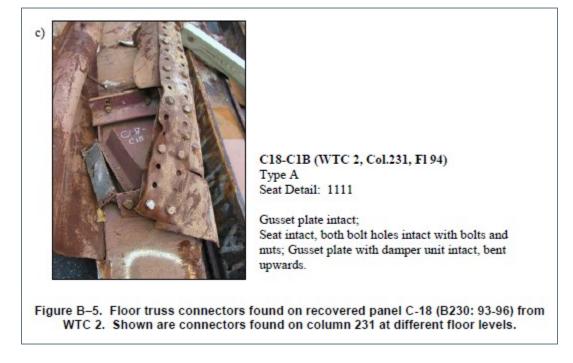
Figure 23: A perimeter column floor truss connection from floor 94 of the North Tower ("Zone 1") indicates upward acting forces that bend the seat upward as the destruction moves upward.

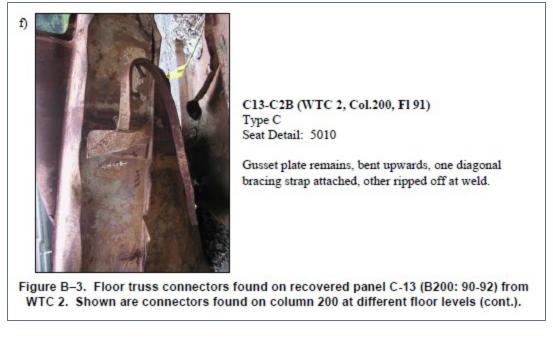
Figure 24 shows the resulting connections from a 91<sup>st</sup> floor "Zone 1" sample in the South Tower. The welded gusset plate remains, but it is bent upwards – consistent with the hypothesis.

Figure 24: A perimeter column to floor truss connection from floor 91 of the South Tower ("Zone 1") indicates upward acting forces that bent the seat upward as the destruction moved upward.

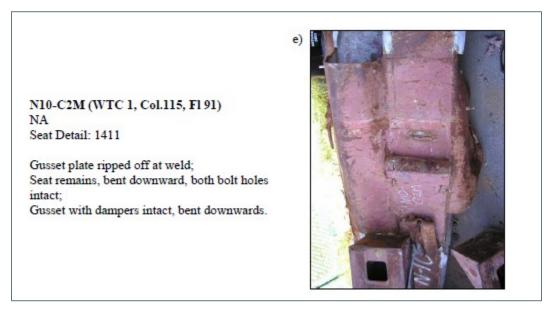
Figure 25: A perimeter column floor truss connection from floor 91 of the North Tower ("Zone 2") indicates downward acting forces that bend the gusset plate and seat downward based on the geometry of the destruction. (NIST NCSTAR 1-3C, p391)

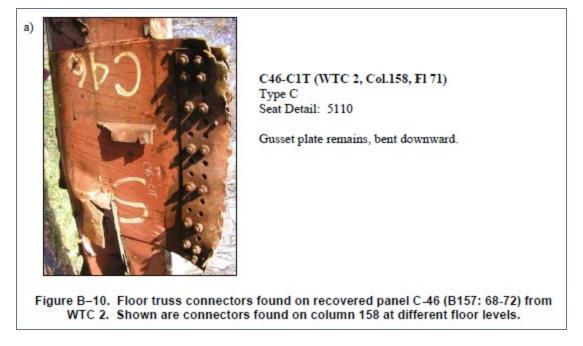
Figure 26 shows the resulting connections from a "Zone 2" sample taken from the South Tower. In this figure, the gusset plate remains – and is shown bent downward – consistent with the hypothesis.

Figure 26: A perimeter column floor truss connection from floor 71 of the South Tower ("Zone 2") indicates downward acting forces that bend the gusset plate downward based on the geometry of the destruction.

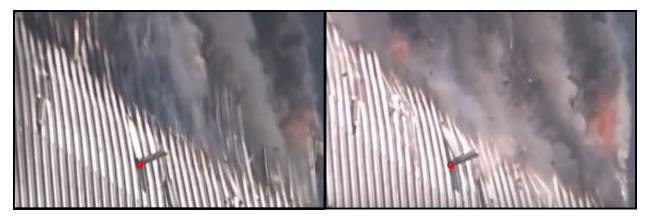
Figure 33: Push-in of the exterior perimeter columns by the hinged upper block as it begins pivoting/rotating.

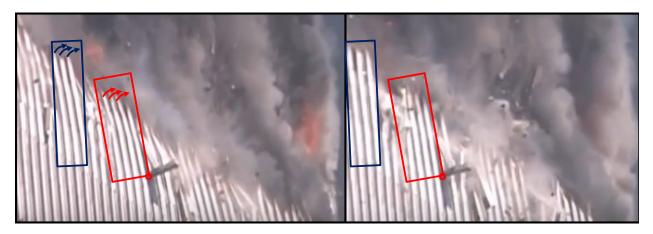
Figure 34: Rebound of the perimeter column sections after probable connecting bolt failure.

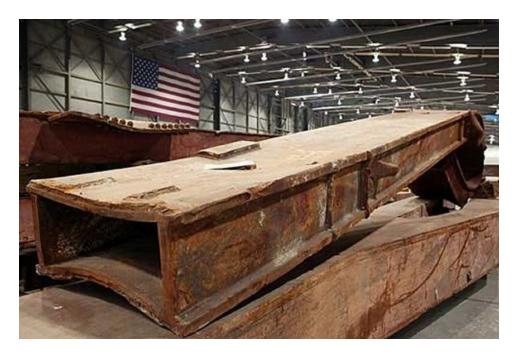
Figure 36: Core column with double concave bends in plates on opposite sides (Photo by Lane Johnson)

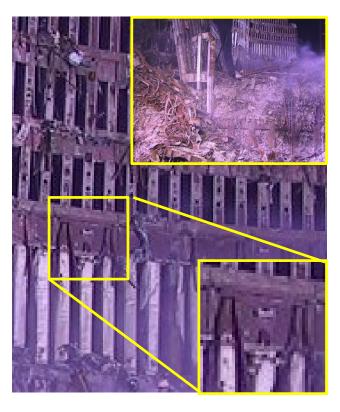
Figure 46: Inner perimeter columns in "Zone 3" of the North Tower showing hanging floor truss top chords.

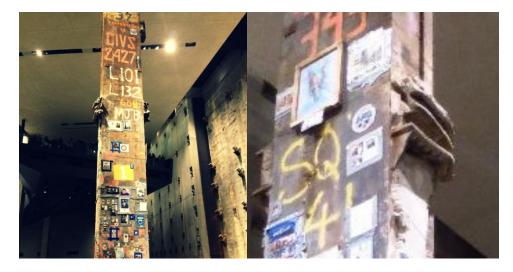
Figure 47: The "Last Column" was from the lowest level in the basement and shows the downward bend in a seat caused by falling debris that is characteristic of "Zone 3" damage.

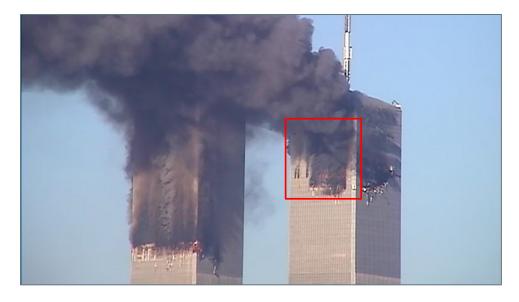
Figure 56: Relatively clear image of the eviscerated perimeter columns and missing floors in the area perpendicular to the core columns.

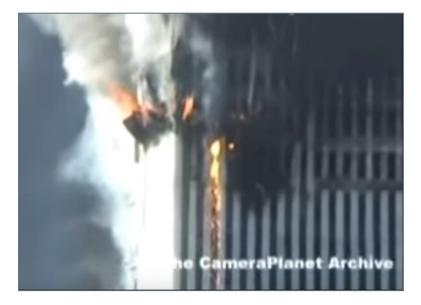
Figure 57: Molten iron streaming out of the South Tower shortly before the demolition began.
