Re: The NIST Report On the Collapse of WTC Building 7
Challenged by 2,100 Architects and Engineers

Technical Discussion:

The National Institute of Standards and Technology was tasked with the investigation to determine how the WTC 7 building collapsed to the ground on Sept. 11, 2001 in New York City. Their final report on this issue was released in November 2008. At that time the structural, erection, and shop fabrication drawings for the steel frame of the building were not publicly released, and thus those interested in the structural details of the building were not able to review them and determine the plausibility of the fire induced progressive collapse explanation given in NIST report.

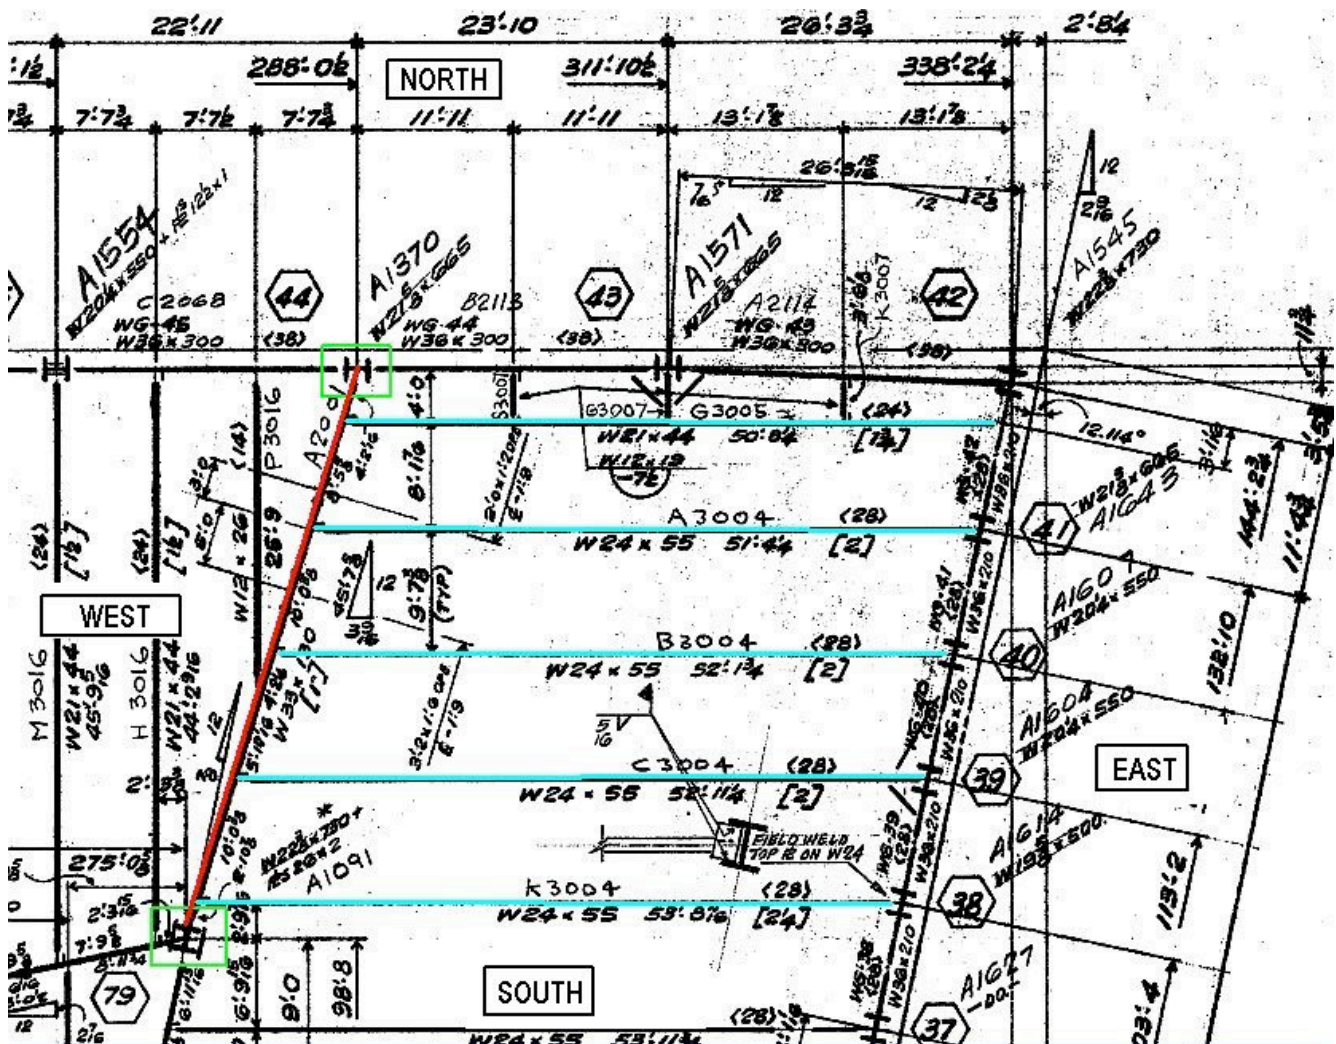
The NIST WTC 7 report claims the initiating event was that a critical girder (girder A2001) in the northeast corner of the building under the 13th floor was either pushed or rocked off its seats at exterior column 44 and corner core column 79 by thermally expanding beams framing into it from the east as shown in Figure 1.

Figure 1: Framing of the northeast corner of the 13th floor of WTC 7 as shown on Frankel drawing #E12/13 with the critical girder (A2001) highlighted in red and the five beams framing into it from the east (K3004, C3004, B3004, A3004, and G3005) highlighted in blue. Columns 44 and 79, which support the girder, are outlined in green.

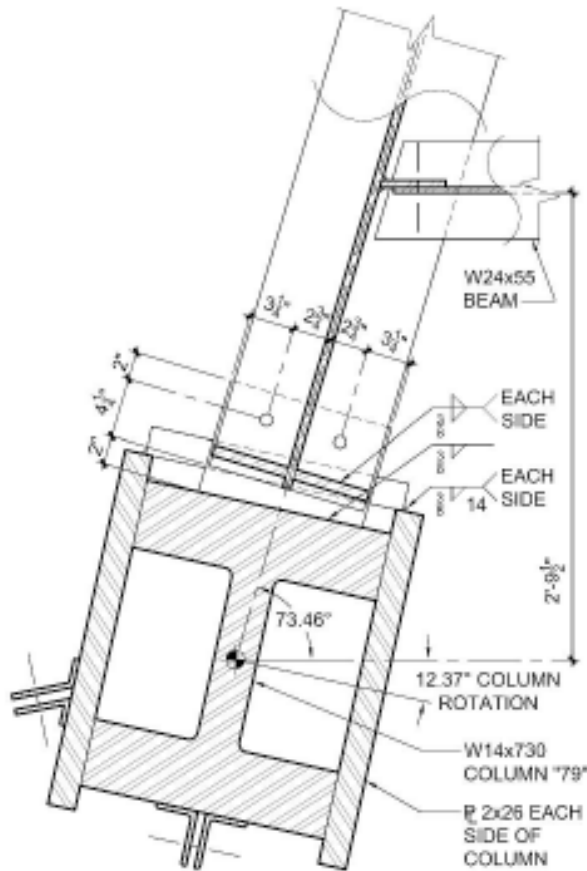
However, when calculated from the provided geometry and details of the girder and seat shown in Frankel drawings #1091 and 9114 the axial bearing length of the girder on the seat is seen to be 6.25 inches as shown in Figure 3 below.

**Figure 3: Plan View at Floor 13, Column 79 Seated Connection of Girder A2001.
(Data from Frankel Steel Limited, 1985b)**

So it is unclear how the 5.5 inch axial travel distance for walk-off was determined as it is not related to bearing length. If it is due to when the seat would fail it needs to be stated.

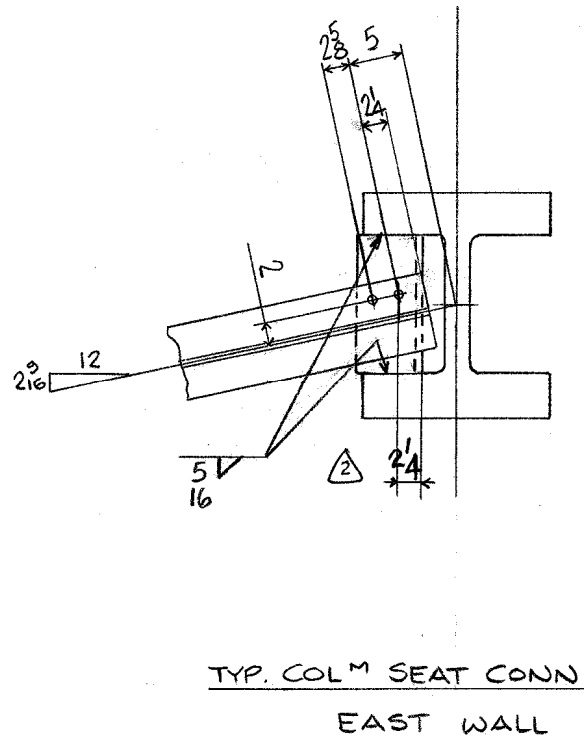
The above also assumes that all of the expansion was directed westwards, and that the four bolts of the beam connections to the columns at the east side exterior would withstand the breaking of the 28 shear studs on the beams. The beam to exterior column connections also contained clearance between the beam and the columns as shown in Figure 4, so if the bolts broke there would be at least an inch of movement to the east. This is not discussed in the NIST WTC 7 report.

Figure 4: Plan View of east side exterior beam to column connections from Frankel drawing #9101.

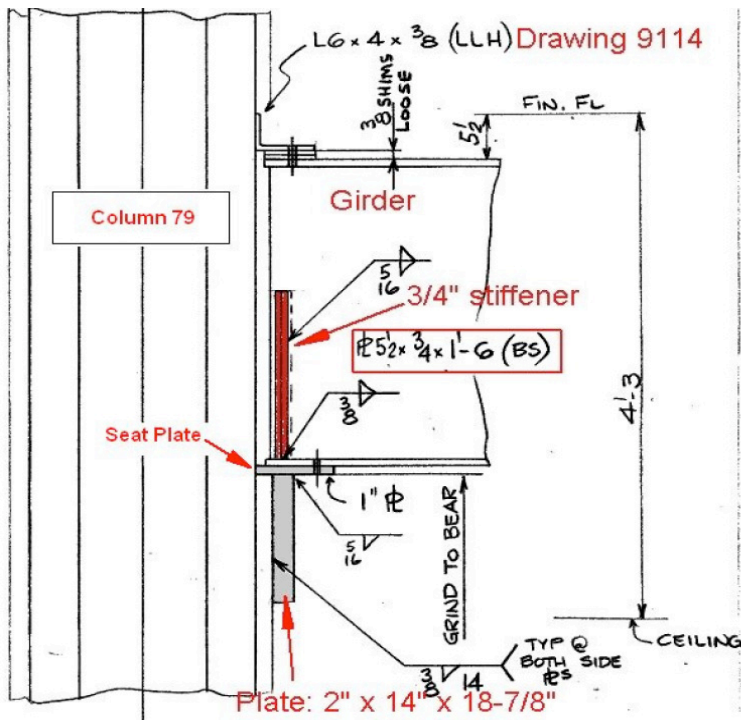
Although the shop fabrication drawing for girder A2001 has not yet been released, the stiffeners at the column 79 end of the girder are clearly shown on Frankel drawing #9114 as seen in Figure 5 below.

Figure 5: Side View of Column 79 Seated Connection of Girder A2001 on Frankel Drawing #9114.

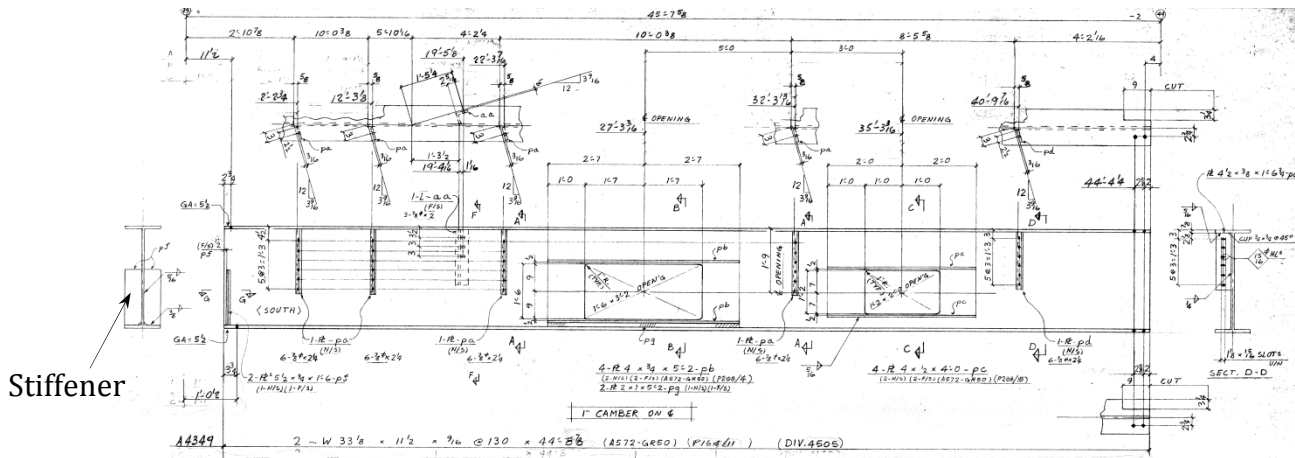
Another WTC 7 girder is shown in Figure 6 to give an illustration of a typical stiffener configuration at the end of many of the girders, which review of the drawings shows was apparently used on girders where the connection design used a narrow support plate under the seat, such as that used under the column 79 girder seat and labeled as plate “pg” on Frankel drawing #1091.

Figure 6: Typical stiffeners used on girder ends with narrow support plates under girder seat.

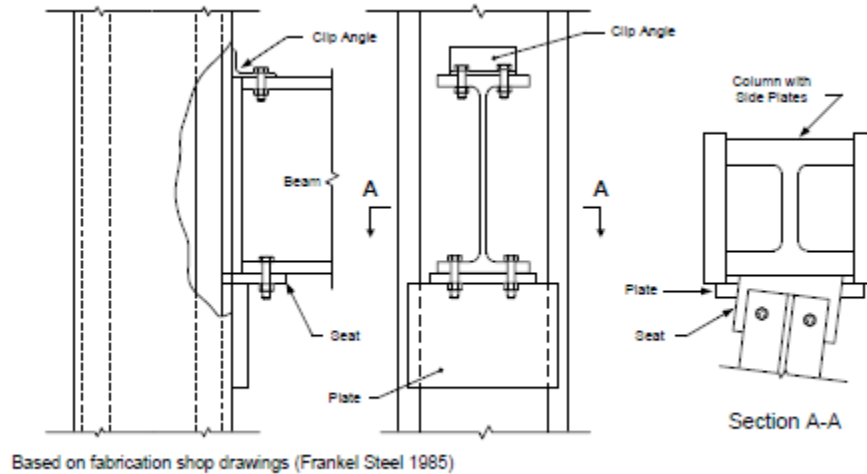
Figure 8-21. Seat connection at Column 79.

Figures 7 and 8 show how the girder was depicted without stiffeners in the NIST WTC 7 report and that the stiffeners were not included in the analysis model of the connection used to support the conclusions of the report.

Figure 7: Typical depiction of the girder end at column 79 in the NIST WTC 7 report.

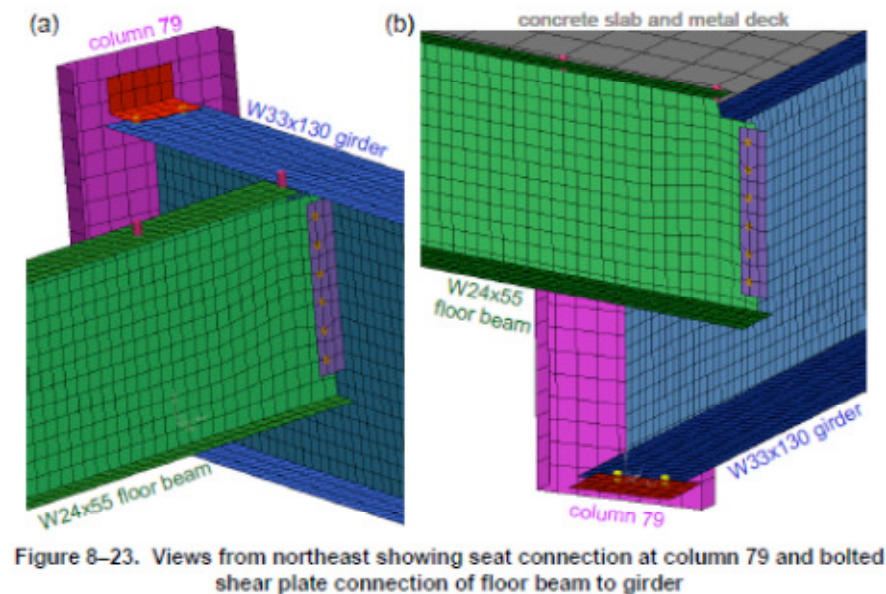
Figure 8: Analysis model provided in the NIST WTC 7 report showing the girder connection at column 79.

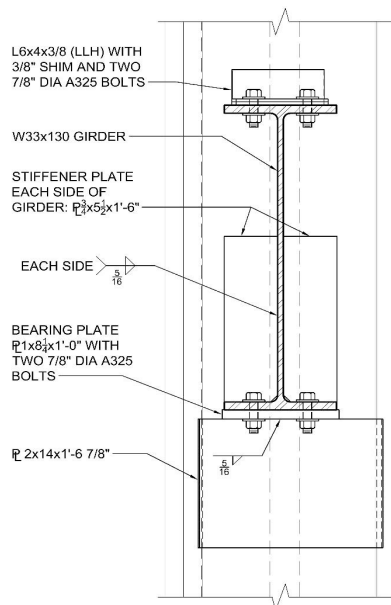
Figure 9 is an accurate to scale depiction of girder A2001's connection to column 79 showing the girder stiffeners based on Frankel drawing #9114. Figure 10 is an accurate to scale 3-D rendering of the connection.

Figure 9: The A2001 girder connection at column 79 with the girder stiffeners depicted as they should have been in the NIST WTC 7 report per Frankel drawing #9114.

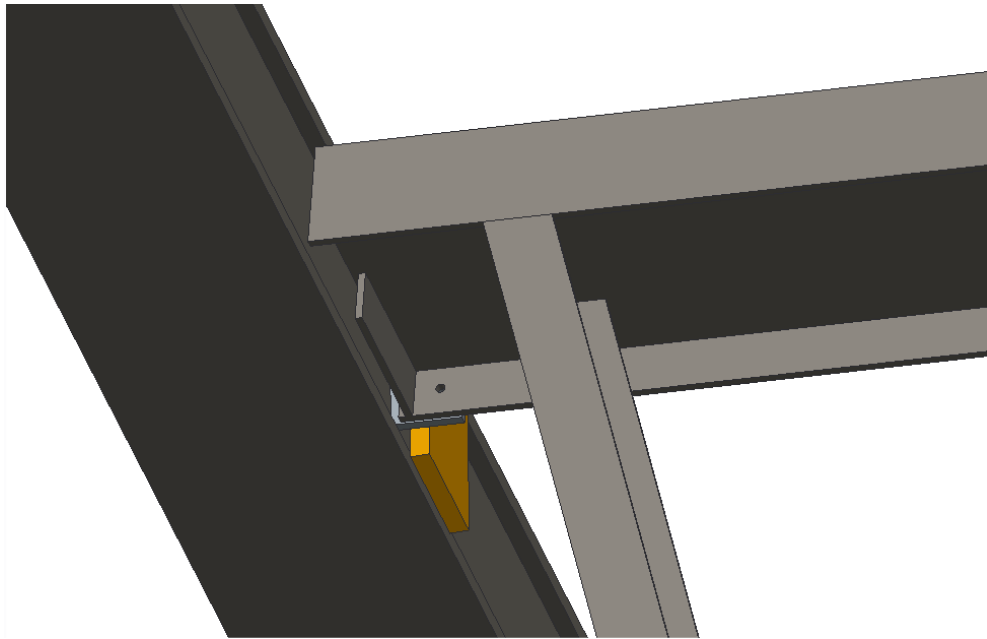
Figure 10: Model showing how the Column 79 seated connection of girder A2001, as shown on Frankel drawing #9114, would actually appear.

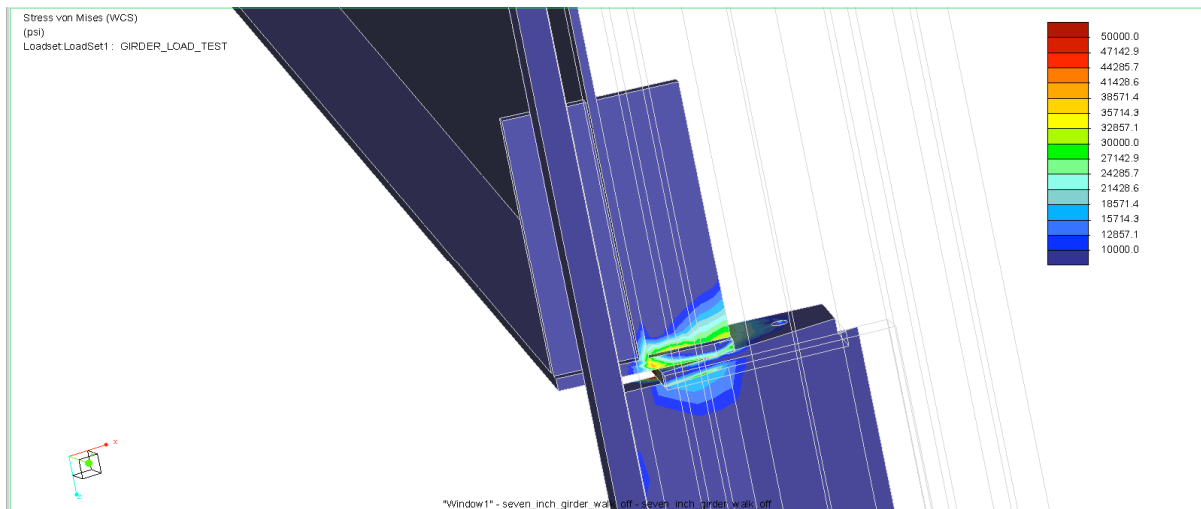
The stiffeners would have done more than simply prevent web crippling as they also strengthen and stiffen the flange. Figure 11 shows the results of an analysis with the girder web beyond the seat with stiffeners included. The stress on the flange and stiffeners is well below yield strength showing the stiffeners would prevent failure of the flange of the girder even if the web was pushed beyond the 12 inch wide seat. In reality, the centered girder web could not move beyond the edge of the 12 inch long seat due to the 5.5 inch beam expansion maximum.

Figure 11: Analysis showing the girder flange does not fail when the web is beyond the seat with stiffeners installed. The above is with 6.75 inches of beam expansion.

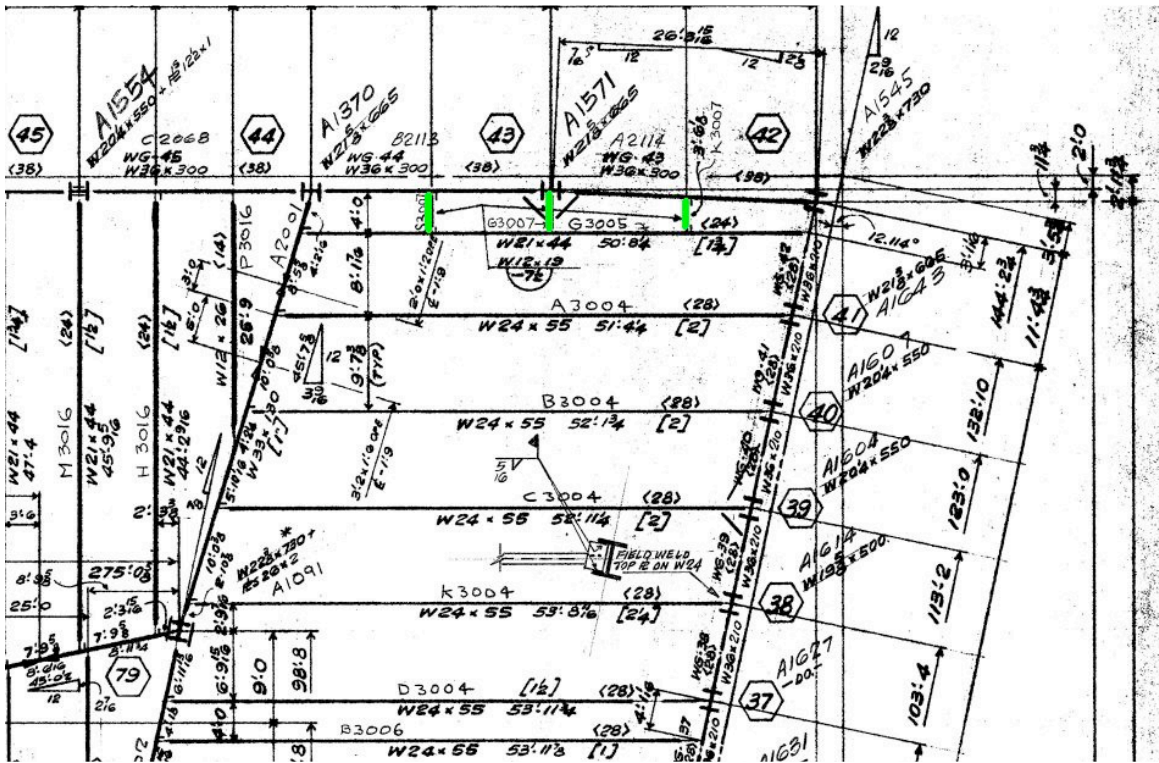
The omission of the lateral support beams from the exterior frame to beam G3005 has not yet been acknowledged, although the question concerning them was also asked in the FOIA letter to the NIST dated March 19, 2012. They can be seen in Frankel drawing #E12/13 as shown in a blow up from that drawing of the northeast corner at floor 13 in Figure 12 below.

Figure 12: Three W12 x 19 lateral support beams labeled S3007, G3007, and K3007 framing into beam G3005 are shown on Frankel drawing #E12/13 (the three beams are highlighted in green here).

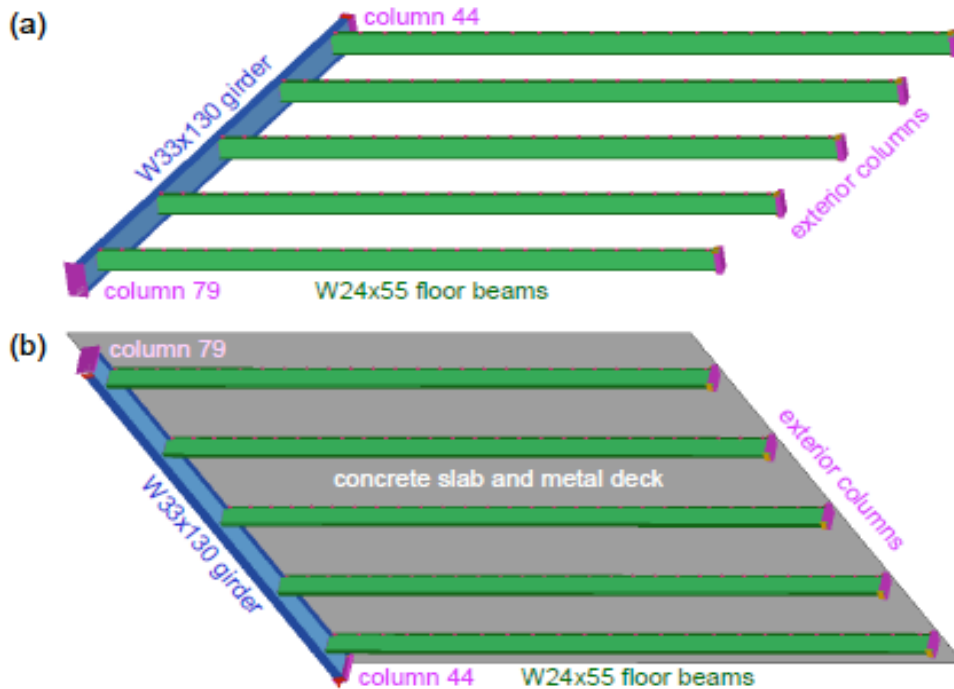
Figure 8-22. Finite element model of northeast corner as viewed from the southeast (a) Top view, with deck removed; (b) bottom view.

Figures 13 and 14 show the elements used in a second NIST analysis of the five floor beams and girder where beam G3005 is said to buckle due to its thermal expansion being restrained by girder A2001, to then lose its load carrying capacity, and subsequently cause the other four beams to buckle which then rocked the girder off its seats. While buckling of this beam, due to restraint from thermal expansion, is possible without the three lateral support beams framing into it, it is not possible when they are included. The lateral support beams drastically reduce the beam's slenderness and cause the required buckling force to be approximately 16 times greater than it is without them. The models from the NIST analyses do not include the lateral support beams.

Figure 13: Figure from the NIST WTC 7 report does not include the lateral support beams framing into beam G3005 from the exterior as shown on Frankel drawing #E12/13.

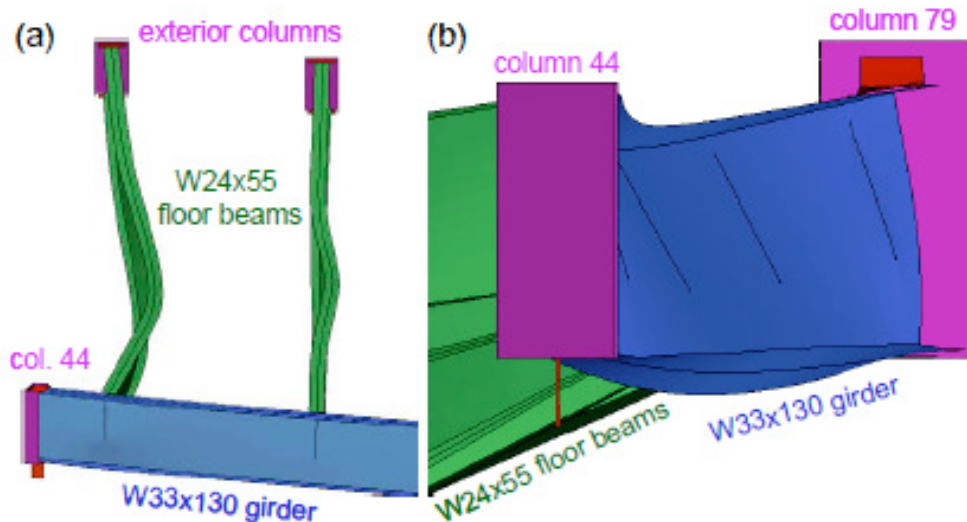
Figure 8-27. Buckled floor beams shown from above (a) and along girder (b).

Figure 14: Figure from the NIST WTC 7 report showing buckling of beam G3005 does not include the lateral support beams framing into it from the exterior as shown on Frankel drawing #E12/13.

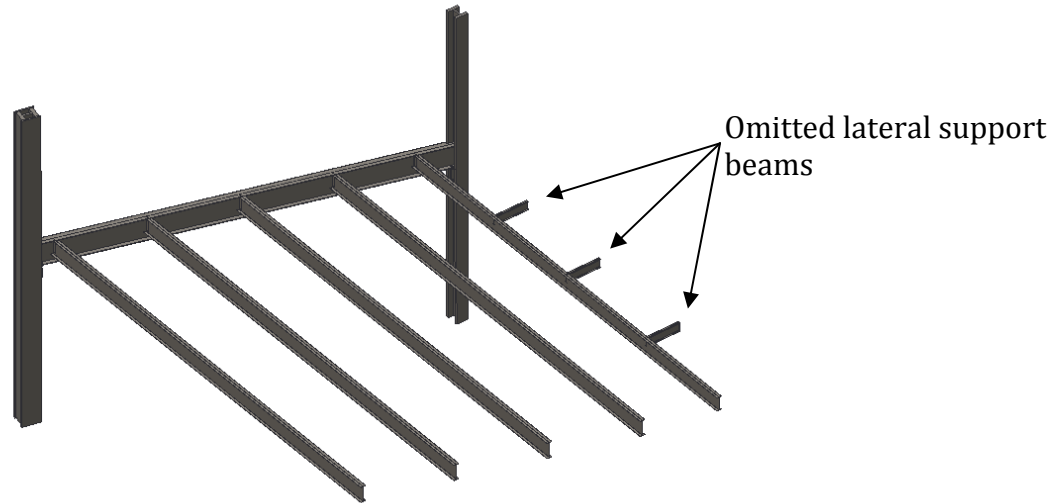
Figure 15 shows the floor framing under the 13th floor in the northeast corner with the omitted lateral support beams included.

Figure 15: Model showing the omitted lateral support beams framing into beam G3005 from the exterior as shown on Frankel drawing #E12/13.

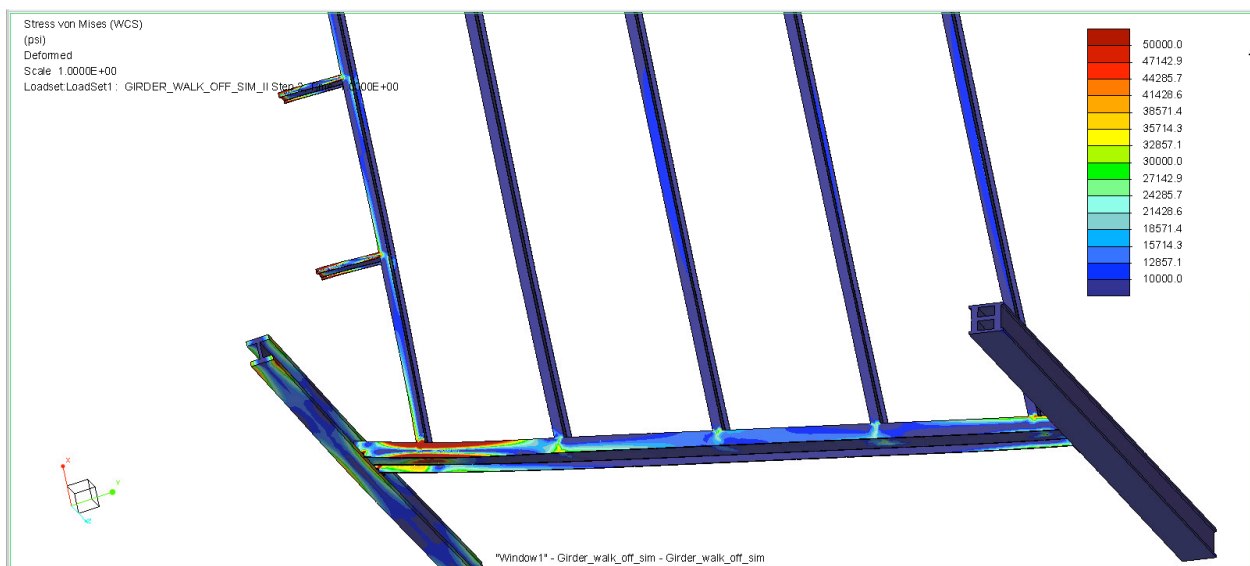
Figure 16 shows the results of an analysis performed with the lateral support beams included. It shows beam G3005 does not buckle when the three lateral support beams are included. This is due to the beam's slenderness being drastically reduced by having the lateral support and requiring approximately 16 times more axial compression to cause buckling. With the lateral support beams included the axial stiffness of beam G3005 is significantly greater than the girder's lateral stiffness and thus when the beam was thermally expanded it would have simply deflected the girder.

Figure 16: Analysis results showing beam G3005 does not buckle with the three lateral support beams included when it is thermally expanded at 600 °C temperatures and girder A2001 heated to 500 °C temperatures per the NIST WTC 7 report.
