The Pentagon Event: The Honegger Hypothesis Refuted

Version 2 - February, 2019

Abstract: The question of whether or not a large plane hit the Pentagon on September 11, 2001 has been vigorously debated by critics of the government's account ever since the event itself. Recently, Barbara Honegger² has become a leading and visible proponent of the "pre-planted explosives only" hypothesis, with the added claim that a large plane was destroyed outside the Pentagon wall without damaging the wall. This paper shows that this hypothesis cannot address the physical and eyewitness evidence that overwhelmingly points to large plane impact as the primary cause of damage and death.

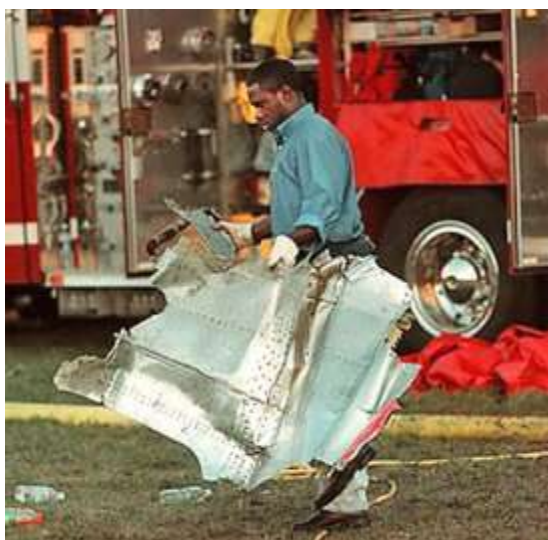
Starting at 5-00:40:30, Honegger argues that a white plane approached the Pentagon and was destroyed outside the wall near the fire station, 120 to 150 feet north of the official impact hole. Therefore, she concludes, the plane could not have been flight AA77 or a normal, silver American Airlines Boeing-757-200 commercial jet. Although she claims multiple witness saw a white plane, she names only three in the Seattle talk who testified to this: Jim Sutherland, Alan Wallace and Mark Skipper who were Pentagon firemen. In addition Honegger presents a small piece of white plane debris found by Penny Elgas. There are in fact many more witnesses who saw a silver plane, and 16 of these are listed in Appendix A. Many other witnesses identified the plane as an American Airlines commercial jet. Photographs taken on 9/11 at the Pentagon show workers holding pieces of silver plane debris. See Figures D-2 and D-3.

Figure D-2 - Silver plane debris at Pentagon

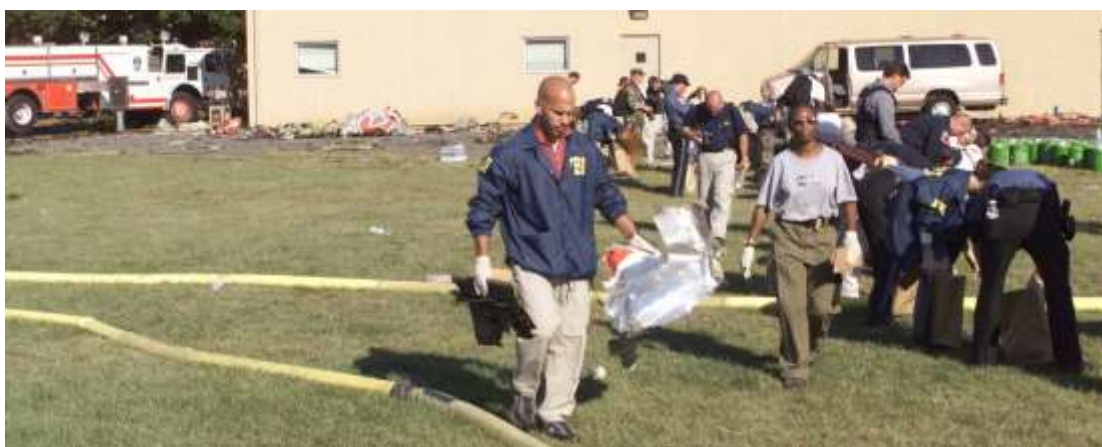
Figure D-3 - Silver plane debris at Pentagon

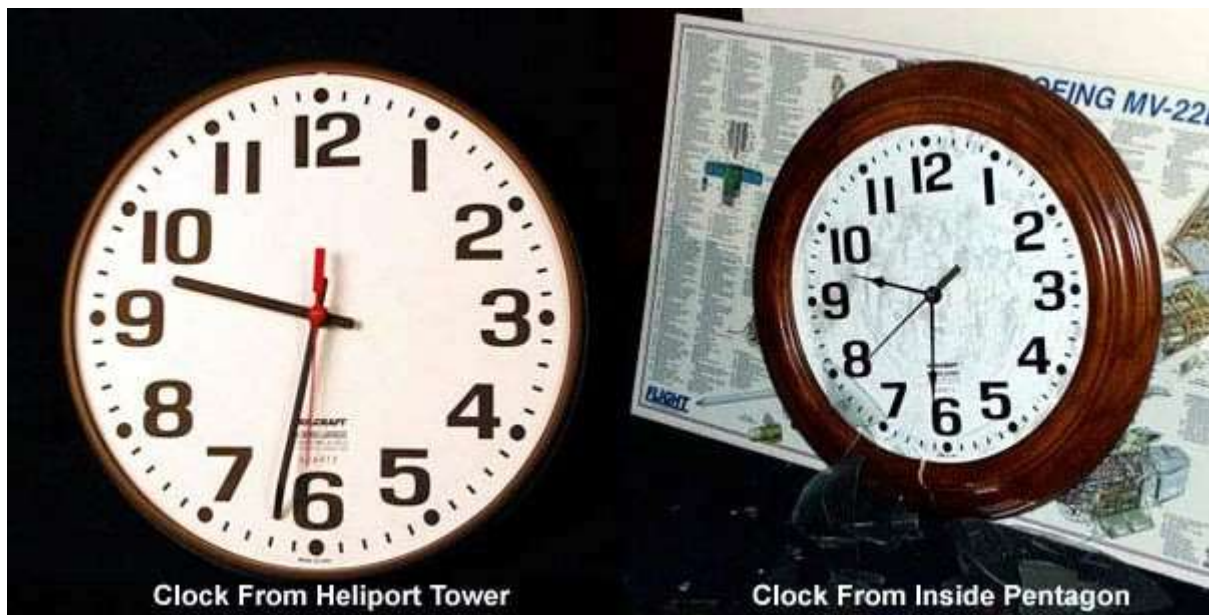
Figure E-1: Pentagon wall clocks cited by Honegger and others
Left: Heliport clock, 9:32:30. Right: Navy Area clock, 9:31:40

The essential problem with the clocks is that, for wristwatches and wall clocks, there is no way to verify that they were initially set at the correct time or were synchronized with standard time. Moreover, for the fallen clocks, it has been established by experiment⁴⁸ that the hands of clocks identical to the Heliport clock can move back if the clock falls and hits the ground. Depending on its orientation when hitting the ground, the backward movement of the minute hand can be zero, a few minutes or as much as 17 minutes. These clocks are battery operated and, as observed experimentally, the batteries can dislodge when the clock is dropped. This dislodgement stops the clock. The conclusion is that the earlier event time evidence based solely from fallen clocks and wristwatches is untrustworthy, unprovable and therefore seriously flawed. Furthermore, Honegger has excluded from consideration two other Pentagon clocks⁴⁹ whose hands stopped at approximately 9:36:27 and 9:37 or a little later. These clocks are shown in Figure E-2 and may have fallen in such a way that there was little or no hand movement. Or they may have read a time later than 9:37 am, but fell in such a way that the minute hand moved back. In either case, the clock readings cannot be deemed reliable.⁵⁰

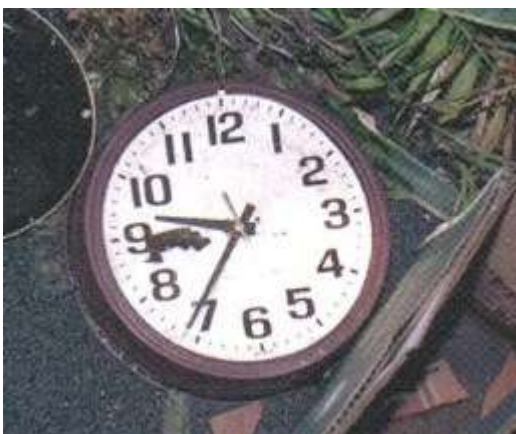
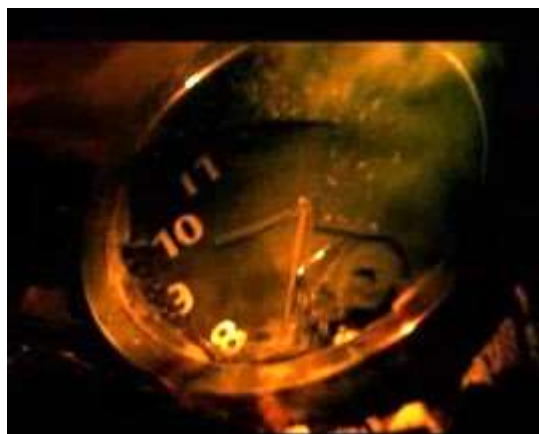
Figure E-2

- (a) Left: Stopped clock from room 3E452 near “hinge” of collapsed floors, 9:36:27
(b) Right: Burnt clock, approximately 9:37

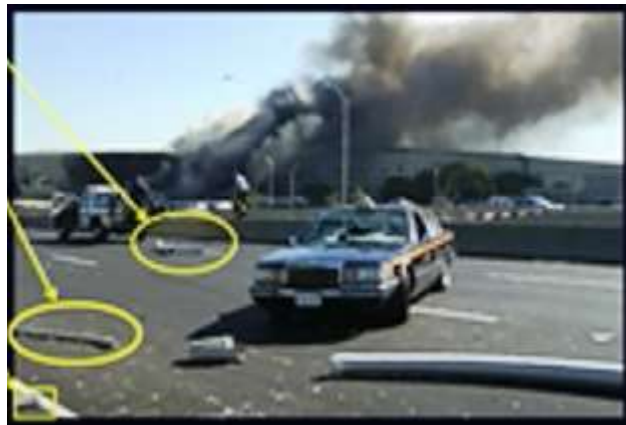
Figure F-3 – Long portion of Pole #1 at Right in Front of Loyde England's Taxi Cab
The Piece from Pole #2 that Pierced the Taxi's Windshield is in the Ellipse at Lower Left

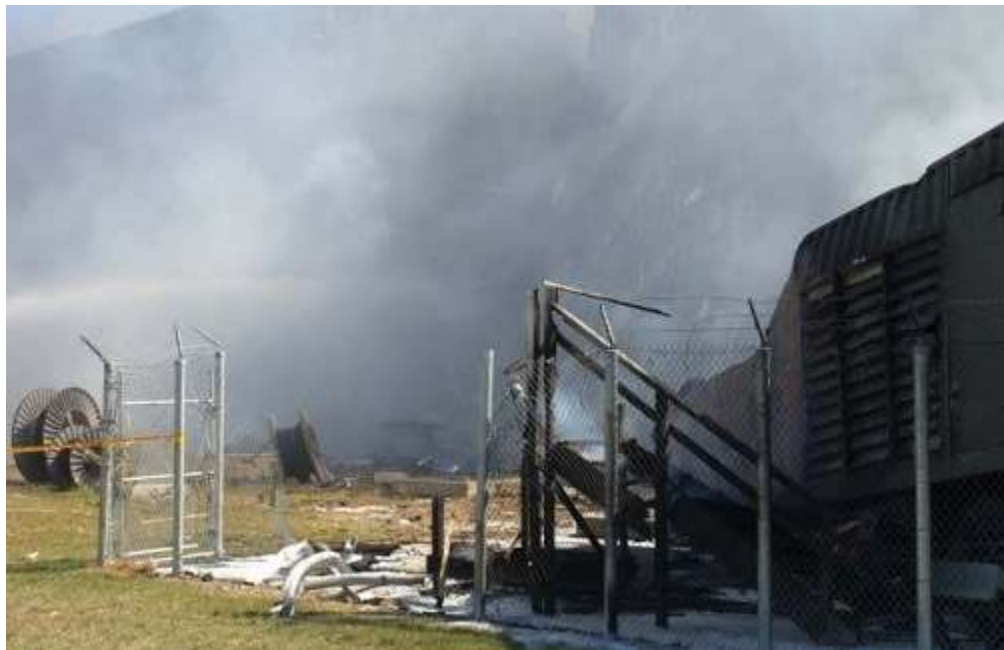
Eyewitnesses⁷⁰ such as Bruce Elliott, Jerry Henson, Don Mason⁷¹ and Frank Probst testified to seeing the generator trailer struck by the plane’s right wing or engine. After first striking the fence, the engine struck the north end of the heavy generator trailer at a point approximately 5 to 8 feet from the ground, creating a large gouge as shown in Figure F-4.

Figure F-4 Generator trailer and fence
The north end of the trailer is gouged

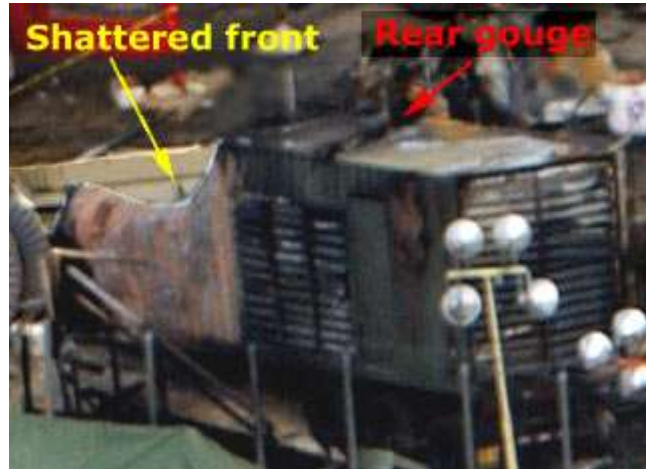
Another gouge about 6 to 10 feet away from the engine damage matches the distance of the right engine from the first flap canoe⁷² on the plane's wing (see Figure F-5). This gouge makes an angle of roughly 45 degrees with the long side of the generator and is consistent with the plane's direction.

Figure F-5 Generator trailer with gouge

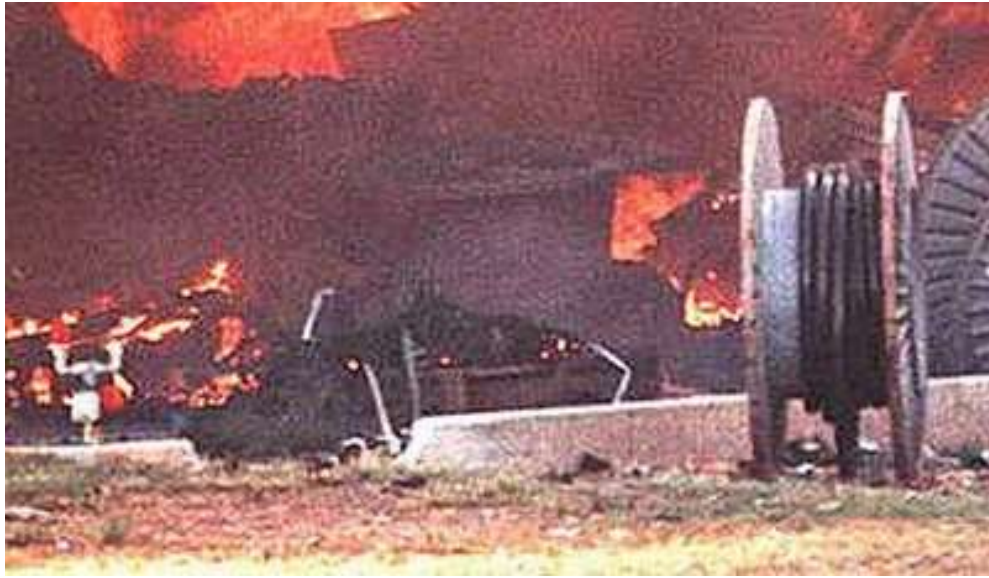
Figure F-6 Low concrete wall gouge

The gouge indicates that the left engine was very close to the ground at this point. However, as shown in Figures F-9 and F-11 and in these photographs, the ground slopes up as one approaches the concrete wall from the highway and from the generator trailer and then slopes down toward the Pentagon west wall. Thus the left engine did not gouge the lawn as it was just above ground level at a high point. The two red lights to the left of the gouge are warning lights.

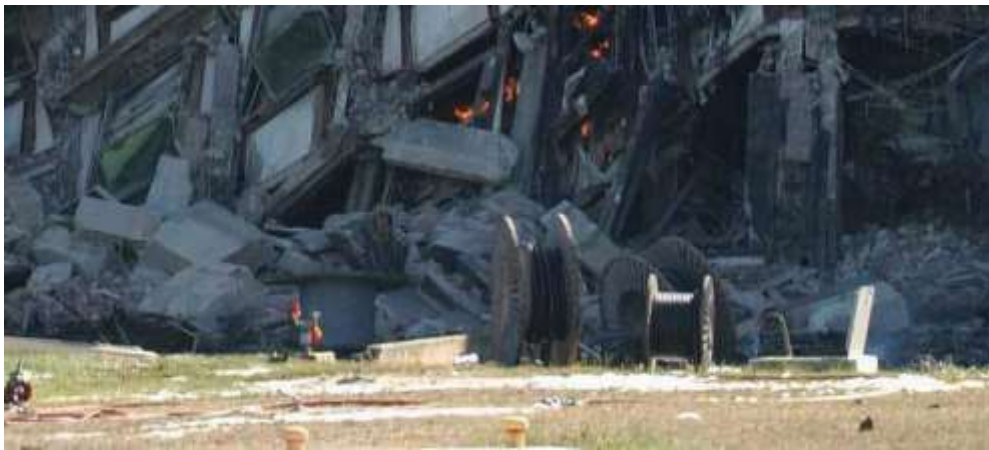
Figure F-7 Low concrete wall and small spool

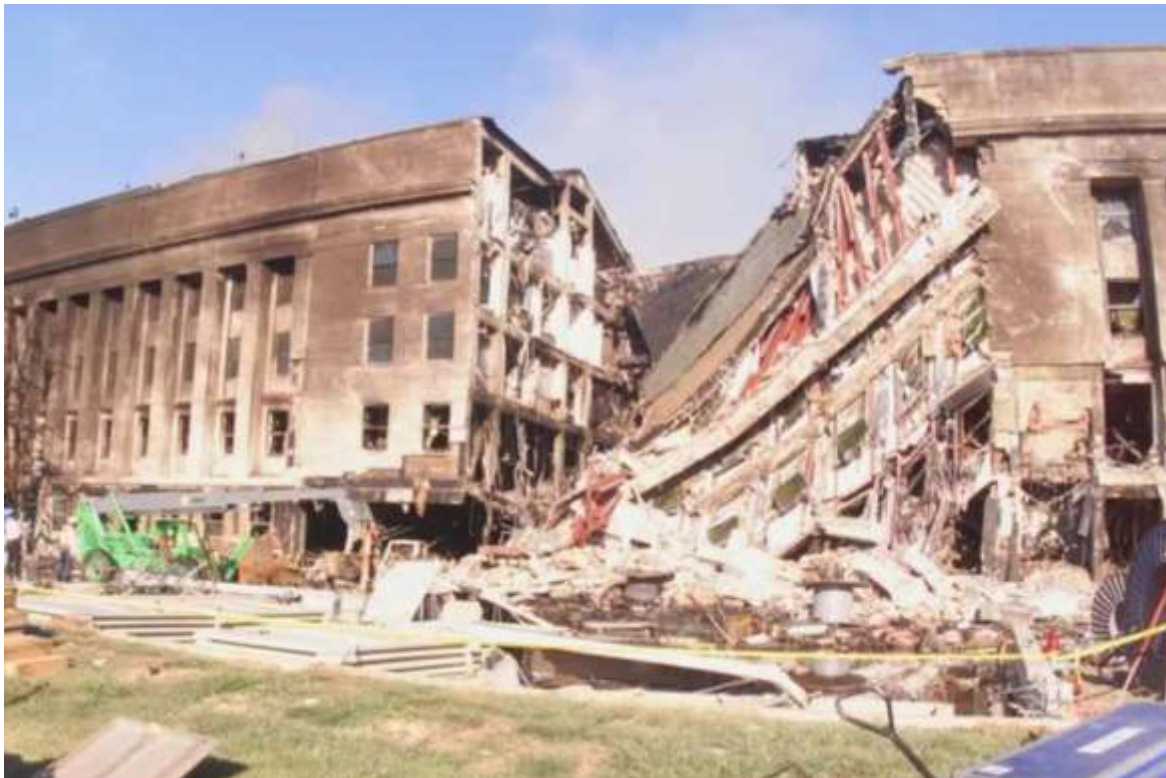
the lights are in the corner where two sides of the low concrete wall meet at a right angle and therefore were not in the path of the left engine.

Figure F-8 Warning lights and collapsed section (see red lights at bottom right)

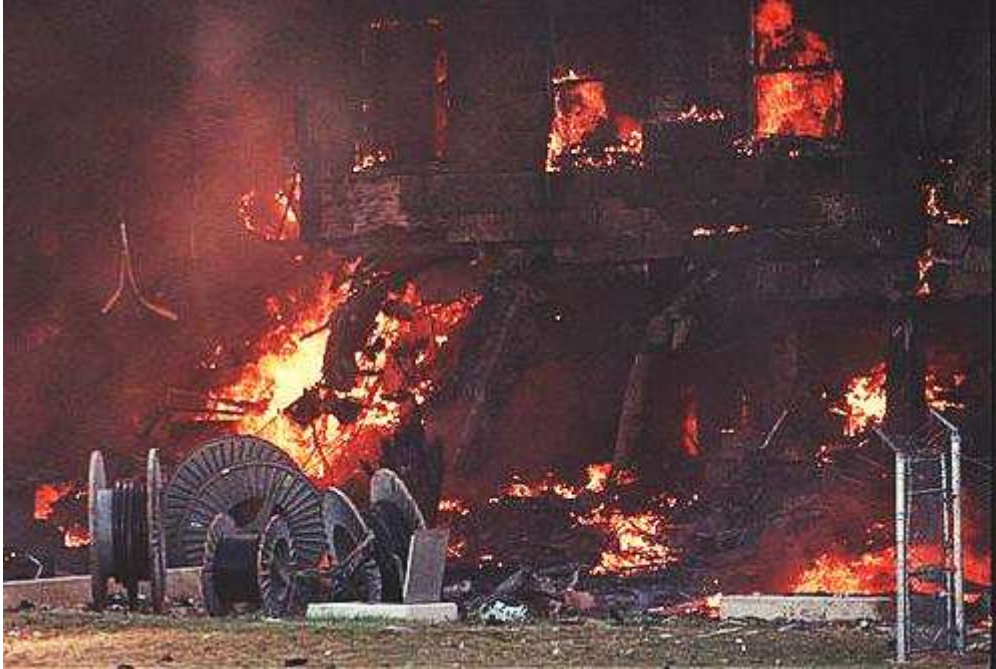
Figure F-15 Façade damage with raging fire
Taken at a more oblique angle facing the façade

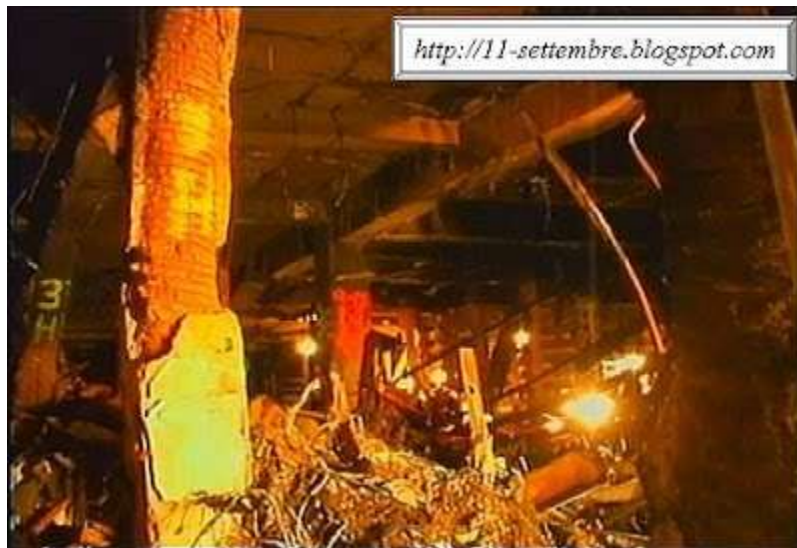
As shown in other sections of this paper, Honegger's treatment of the damaged columns focuses on two areas: the fact that outer columns were missing and some column "remnants" appeared to be bowed out rather than in. Although she refers to PBPR figure 7.9 (Figure H-1), she pays no attention to the overall damage pattern highly suggestive of plane impact and penetration, or to the physical appearance of many columns which is also highly indicative of plane debris flow in the direction of the plane path.

Figure G-1 Curved and abraded column

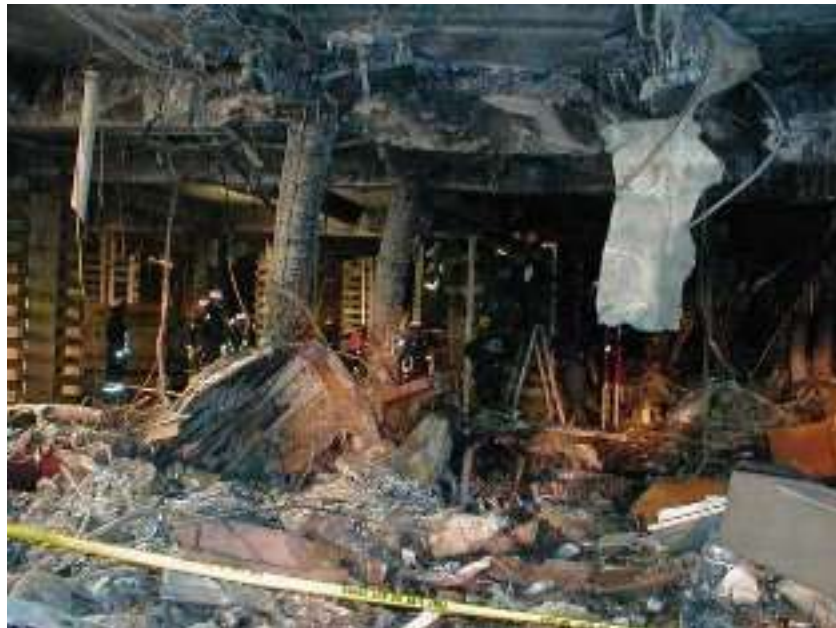
Figure G-4 shows a piece of silver metal hanging from the ceiling with another large piece of metal debris up against one of the bowed columns.

Figure G-4 Curved columns and aluminum metal

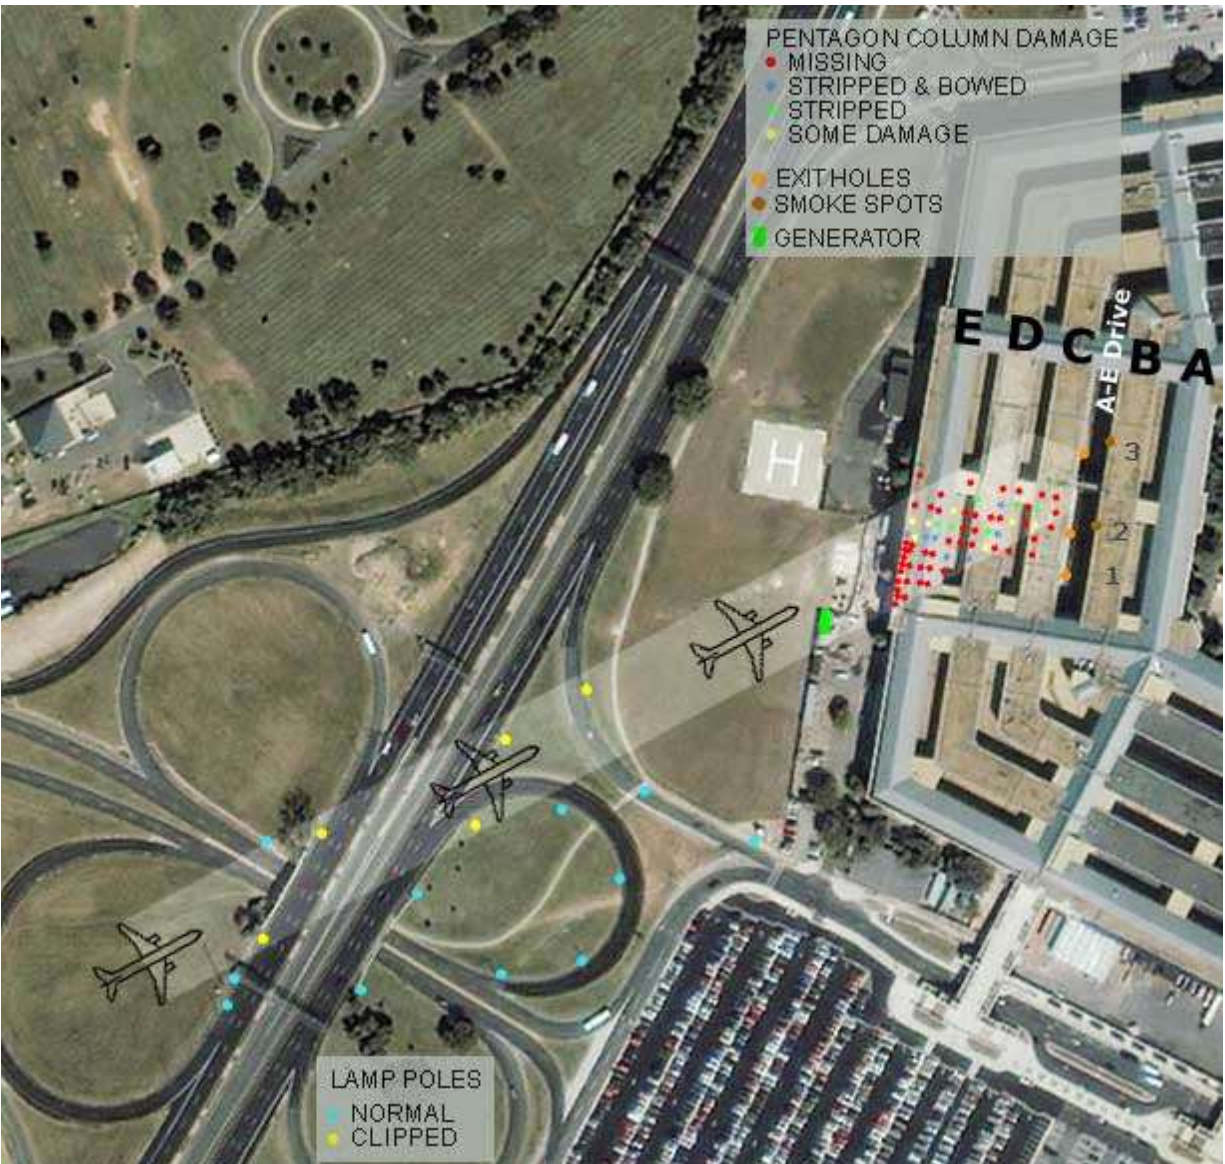
Figure G-5
Aerial photograph with three marked “Exit” holes

Hole 1 is a door, hole 2 is a roll-up door larger in width, and hole 3 is the C Ring hole where debris from the large plane broke through into the A & E driveway. In her text (book) version of her Toronto Hearings' talk, Honegger acknowledges that holes 1 and 2 are doorways, but she does not mention this fact in her Toronto or Seattle live presentations where she compares Figure G-5 with a similar figure showing only one "EXIT HOLE," the C Ring hole (see Figure G-6).

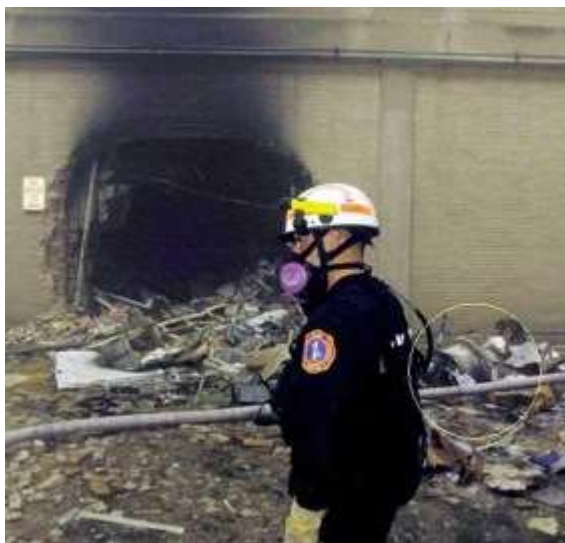
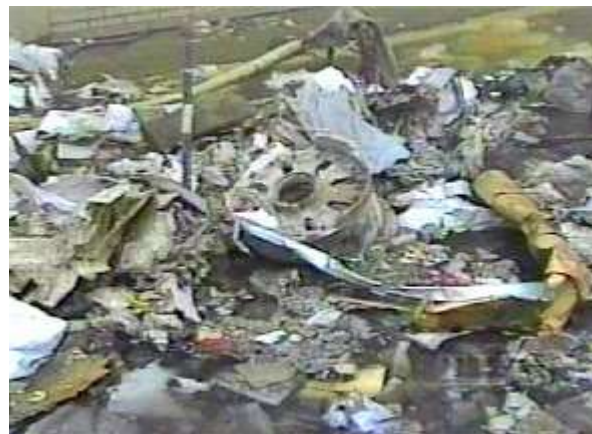
Honegger disputes this theory and claims that the hole was *not* caused by an aircraft, but rather caused by shaped charges in order to provide access to the area by Pentagon and rescue personnel. She further states that it is virtually impossible for a plane to travel through the column network; therefore, the circular hole could not have been from any plane. In her Toronto talk Honegger repeats a widely-held misconception that the plane traveled through the walls of “3 of 5 rings”. The plane actually traveled through the walls of only two rings, E and C, since the intervening D ring had no wall on the first and second floor levels. This can be seen in Figure G-8(a) where a viewer standing in the A&E driveway outside the C ring wall can see light coming through the E ring windows.

Wheel hub found outside C ring hole

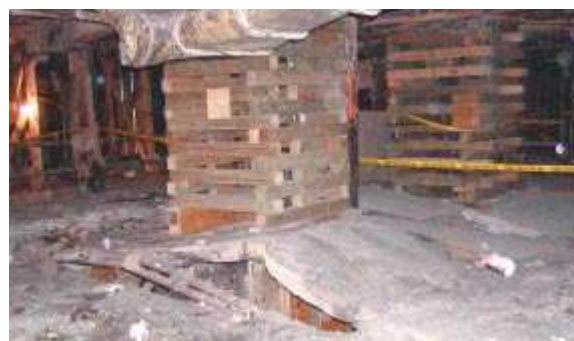
Figure H-2
 Pentagon Building and Performance Report
 Figure 5.27 Breached second-floor slab
