BEYOND MISINFORMATION

What Science Says About the Destruction of
World Trade Center Buildings 1, 2, and 7

ARCHITECTS
& ENGINEERS
for 9/11 TRUTH

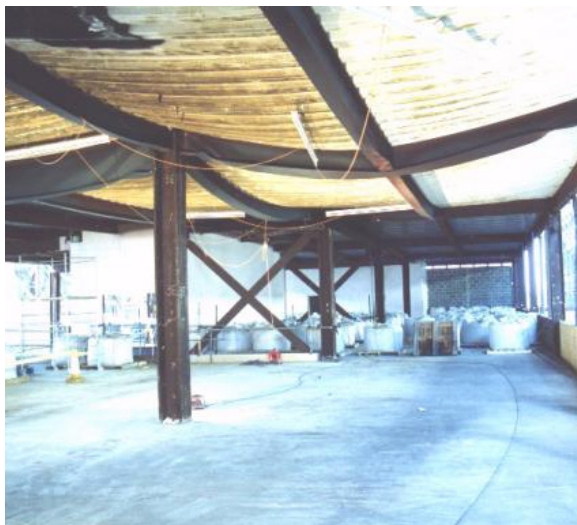
BRE tests in Cardington, United Kingdom.

The NIST survey also noted two major fire test programs conducted at the Building Research Establishment (BRE) Laboratories in Cardington, United Kingdom. The first series of tests, conducted on a representative eight-story composite steel-framed office building, resulted in significant fire damage but did not result in collapse, even with unprotected steel floors. The second series of tests conducted on a seven-story concrete building also did not result in collapse.

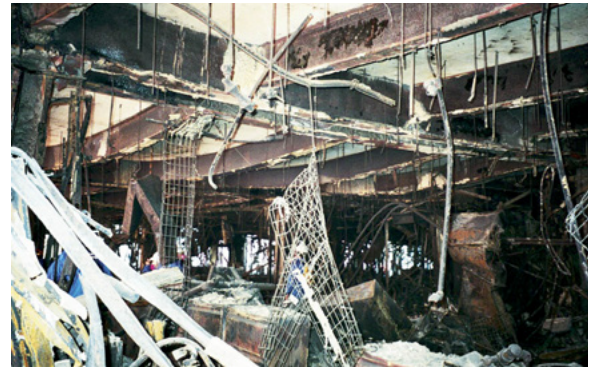
Fire damage in WTC 5 (2002 NIST survey of fires that resulted in total or partial collapse).

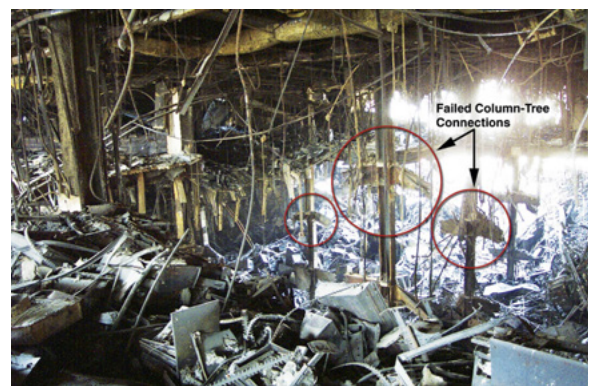
Partial connection and floor failures in WTC 5 (2002 NIST survey of fires that resulted in total or partial collapse).

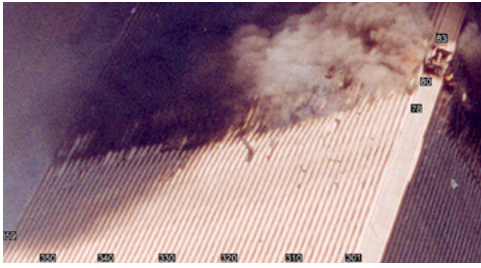
WTC 2 exterior columns bowing inward across the east face between Floors 77 and 83 at 9:58:55 a.m. (NIST NCSTAR 1-6, page 178, Figure 6-21).

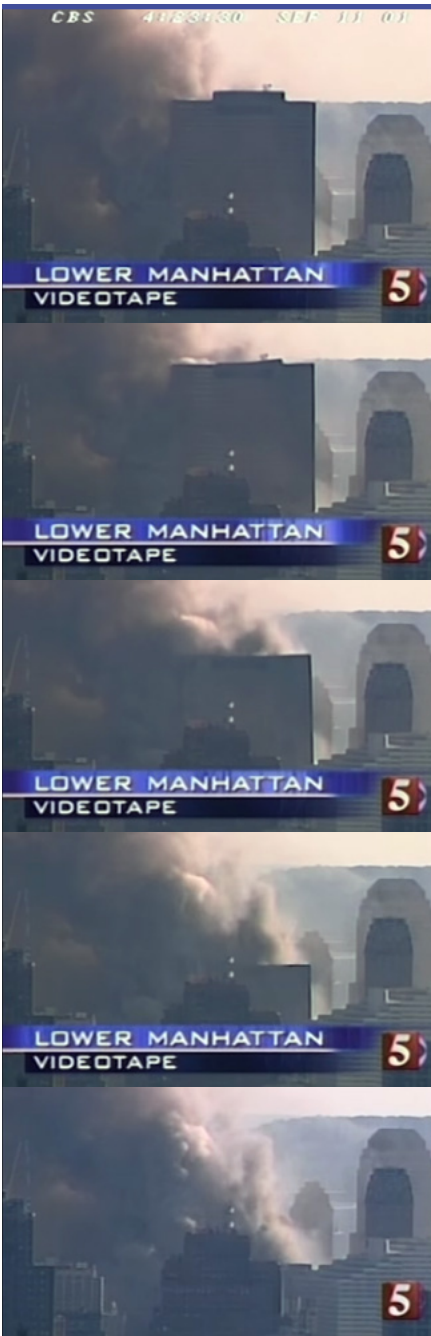
WTC 7 is shown falling symmetrically into its own footprint. It accelerated at free fall for 2.25 seconds of its descent.

Today, NIST acknowledges that WTC 7 fell at a rate of free fall (or the rate of gravity) for a period of approximately 2.25 seconds before it started to

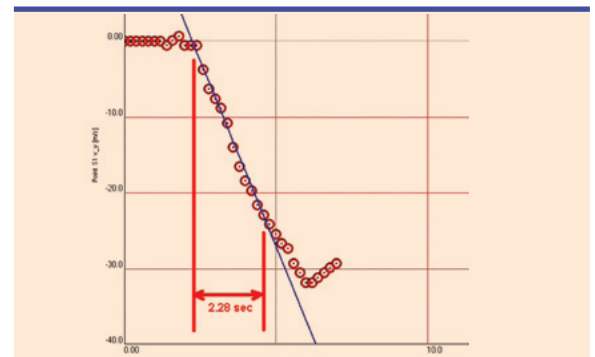
David Chandler's graph from Part 3 of "NIST Finally Admits Free Fall" plots the velocity of WTC 7's roofline versus time. The slope shows a free-fall rate of acceleration. The sudden change in slope shows the sudden onset of free fall.

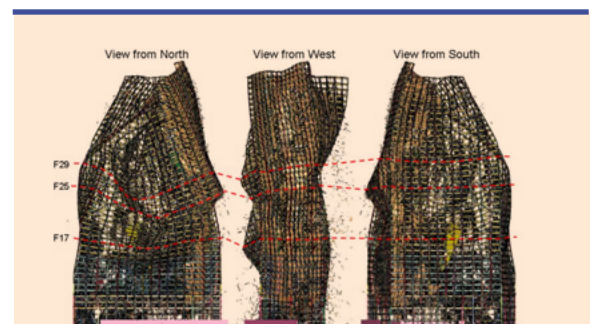
NIST's model of WTC 7's collapse shows large deformations to the exterior of WTC 7 not observed in the videos, while failing to show 2.25 seconds of free fall.

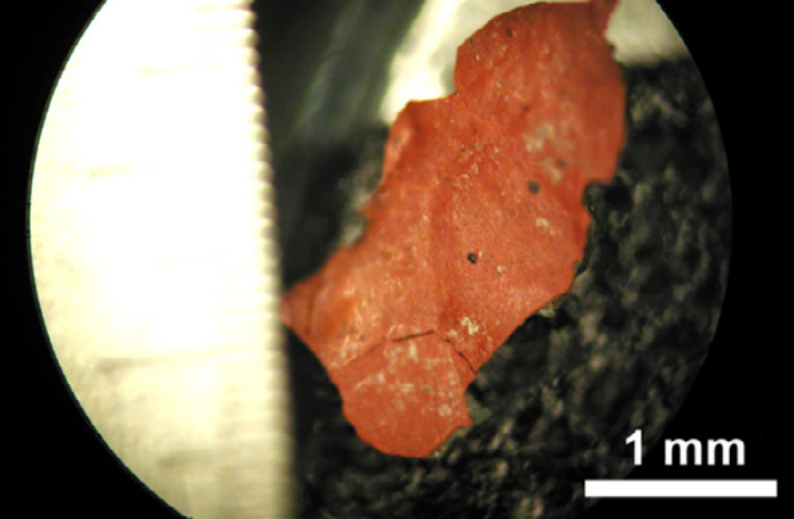
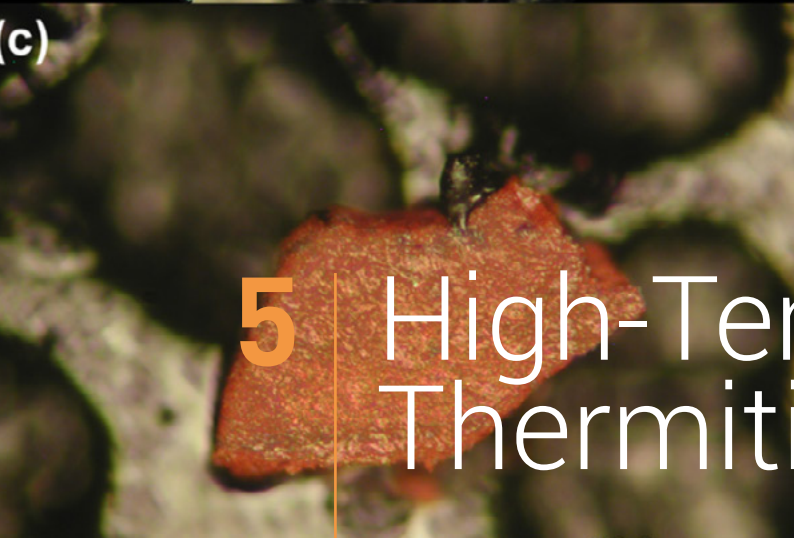
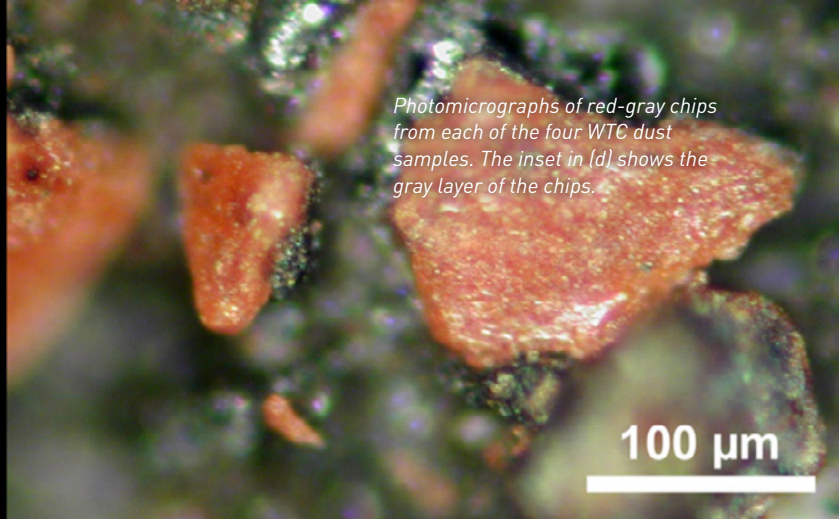
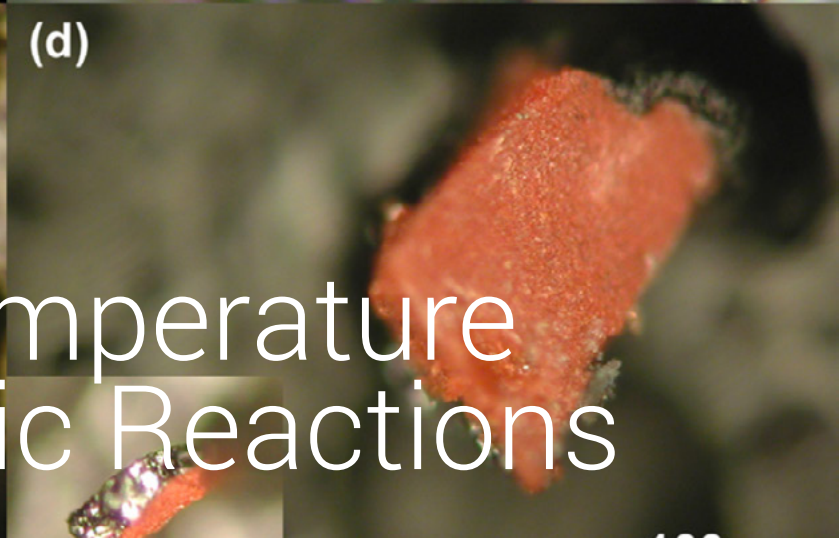
Photomicrographs of red-gray chips from each of the four WTC dust samples. The inset in [d] shows the gray layer of the chips.

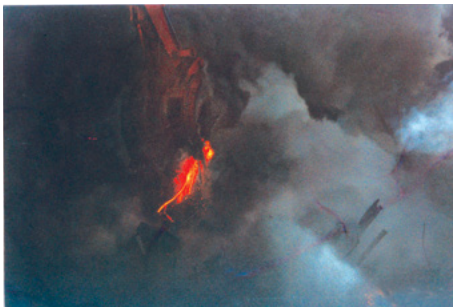
This photograph, taken by Frank Silecchia on September 27, 2001, shows a piece of metal being dug up that is salmon-to-yellow color, indicating temperatures from 845°C (1,550°F) to 1,040°C (1,900°F).

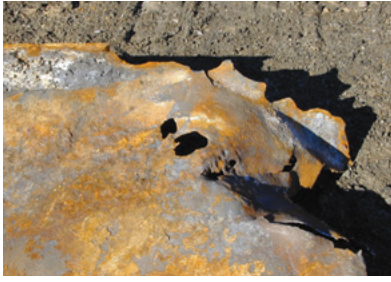
The eroded, sulfidated steel from WTC 7 at the scrapyard before it was cut off and taken for testing.

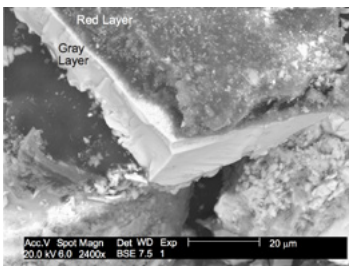
A backscattered electron image of a red-gray chip.

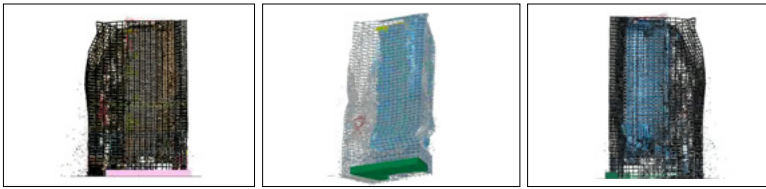
Above: The final frame from three different computer simulations showing WTC 7's collapse from the north, northwest, and south, respectively.

However, when we view the model,¹⁴ we see — besides the fact that it stops after only two seconds,
