September 2009

Evidence for the Explosive Demolition of World Trade Center Building 7 on 9/11

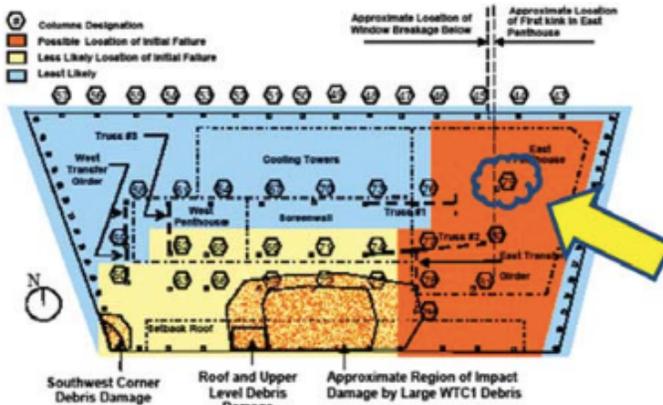
Figure L-29. Plan view of regions for collapse initiation.

beams leading to the progressive collapse of 9 floors. This ultimately caused the failure of column #79 – the first one to fail – followed by all the rest.

Figure 1: 24 columns removed within a fraction of a second - by fire?

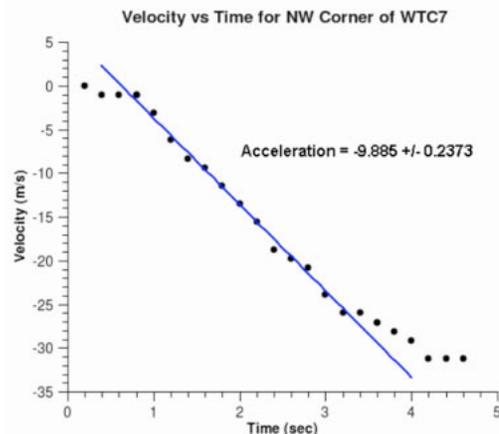
WTC 7 descended at free-fall acceleration over 2 seconds for a distance of over 100 feet – at least eight stories. NIST initially denied the fact of free-fall in its final draft report released in August 2008. In the technical briefing that followed, NIST’s lead investigator, Shyam Sunder explained, “A free-fall time would be an object that has no structural components below it.” He claimed that WTC7 took 40% longer than “free-fall time” to collapse, “and that is not at all unusual because there was structural resistance that was provided in this particular case. And you had a sequence of structural failures that had to take place and everything was not instantaneous.”

However, physics instructor and AE911Truth associate David Chandler had used network television videos to carefully measure the acceleration of the building during its fall and shown conclusively that a significant period of free-fall was an indisputable fact. He publicly challenged NIST’s claims at the technical briefing. Along with several others, he filed formal requests for corrections during the public response period.

Figure 2: WTC 7 in free-fall for 8 stories

In its final report NIST reversed itself on its denial of free-fall, but it couched its revised statement in deceptive language and failed to address how free-fall could be compatible with its fire-induced progressive collapse analysis. For the observed straight-down collapse, a thick network of heavy steel columns and beams, had to be forcibly removed and more than 400 structural steel connections had to fail per second, evenly all across each of the eight floors involved. These failures had to occur *ahead* of the collapsing section – NOT caused by it – because a free-falling object cannot exert force on anything in its path without slowing its own fall.

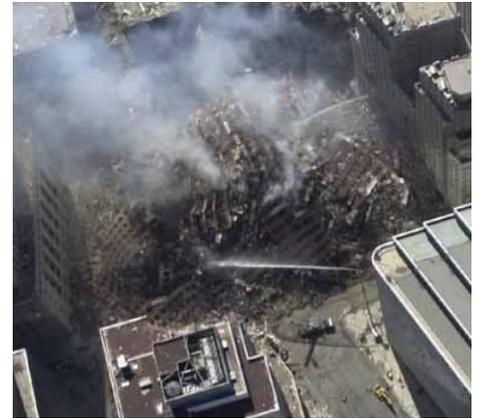
reduced, in less than seven seconds, to about four stories of debris – like a house of cards – with the virtually complete dismemberment of the steel skeleton, including both braced and welded moment-resisting (bend-resistant) frames.

Figure 3: Total dismemberment of WTC 7's steel structure.

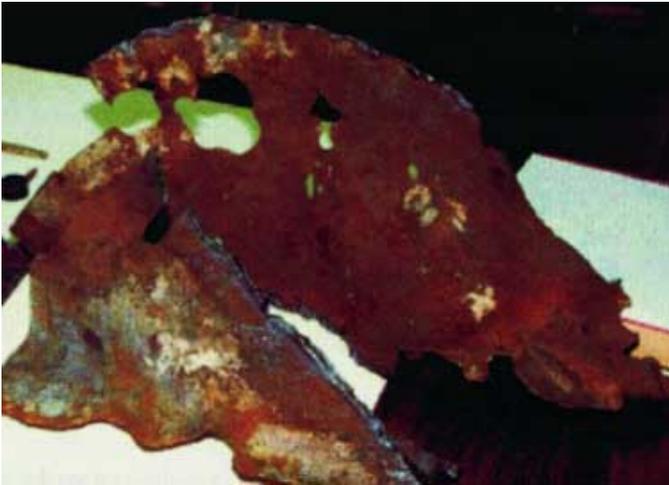
Prior to the NIST investigation, FEMA, the Federal Emergency Management Agency, had conducted a preliminary, cursory, underfunded investigation and produced a Building Performance Assessment Report. In Appendix C of that report, FEMA described steel samples from Building 7 that had undergone a “high temperature corrosion attack” that had turned a heavy steel flange “into Swiss cheese.” They found “evidence of a severe high temperature corrosion attack on the steel, including rapid oxidation and sulfidation with subsequent intergranular melting....”

Figure 4: Office fires don't do this to steel.

FEMA’s metallographic analysis showed that the steel had not only melted but some of it had even “evaporated”. “A liquid eutectic mixture containing primarily iron, oxygen, and sulfur formed during this hot corrosion attack on the steel.”... “No clear explanation for the source of the sulfur has been identified.” The *New York Times* called this “perhaps the deepest mystery uncovered in the investigation.” What did NIST say about this mystery described by FEMA? They did not mention it.

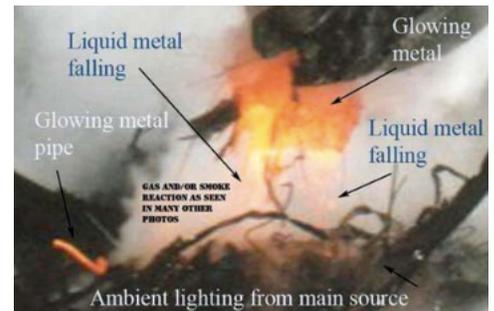
Photos clearly reveal molten

Figure 5: Office fires are not hot enough to create the molten metal seen by dozens of witnesses.

metal dripping out of the material held in the jaws of “crabclaw” excavators.

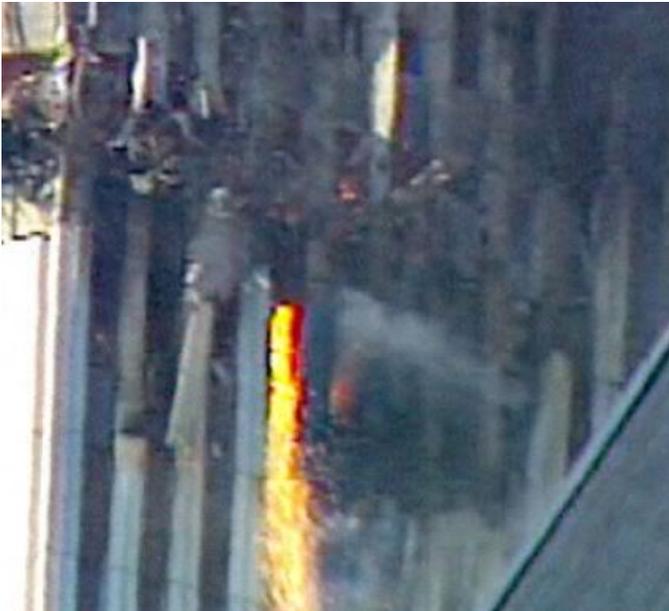
Video taken of the South Tower shortly before it came down shows a spout of molten metal spewing from near the impact hole, brightly glowing orange-yellow in daylight, unlike molten aluminum, which appears silvery under these conditions. It could only be molten iron or steel.

Figure 6: Jet fuel and office fires can't create molten metal

John Gross, lead engineer for NIST, publicly denied the existence of molten metal despite the abundant evidence. Shyam Sunder of NIST later acknowledged it but could not offer a rational explanation for it. NIST's afterthought Answers to Frequently Asked Questions (FAQ) webpage attributes the spout's color to mixing of office contents with the aluminum – a hypothetical phenomenon that physicist Steven Jones and independently a NASA engineer have been unable to reproduce in two laboratory experiments. Given the stakes, one might expect NIST to have used some of the 20 million dollars allocated to the WTC study to show us – not just

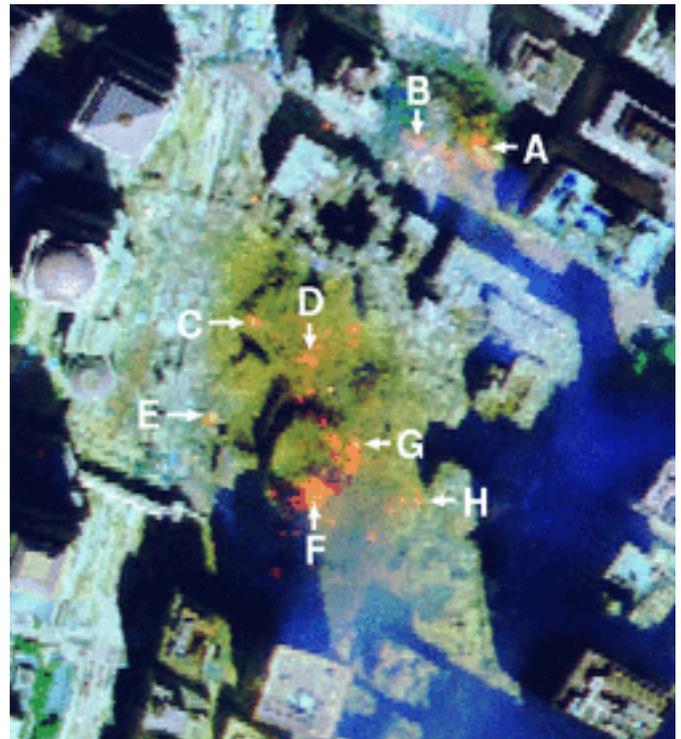
USGS used NASA thermal imaging of the surface of the WTC rubble pile to document hot spots with extreme temperatures of almost 1,400°F. These temperatures, too, are hotter than most office fires produce. And there were no fires on the surface of the WTC 7 pile following the collapses.

Figure 7: Impossible temperatures on the surface of Ground Zero a week after the collapses.

The detected surface temperatures indicate much higher temperatures deep in the pile, which persisted for several weeks despite the

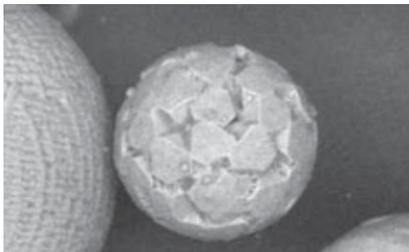
Chemical and micrographic analysis of the dust that blanketed Lower Manhattan after the destruction of each of the Twin Towers revealed the presence of iron-rich “microspheres.” These microspheres were found in separately collected samples of the dust both near and far from Ground Zero, some of it collected before cleanup operations had begun. Their shape indicates that they were previously molten fragments that were

Figure 9: Billions of previously molten iron spheres found in all WTC dust samples.

pulled into spherical form by surface tension into droplets, which solidified before hitting the ground. They are direct evidence

that temperatures exceeding the melting point of iron were present during the buildings’ destruction. These microspheres could not have been produced by friction or any other known process during the Towers’ collapses. Furthermore, they lack the chromium present in structural steel and contain manganese, an ingredient of potassium permanganate, a common thermite additive.

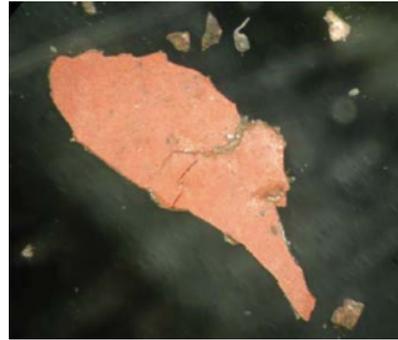
An even more definitive discovery arose during a scientific examination of the dust: red-gray chips. An international team of chemists, physicists, and

Figure 8: Hundreds of red/gray chips of "unignited nanothermite" in every WTC dust sample.

others confirmed that the chemical makeup of the red layer of these chips, their granular structure, and thermal behavior, were all consistent with those of advanced thermitic explosives.

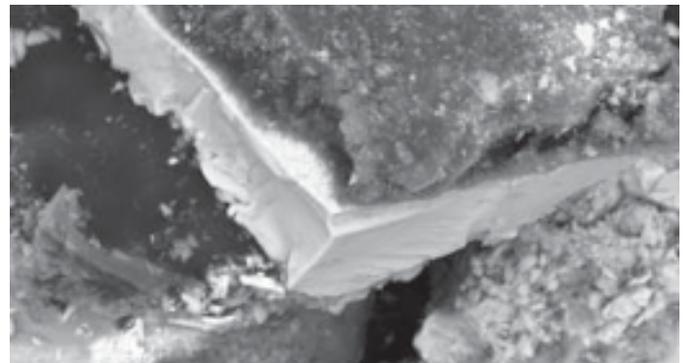
Particle sizes of less than a tenth of a micron in the red layer classify this material as nanothermite. The significance of the extremely small particle sizes is that the surface area is much greater for a given volume of the components, so chemical reactions are greatly accelerated.

Figure 10: Nanothermite particle sizes are 1,000 times smaller than a human hair. This material is not made in a cave in Afghanistan.

It contains ultra fine grain particles of aluminum and iron oxide, 1,000 times smaller than a

human hair, “intimately intermixed” and embedded in a matrix of organic material. When it is heated slowly to about 430° C it “goes off ” thermally, producing molten iron in spheroids reminiscent of those found in the dust. Clearly the reaction, triggered at only 430° C, releases enough energy to raise the temperature beyond the melting point of iron (1538° C.).
