WHY THE RED/GREY CHIPS ARE NOT PRIMER PAINT

Niels Harrit, May 09

It has been suggested, that the red/grey chips discovered in the dust from the WTC collapse catastrophe¹ could originate from rust-inhibiting paint (primer paint) applied to the steel beams in the towers. This letter compares the elemental composition and the thermal stability of the two materials based on the description of the protective paint in the NIST report and observations on the red/grey chips.

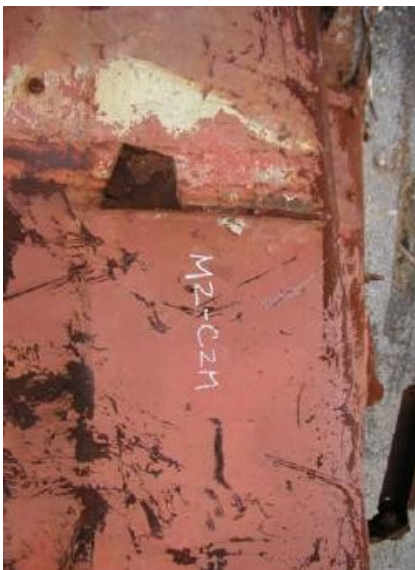
Examples of typical beams are shown in Figure 1 and Figure 2.

Figure1. M2-C2M (WTC1, Col.130, FI98)
From NCSTAR 1-3 C appendix D².

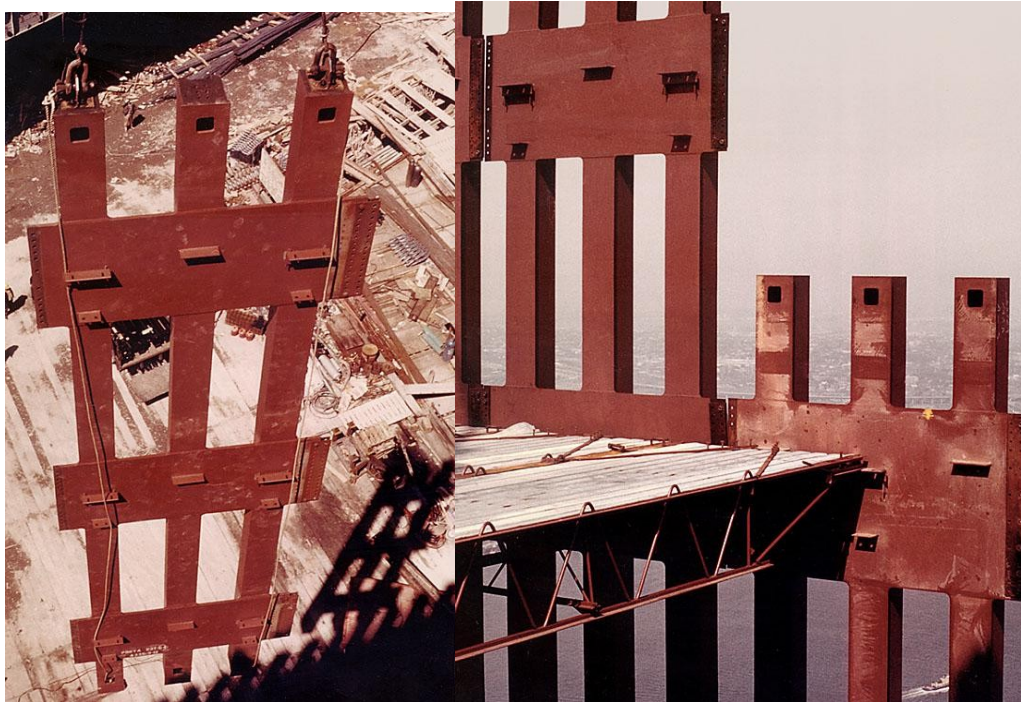
Figure 2. Perimeter columns in WTC towers. From NIST.

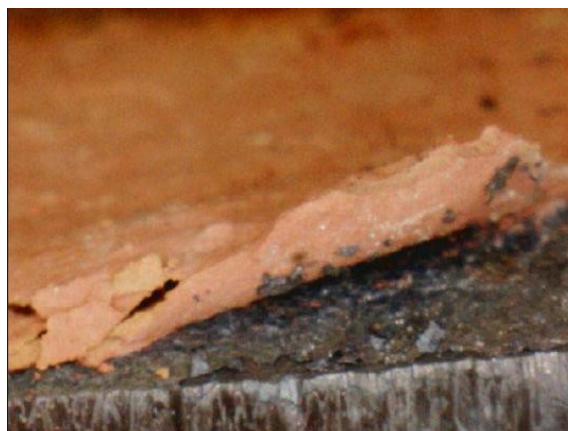
Source: NIST.
Figure D-4. Formation of a black scale between paint and steel after exposure greater than 650 °C. Paint readily spalled.

Figure8. From NCSTAR1-3C appendixD² showing formation of a black layer under the primer paint at temperatures beyond 650 °C.

between the paint and the steel (Figure 8). NIST took the samples beyond 800 °C at which temperature the scale formation and peeling off of the paint from the steel was prevailing. One may hypothesize that formation of the black scales is due to charring of the organic binder.
