1 *Introduction*

1.1 Purpose and Scope of Study

This report presents observations, findings, and recommendations regarding the performance of buildings affected by the September 11 attacks on the WTC towers in New York City. This report also describes the structural and fire protection features of the affected buildings and their performance in response to the terrorist attacks. Due to the unprecedented nature, magnitude, and visibility of the terrorist attacks, this event is among the most well-documented in the media, particularly in terms of photographic images, lives affected, and the immediate responses and ensuing sequence of events. An understanding of these events must include the performance of the buildings under extreme conditions beyond building code requirements. This includes determining the probable causes of collapse and identifying lessons to be learned. Recommendations are presented for more detailed engineering studies, to complete the assessments and to produce improved guidance for building design and performance evaluation tools.

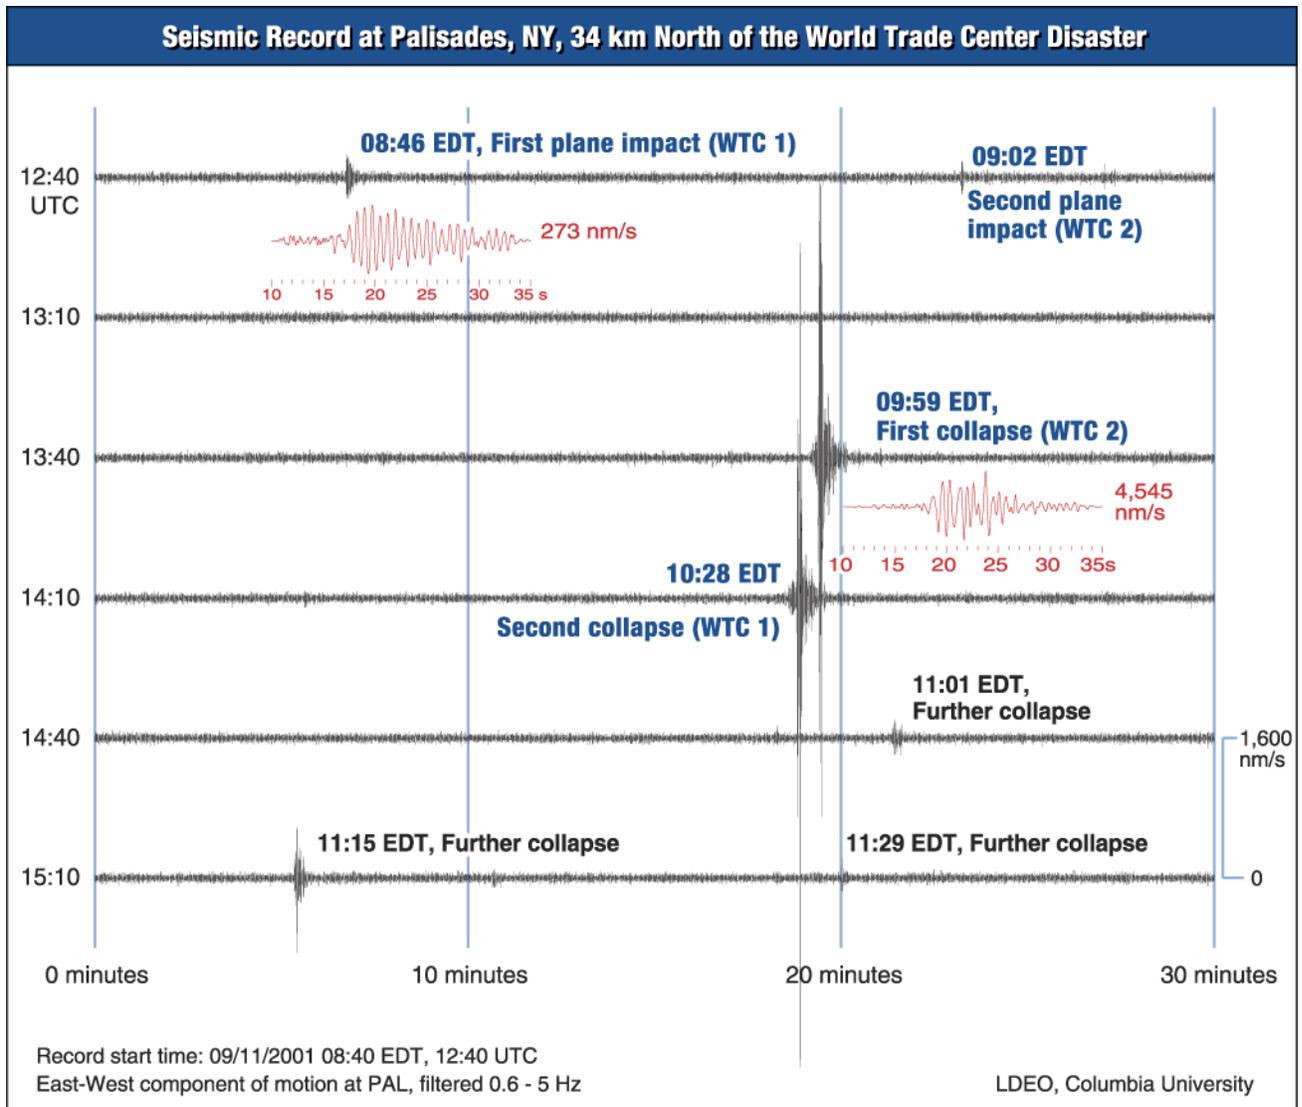
The timeline of the major events is summarized in Table 1.1. The times and seismic data were recorded at the Lamont-Doherty Earth Observatory (LDEO) of Columbia University. The signal duration and Richter Scale magnitudes were included to indicate the relative magnitudes of energy transmitted through the ground between the events. Figure 1-8 shows the accelograms recorded by the observatory during the events.

Figure 1-8 Seismic recordings on east-west component at Palisades, NY, for events at WTC on September 11, 2001, distance 34 km. Three hours of continuous data are shown starting at 08:40 EDT (12:40 UTC). The two largest signals were generated by the collapses of towers 1 and 2. Expanded views of first impact and first collapse are shown in red. The amplitude of the seismic signal is in nanometers per second (nm/s), and the peak amplitude of the ground motion at this station reached to 4,545 nm/s for the first collapse. Note the relatively periodic motions for impacts 1 and 2.
