#### Investigating the Mechanics of Destruction at the Twin Towers on 9/11: The Case for Propelled Demolition

#### By Wayne H. Coste, PE

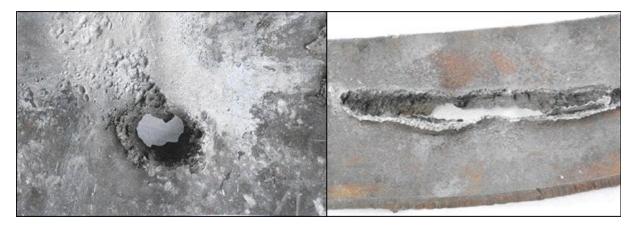
As shown in Figure 1, high explosives forceful enough to cut steel would leave behind an unmistakable forensic trail<sup>7</sup>. Damage from this mechanism was not documented in the remnants of the bent, ripped, torn and otherwise deformed steel.

Figure 1: Holes punched through 1 inch steel plates from the explosive energy of shaped charges: Cone shaped charge (left); Linear shaped charge (right).

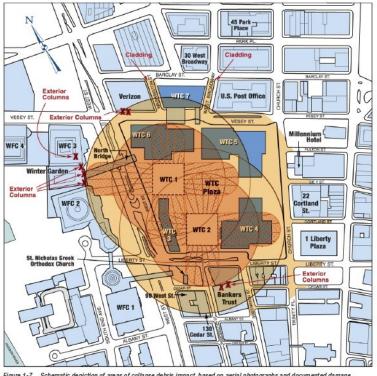
The 2002 FEMA report describes a 1,200 foot diameter debris field around each tower that is centered on the core as shown in Figure 2. As documented in this figure, each building is not only at the center of a circle of debris around each core, but each tower has significant documented ejection patterns in the cardinal directions (north-south-east and west). These north-south and east-west ejection patterns suggest forces emanating perpendicular to the core pushing the perimeter columns and floor structure outward in these directions. A corollary to this directionality is that that propelling forces were weakest in the ordinal directions (northwest, southwest, southeast and northeast). This directionality suggests the propelling forces did not act strongly into these corner quadrants of the towers. This suggests that the primary destructive forces emanated perpendicular to the core – and were not distributed uniformly throughout the floor-space.

Figure 1-7 Schematic depiction of areas of collapse debris impact, based on aerial photographs and documented damage. Striped areas indicate predominant locations of exterior steel columns. Inner circles indicate approximate radius of exterior steel columns and other heavy debris. Outer circles indicate approximate radius of aluminum cladding and other lighter debris. Heavy Xs show where exterior steel columns were found outside the predominate debris areas.

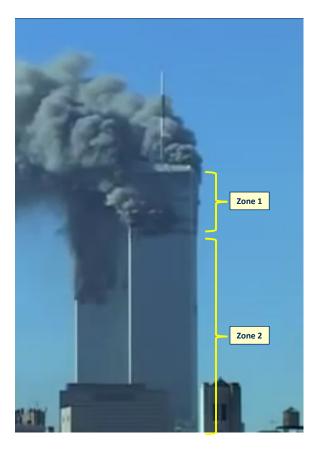
Figure 3: "Zone 1" is where the destruction appears to travel up the tower and "Zone 2" is where the destruction proceeds down the tower. "Zone 3" (not shown) encompasses the four story atrium at the plaza level and below.

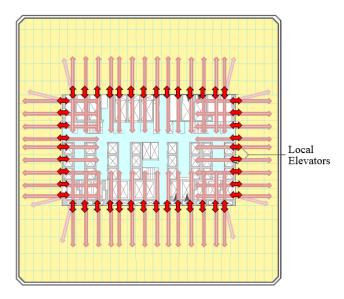
As shown by the red arrows in Figure 5, the propellant was assumed to be activated around each floor in all directions simultaneously. This way, the perimeter columns around the outside of each floor are all pushed outward simultaneously. In accordance with Newton's third law which states, "for every action, there is an equal and opposite reaction", The propulsive force to push the exterior perimeter columns outward must be created by an equal "reactionary" force in the opposite direction – such as into the region of the core columns and then out through the opposite side.

## Figure 5: Ignition of propellant at each floor level pushes the perimeter columns outward and creates a reactionary force into the core columns and out through the opposite side.

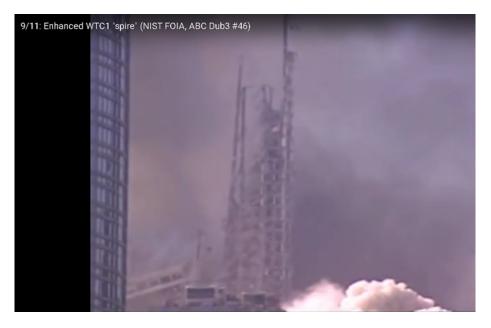
for about 20 seconds in the case of the North Tower and only moments for the South Tower<sup>20</sup>. The "ghost spire," reaching up to about the 70<sup>th</sup> floor of the North Tower, is seen in Figure 6 just before it collapses<sup>21</sup>. Figure 7 shows similar, but shorter, remnants of the South Tower core. This portion of the core remains standing for a much shorter period of time.

Figure 6: The "Ghost Spire" consisting of remaining core columns in the immediate aftermath of the destruction of the North Tower

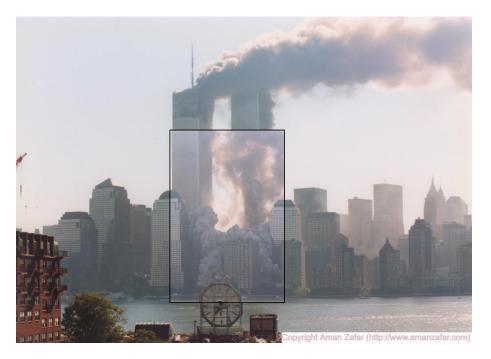
Figure 7: Remnants of the South Tower core columns remain standing for moments after the surrounding office space is destroyed. (Composite of a pre and post photos by Aman Zafar)

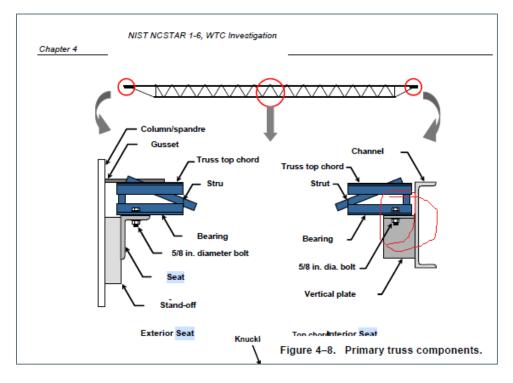
The connection of the floor trusses to the channel consisted of only two 5/8 inch bolts per truss. Figure 8 shows the floor truss connections between the perimeter columns on the left and the channel on the right (e.g., to the core column).

Figure 8: Comparison of floor truss connections to core and perimeter columns. Note the gusset plate weld to reinforce the truss to perimeter column seat connection.

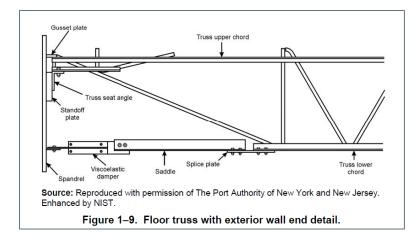
While the connection of the floor truss to the interior channel consisted of only two bolts, the connection to the outer perimeter columns was more structurally substantial. As shown in Figure 9, in addition to the two 5/8 inch bolts, there was a gusset plate that was welded between the perimeter column and the trusses' upper chord. Additionally, there was a viscoelastic damper that connected the trusses' lower chord to the perimeter column. Then, two additional connections per truss went to both the left and the right side at about a 45 degree angle to provide additional horizontal stability.

Figure 9: Perimeter connection to floor truss showing viscoelastic damper.

Consequently, the interior connection to the core channel with just two 5/8 inch bolts was much weaker than the exterior connection to the perimeter columns. It is therefore reasonable to hypothesize that this was the weak point of the structure that provided the perpetrators with the opportunity to destroy the Twin Towers with the "right-tool-for-the-job" if access to the elevator shafts could be obtained (e.g., nano-thermite based propellant). The opportunity to exploit this fatal weakness, thus it appears, was the reason that the Twin Towers were destroyed in the manner of horizontal ejections.

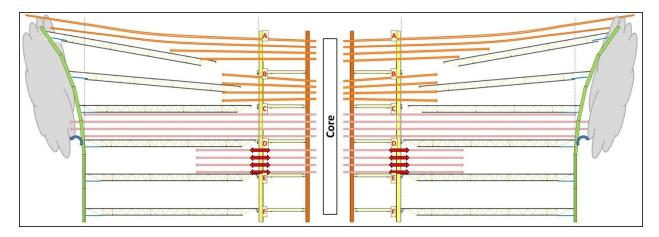
Figure 15 shows the same conditions as Figure 14 but also includes the opposite side of the tower to illustrate the reactionary forces. The orange arrows represent the reactive forces which are a necessary result of the propellant force. As shown in the top group of orange arrows, the propellant traversing across the core will not be constrained between upper and lower floors. In the areas where the floor slabs (or their remnants) are falling, the propellant will be directed upward as it continues outside the tower on the opposite side. This upward direction of the reactionary propellant would provide an observable feature during the destruction of the towers in the form of a "rooster-tail." Additionally, as the reactionary propellant particles impacted the remaining concrete, the additional imparted energy would further churn and break-up (e.g., tend to "further pulverize") the concrete.

These reactionary forces will also propel the falling floors, office contents and perimeter columns on the opposite side of the tower further outside of the footprint of the building.

Figure 15: Newtonian reactionary forces (orange arrows) travel in the opposite direction across the core into, and above, the collapsing structure to create the observed "Rooster Tails"

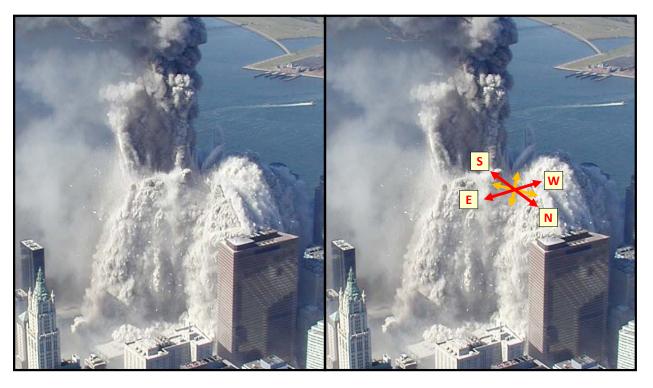
The directionality of the propulsive forces and "rooster-tail" hypothesized in this scenario match the observations captured in aerial photos of the destruction of the North Tower. It is unlikely that these "rooster tails" contained heavy steel components, but rather illustrate the movements of lighter materials. As shown in Figure 16, the propulsive forces operate in the cardinal directions of north-south and east west (red arrows), which is consistent with the propellant being placed on the inside of the elevator shafts. As confirmed by the photograph, such a geometric arrangement would provide significantly less propulsive forces in the ordinal directions (orange arrows).

Figure 16: The majority of the propulsive forces in the cardinal directions creating "rooster tails" with significantly less propulsion in the ordinal directions. Photo by Detective Greg Semendinger/N.Y.P.D.

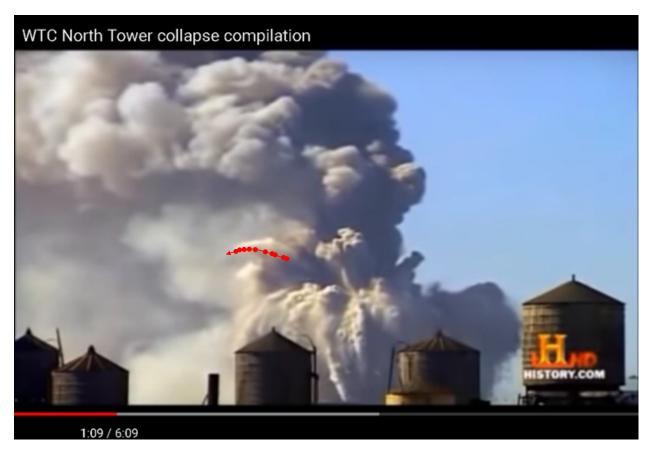
Figure 17 shows an upward-arching "Rooster Tail" that can only be explained by the reactionary force of the propellant and the geometry described above. Figure 18 shows the evolution of this "rooster-tail" by

Figure 17: Upward-arching "Rooster Tail" can only be explained by the reactionary force of the nano-thermite based propulsive forces.

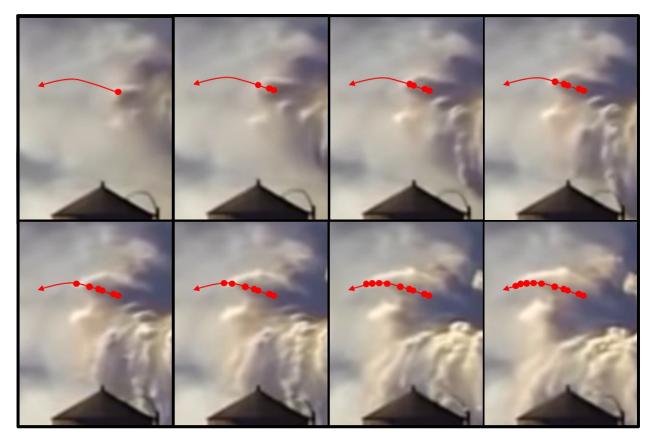
tracing the leading edge of a fast moving debris cloud with red dots as place markers. While the leading edge of this debris cloud is seen rising, peaking and then descending, it should be noted that the debris cloud trailing behind the leading edge can be seen rising further above the red trace. This confirms the upwardly directed reactionary propulsive force expected according to the hypothesis.

Figure 18: Evolution of the upward-arching "Rooster Tail" with dots showing the leading edge of the entrained material. An upward billowing debris cloud can be seen above and behind the trace which further illustrates the reactionary propulsive force.

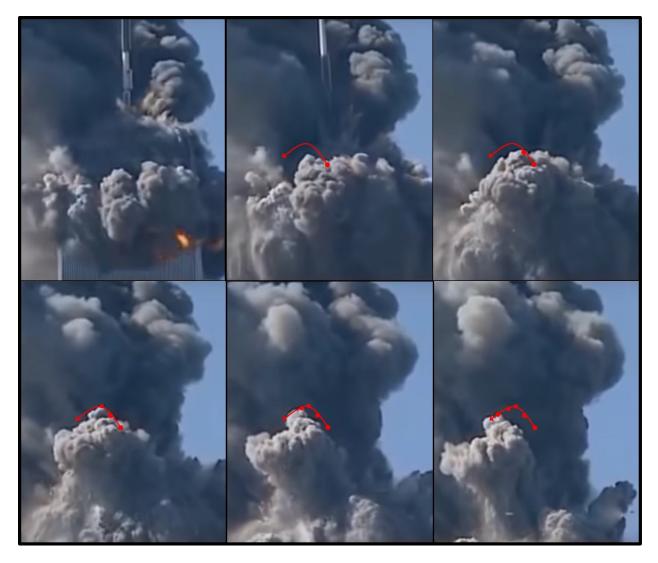
Another feature of the propellant that is observable because of the reactionary forces is the plume that erupts through the core area during the destruction phase. As multiple reactionary streams from the propellant collide in the core area, some portion will be forced upward. Figure 19 traces the upward movement of one section of this plume using red dots as place markers. The plume of debris is clearly rising against gravity and then it quickly begins to settle. If the plume were simply hot air containing micro particles it would continue rising, but instead it reverses direction and descends suggesting heavy macroparticulate loading.

Figure 19: Collision of opposing reactionary streams in the region of the core results in a vertically driven debris cloud plume.

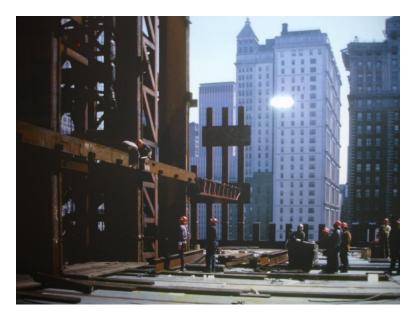
Figure 20 shows an installed steel channel that is solidly bolted to the core columns. The regularly spaced protrusions are the channel-to-floor truss seats described in Figure 8.

# Figure 20: Photo showing a channel with floor truss seats. A floor truss connecting the channel to a perimeter column is shown at the far end of the construction zone.

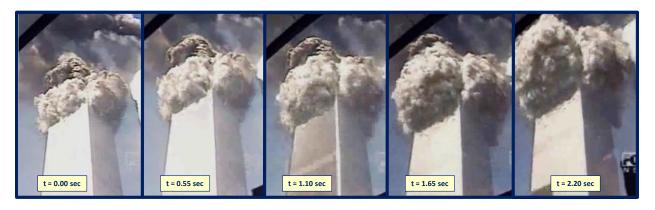
The sequential floor-by-floor destruction of the towers can be seen in Figure 27 for the South Tower and Figure 28 for the North Tower. In both cases the rate of descent is approximately constant and appears to be proceeding slightly faster than freefall acceleration during the Zone 2 demolition<sup>24</sup>. This observation about faster than freefall acceleration is because the ejected debris outside the tower from the higher floors (e.g., the debris is in free fall – including steel components) does not have time to fall and obscure the

Also, a review of the recorded sequence of demolition for each tower shows that the greatest propulsive forces occurred in the middle of each face of the tower. This supports the placement of the propellant along the inside perimeter of the elevator shafts. As expected for this hypothesis, the propellant is not observed acting with significant force into the corners (ordinal directions).

Figure 27: Using the debris cloud to observe the sequential activation of propellant - South Tower

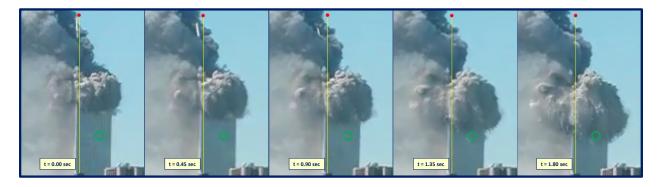
In Figure 28, the antenna is observed to both descend and rotate-away. Figure 29 shows the antenna of the North Tower falling to the side of the tower. These two figures show that the top 15 stories of the North Tower tilted as a single entity, similar to the top 30 stories of the South Tower, before each was propelled into oblivion. Because of its smaller height, the top of the North Tower was more easily obscured by the propelled debris cloud. Figure 30 shows the top of the both towers when the tilt of the top block first becomes noticeable.

While there is little evidence to determine exactly what happened at the interface between "Zone 1" and "Zone 2" there are some clues. As shown in Figure 28, the antenna on the North Tower does not rotate away, but rather it falls away as it is descending. This can be observed in the figure by comparing the top of the antenna to the red dot marking its initial location and then observing the motion in the subsequent frames. This is suggestive of the core columns on one side remaining intact slightly longer than the other and acting as a moment arm for the rotating upper block (i.e., the arm acts like a hinge).

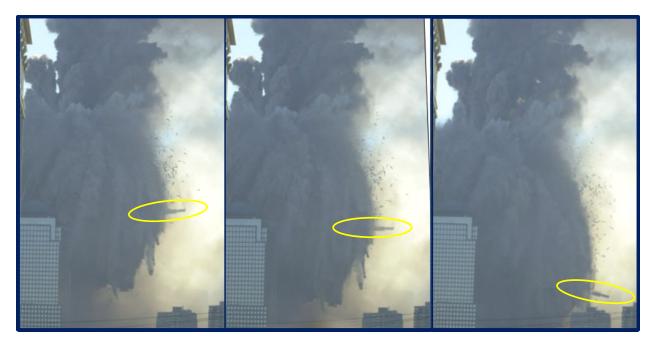
Figure 29: Tracing the descent of the North Tower antenna confirms the top 15 stories rotated as a single block and did not descend through the core of the tower (John O'Boyle /Star-Ledger).

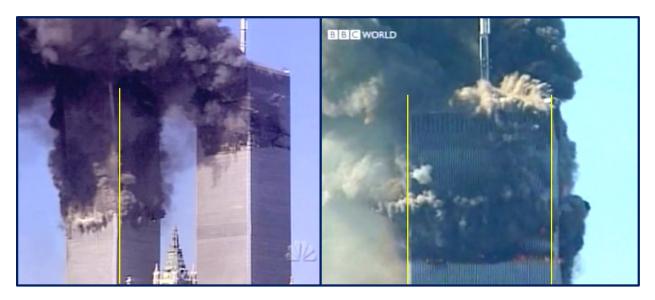
Figure 30: South Tower starts to lean (left) and North Tower starts to lean (right)

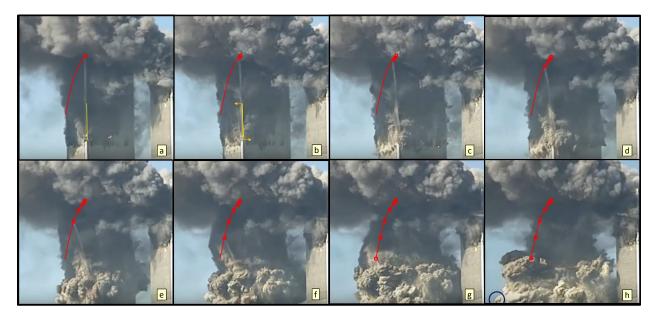
A similar movement is seen in the behavior of the South Tower<sup>25</sup>. Figure 31 highlights the movement of the northeast corner of the tower as it falls away and descends. The last frame in the sequence (frame "h") shows the emergence of a row of the core columns through the debris cloud (e.g., the "blue" circle). The movement of these core column ends might provide clues about the location of the lower end of the moment arm. If it is assumed that the core columns were all weakened at the same elevation then the location of the initiation can be hypothesized. If this motion could be verified, it may suggest destruction of the columns a dozen floors below the location of the aircraft impact. The movement of these top blocks indicates that columns were not severed simultaneously as in WTC Building 7.

Frames "a" and "b" of Figure 31 show a yellow vertical line alongside the northeast corner where the buckling of the corner structure will be seen in frames "c" and "d." In frame "c," this corner region appears to bend outward for about ten floors in height above the interface. This suggests that the weight of the top block has exceeded the capability of the structure – and it is giving way to create the observed deformation.

The more interesting observation in these figures is the effect that is shown in frame "b" by the two orange arrows. The upper orange arrow shows the movement of the block in the outwards leaning direction, while the lower orange arrow shows the inward movement due to the hinge effect – as the top block begins to tilt. This is the source of the "inward bowing" movement observed at the onset of destruction of the South Tower.

Figure 31: Rotational sequence of the South Tower showing the position of the northeast top corner during descent. Frame (h) shows the emergence of a row of core column.
