The Pentagon Event: The Honegger Hypothesis Refuted

Version 2 - February, 2019

Abstract: The question of whether or not a large plane hit the Pentagon on September 11, 2001 has been vigorously debated by critics of the government's account ever since the event itself. Recently, Barbara Honegger² has become a leading and visible proponent of the "pre-planted explosives only" hypothesis, with the added claim that a large plane was destroyed outside the Pentagon wall without damaging the wall. This paper shows that this hypothesis cannot address the physical and eyewitness evidence that overwhelmingly points to large plane impact as the primary cause of damage and death.

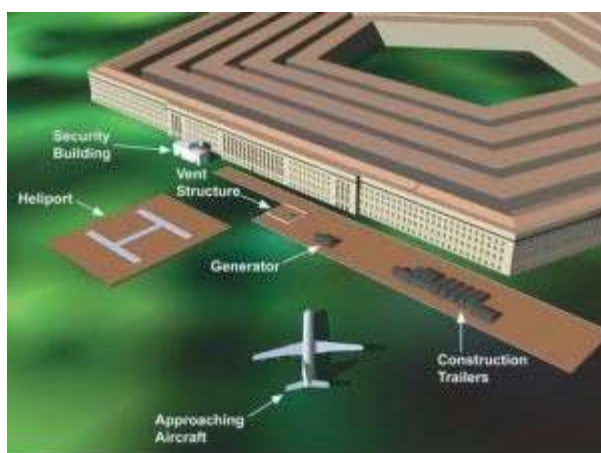
Figure A-1 (PBPR Figure 3.2) Pentagon event location

Pentagon offices are located in five rings numbered A through E, beginning with the innermost ring. The outermost E ring, followed by the D and C rings as one proceeds inward, sustained all of the structural damage. Wedge 1 extends from the lower right building corner to the mid-point of the west wall. Wedge 2 adjoins Wedge 1 at the left. The A & E driveway lies between rings C and B.

The large plane impact hole was just inside Wedge 1 close to Wedge 2. Wedge 2 also sustained considerable damage. Note the locations of the Vent Structure and Generator, both of which sustained damage. The Vent Structure was surrounded by a low concrete wall while a wire fence enclosed the Generator. The Heliport control tower is part of the structures labeled Security Building.

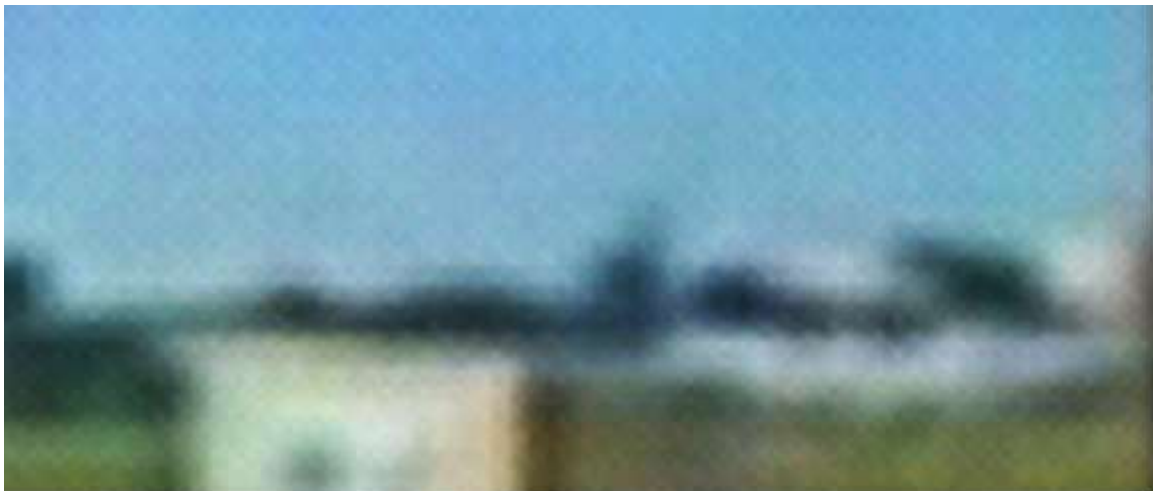
Figure E-5: Fuzzy tail-like image and white smoke trail

One of the first of the five frames (see Figure E-5) shows a fuzzy object resembling a plane tail projecting upwards above and behind the top of a metal box that obscures most of the approaching object itself. In the next frame, this tail-like image is gone, and the fireball is seen coming from the side of the Pentagon building.

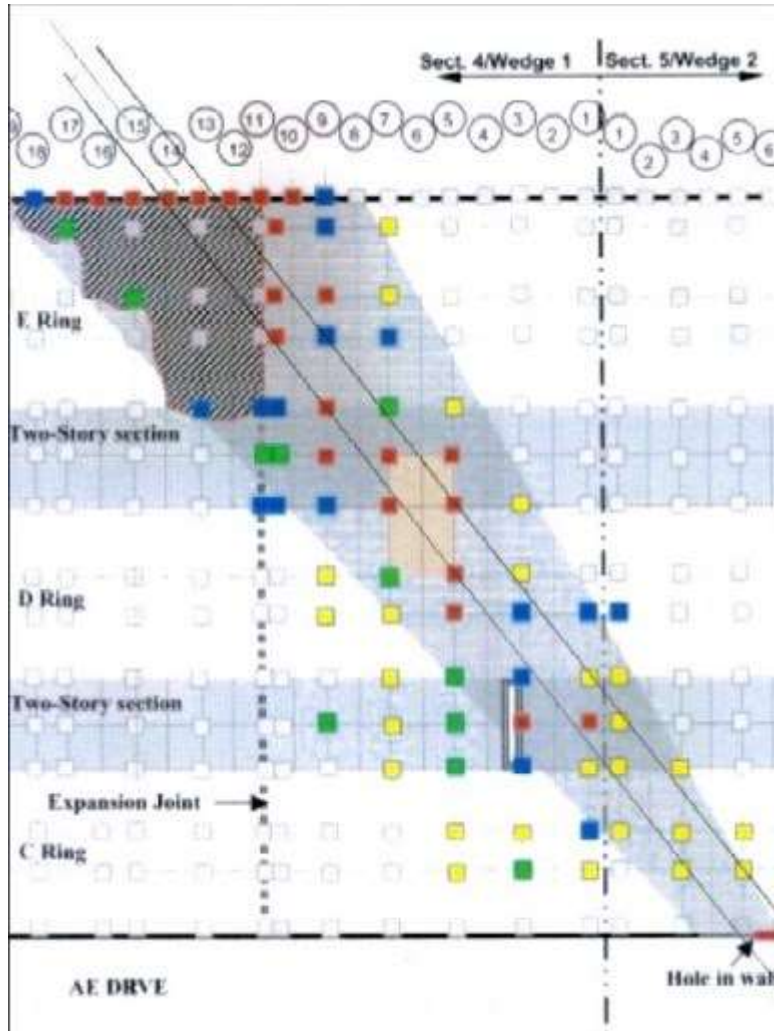
Figure E-7

The damage trail outside and inside the Pentagon, together with the many witnesses, indicates that the plane did penetrate the outer wall. The evidence supports penetration.

Plane debris main penetration path (two parallel lines 12.33 feet apart)

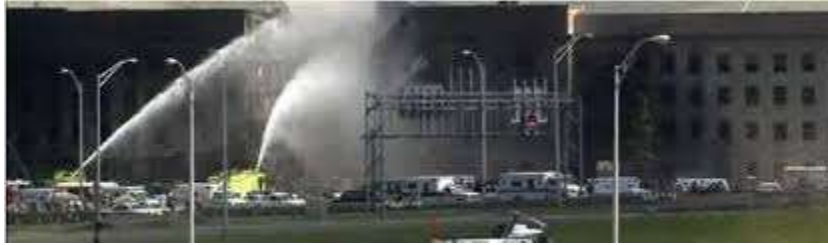
Figure F-1 – View showing light poles on roads next to Pentagon

2. The poles were on bases and, for the protection of motorists, were designed to break away from these bases when struck. The poles consisted of two parts, a tall tapered column section to which was attached a cantilever truss that extended outward and held the lamp head at a height of 40 feet (see figure F-1). The long tapered portion of the poles was 36 feet in length, had a diameter of 10 inches at base and 6 inches at top, and was made of 1/8 inch thick aluminum. The poles weighed 247 pounds. The poles were severed between about 23 feet and 31 feet above their bases (see Figure F-2), becoming progressively shorter as the Pentagon was approached⁶⁶.

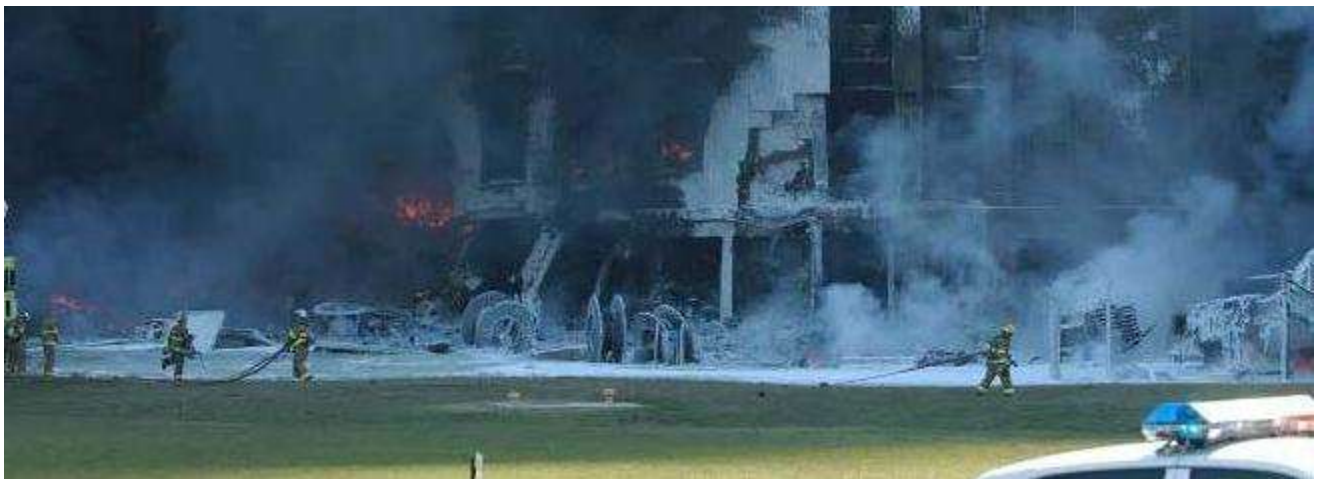
Figure F-9 Spools with fire mostly extinguished

Spool 4: A large upright spool seen as the leftmost upright spool in Figure F-9, and directly behind spool 2 (small spool) in Figure F-10. In Figures F-7 and F-8, spool 4 is lying on its side.

Spool 5: A large spool lying on its side; the leftmost spool in Figures F-8, F-9, and F-10.

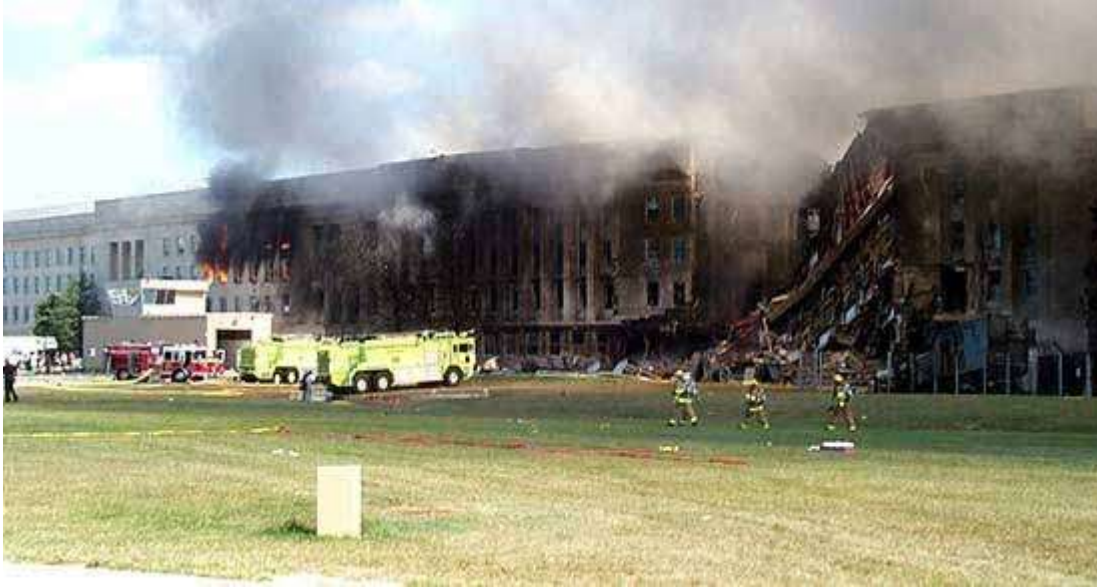
Figure F-11 Pristine lawn

Regarding argument (2), Honegger shows a well-known photograph of the "pristine lawn" at S-00:34:35. This photograph is deceptive because of foreshortening; the lawn appears to reach almost to the Pentagon west wall, but in reality the photograph shows only the lawn up to about 95 feet from the west wall. Other photographs reveal much debris within the space 95 feet from the west wall and in a direction perpendicular to the impact hole.

Examine the photograph in Figure F-11, which shows the same scene as Honegger’s “pristine lawn” photograph but taken from a different angle. The firemen nearest the center are in front of the gouge in the low concrete wall in the background. On their right can be seen a large standing spool. On their left and just visible is the white box that is part of the warning lights. At the right of the photograph can be seen the fence that encloses the generator trailer. Note the incline of the fire truck left of center – the ground rises up, showing that the low concrete wall that was gouged was on higher ground than the surrounding lawn. The plane was rolled to the left, and the left engine hit the low concrete wall almost at ground level there, which was higher than the level of the lawn in the foreground. Given these facts, there is no mystery as to the absence of a gouge in the pristine lawn.

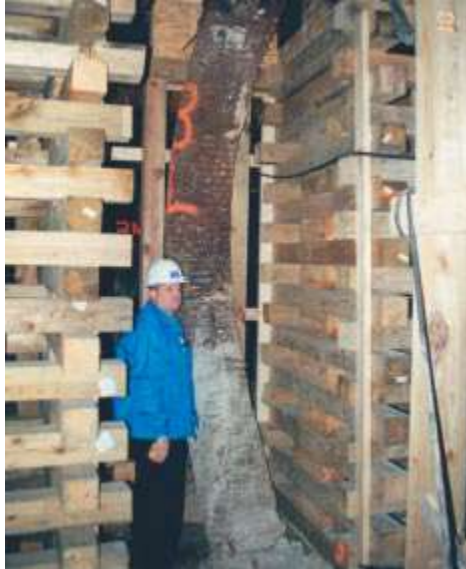
Figure G-2

⁷⁸ PBPR Page 34: "The orientations of the distorted columns and the columns that were severed all indicated a common direction for the loads that caused the damage. The direction of column distortion consistently formed an angle of approximately 42 degrees with the normal to the west exterior wall of the Pentagon." Also see PBPR p.29.

by large plane impact, while the bomb hypothesis cannot explain these observations. Honegger does not mention this evidence.

PBPR Figure 5.20 Column 3L with large deformation

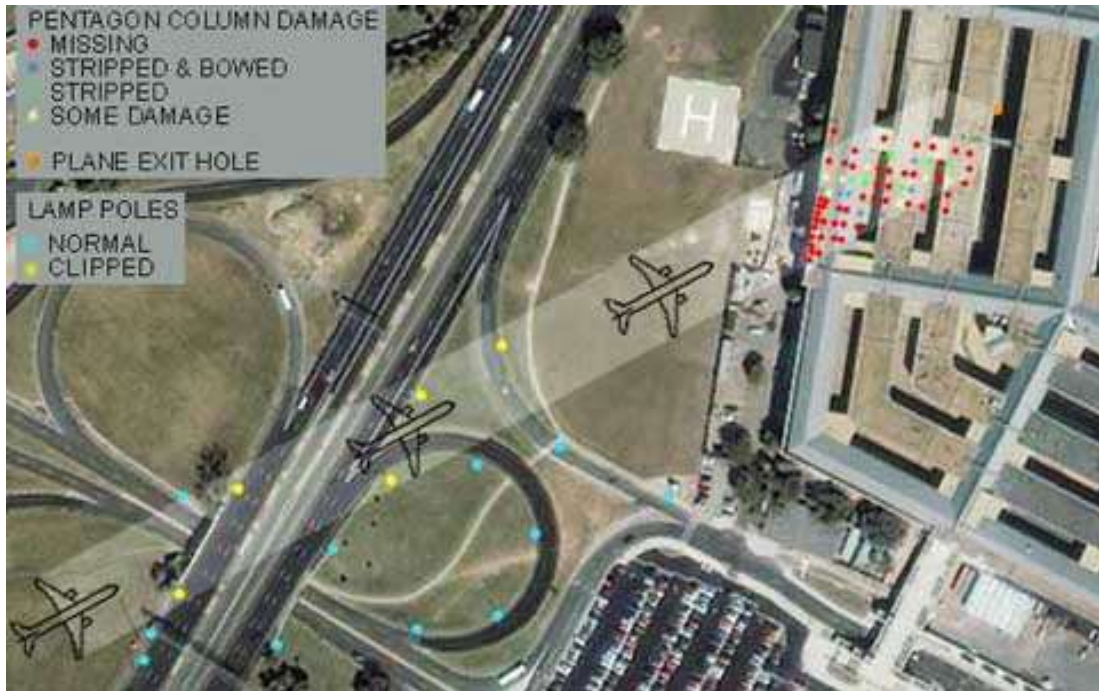
Figure G-6

Hole 1 is a door, hole 2 is a roll-up door larger in width, and hole 3 is the C Ring hole where debris from the large plane broke through into the A & E driveway. In her text (book) version of her Toronto Hearings' talk, Honegger acknowledges that holes 1 and 2 are doorways, but she does not mention this fact in her Toronto or Seattle live presentations where she compares Figure G-5 with a similar figure showing only one "EXIT HOLE," the C Ring hole (see Figure G-6).

Aerial photograph showing one exit hole

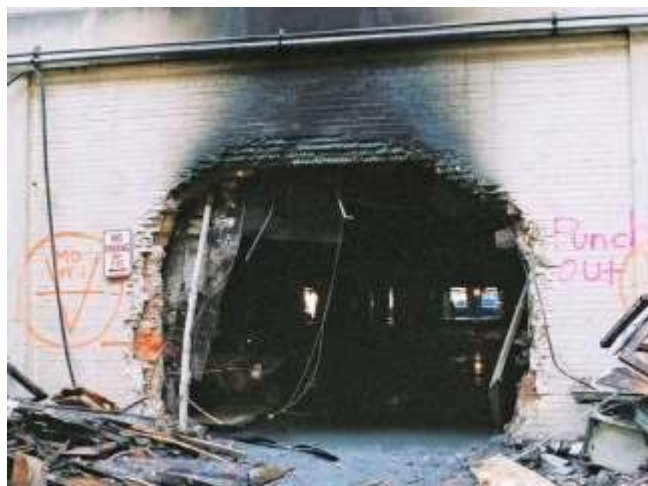
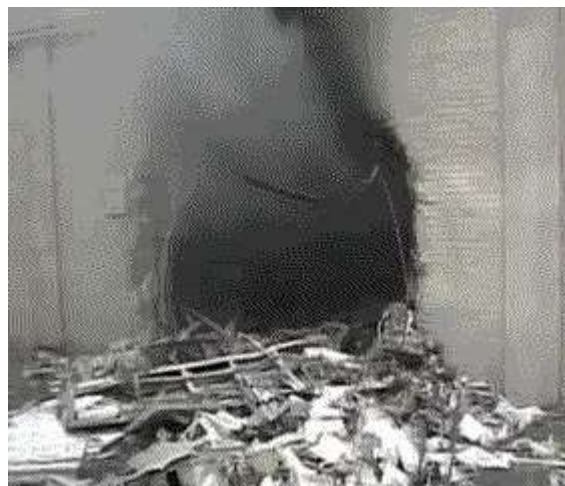
Figure G-8 - C ring hole

On the right side of the hole, the words “Punch Out” had been written. Punch-out is used in many different contexts, such as to punch out an opponent in a boxing ring, punch out or bail out of an airplane, or punch in and punch out at a time clock in a work environment. In the construction industry it is widely used to mean a list (punch list or punch out list) of details to be finished in a construction job. As used in construction, it is a to-do list and not a directive to punch a hole in a wall or other object.

As earlier photographs show (see Figure G-8(b)), the hole was there before the marking, so it would make no sense to add “Punch Out” later as a directive. Evidence presented below strongly suggests that the construction-terminology meaning of “Punch Out” was adapted here to mean a list of bodies found/removed. See Figure G-9 below for “Punch Out” used to label bodies removed.

On the left side of the C ring hole is a marking added some days after September 11. This is the international symbol for victim, V. A line through the V indicates the victim is deceased, a circle around the V indicates the body has been removed. Many bodies were probably removed through the C ring hole. At S-01:10:10 Honegger shows a figure that she incorrectly attributes to the PBPR. The figure, dated June 2008, is a “Screenshot of Flash Presentation depicting where body fragments were found on the first floor of the Pentagon after Flight 77 hit. This was used in the trial of Zacarias Moussaoui.”⁸⁵

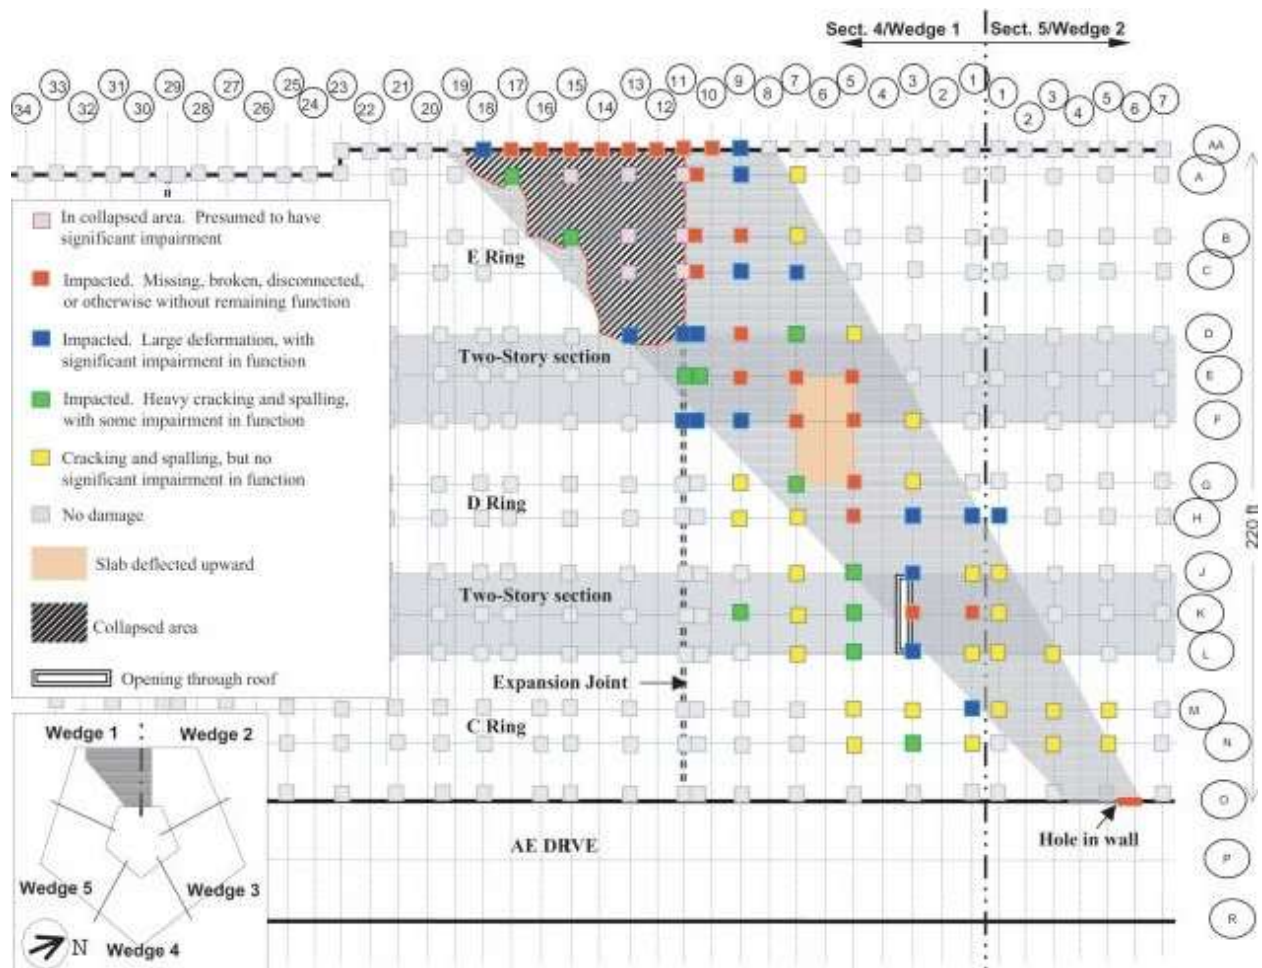
Figure H-1
 Pentagon Building and Performance Report Figure 7.9

The Pentagon Building and Performance Report (PBPR) mentions an area where the second floor slab (first floor ceiling) is breached upward. This area is shown as the orange rectangle marked "Slab deflected upward" in PBPR figure 7.9 (Figure H-1) reproduced below. PBPR figure 5.27 (Figure H-2), also reproduced below, shows the upward breach (or part of it).

- Having invoked PBPR figure 7.9 (Figure H-1) as evidence, Honegger completely ignores the implications of most of the data in this figure. She never addresses the overall damage pattern that is highly consistent with large plane impact at the west wall followed by fragmentation of the fuselage and debris passage at high speed through the interior ending at the C ring hole. Was this pattern planned to simulate a plane impact? How did a massive explosion at the orange rectangle create such a pattern? Honegger does not explain the implications of her hypothesis.

- The relatively minor upward breach in PBPR figure 5.27 (Figure H-2) and the limited area in which it occurred is highly unlikely to be the result of a “massive” explosion, but more likely a local anomaly caused by high-speed plane debris. The orange rectangle in PBPR figure 7.9 (Figure H-1) where the upward deflection occurred is directly in the center of the line of travel of the plane debris and is bounded by five red (severely impacted) columns, indicating an anomaly in the damage pattern caused by the plane debris.

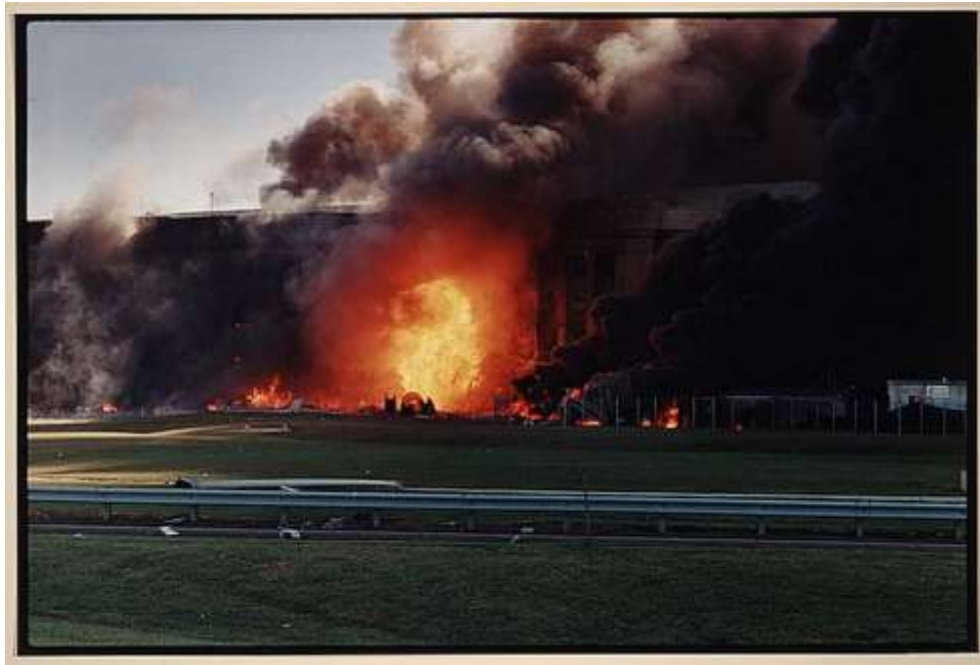
Figure H-4
Daryl Donley photograph taken some minutes after plane impact

reported only one major “explosion.” The event shown in Donley’s photograph occurred several minutes after he observed the plane fly into the Pentagon when he retrieved his camera from his car and began taking photographs.

Honegger’s account of Donley’s photograph is confused and speculative, to the point of her suggesting it “may or may not be” the explosion in the famous “five frames” and that it looks like a thermite explosion. She compares it with a photograph of the F-4 Phantom experiment, a plane hitting an impenetrable concrete wall, and notes the two photographs are “nothing like” each other. Given the likely origin of the Donley “fireball,” this makes perfect sense. Whatever the cause, the Donley “fireball”

is not the fireball that occurred upon plane impact or that Thurman heard, and is not credible evidence for pre-planted explosives that Honegger claims led to the Pentagon damage.

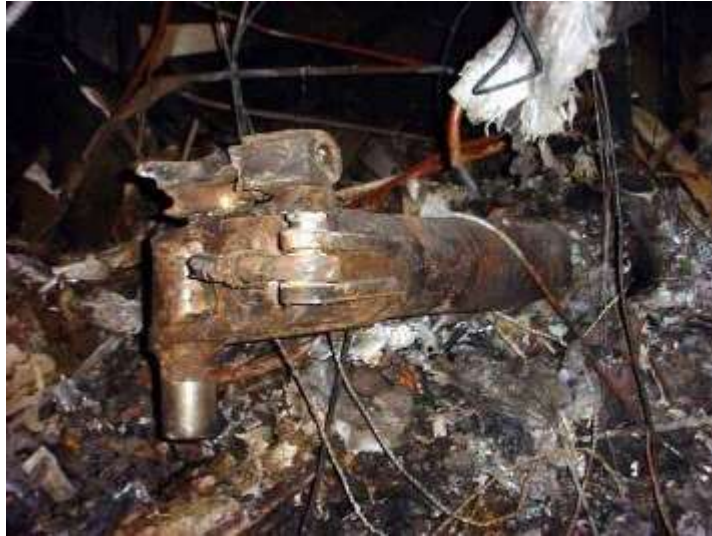
Figure AppE-1 Landing gear

The landing strut shown in Figure AppE-1 was found near the C ring exit hole but on the inside of the Pentagon.

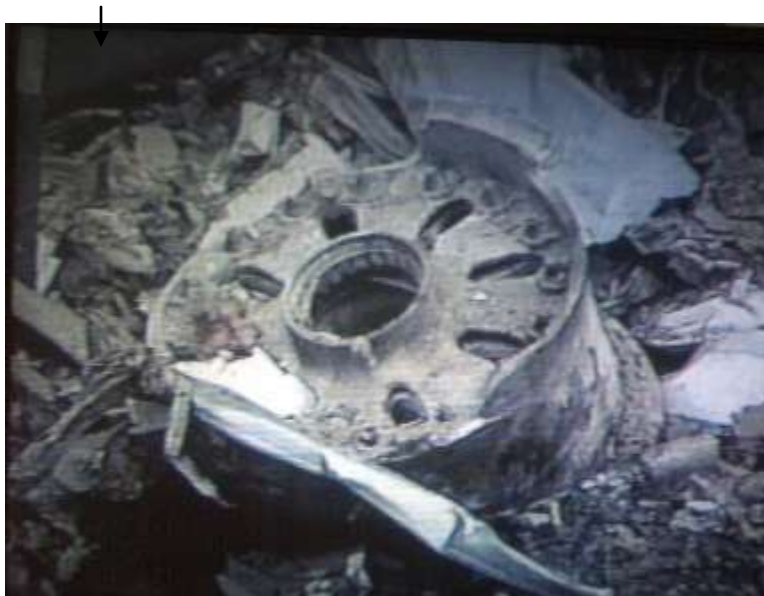
Figure AppE-2 Wheel hub

According to TLC's "Pentagon Under Fire," aired 9/11/02, this wheel hub was found near the exit hole. See Figure AppE-2.

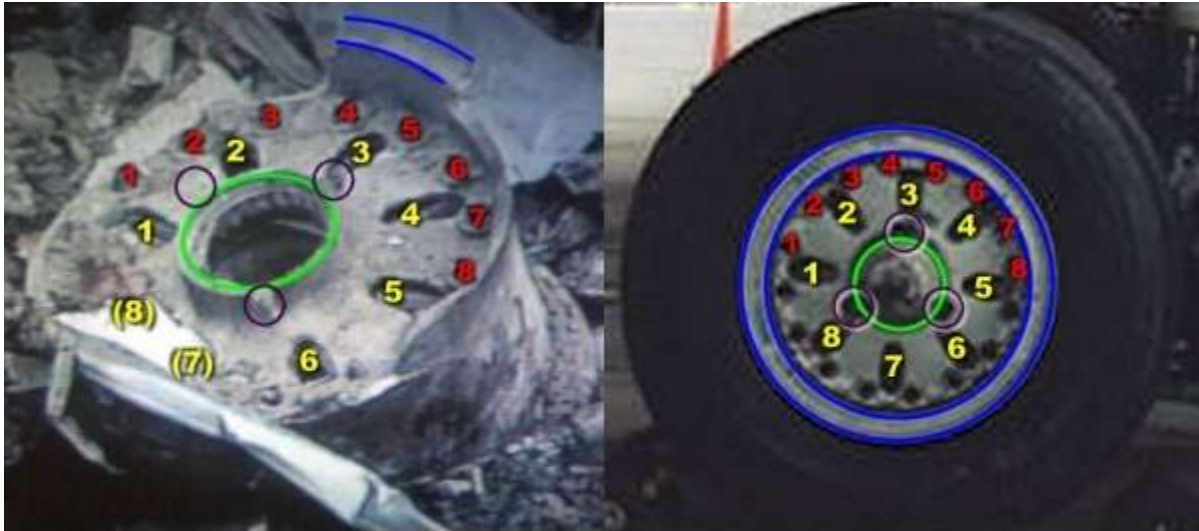
Figure AppE-3 shows the wheel hub found in the A&E driveway alongside a main landing gear wheel of a Boeing 757-200. The match is exact. This match is discussed in full in an answer to a question on the website www.aerospaceweb.org. The article is entitled "Pentagon & Boeing 757 Wheel Investigation" and the question can be found here: <http://www.aerospaceweb.org/question/conspiracy/> The wheel found on the ground in the A&E driveway has 8 cutouts, matching the main landing gear of a Boeing 757-200.

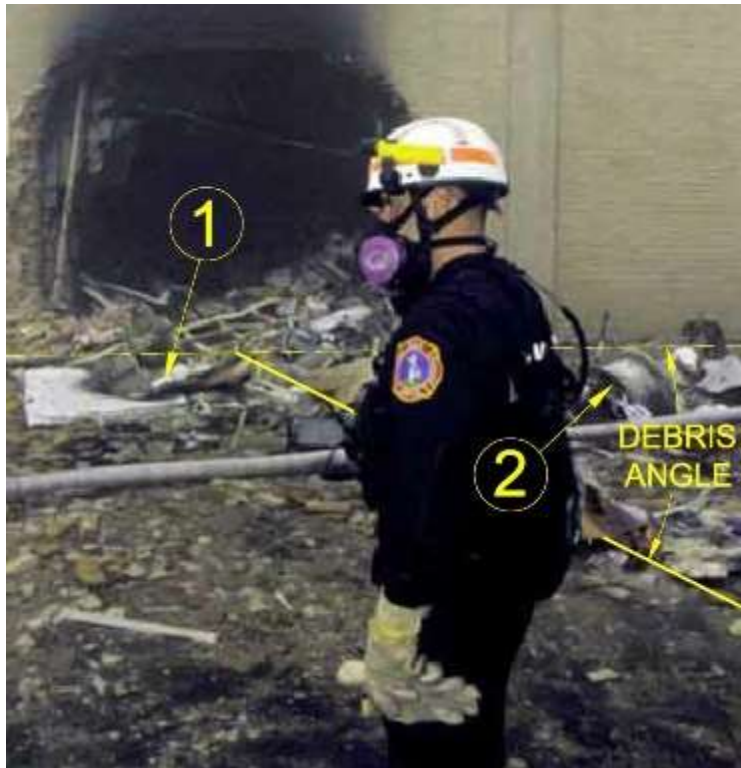
Figure AppE-4 Plane parts and debris angle

In the next photograph, Figure AppE-4, an object that looks like a wheel hub is visible (2). A semi-circular part of the plane appears at left (1). Also notice that the majority of the debris is to the individual's right, or at an angle that is consistent with the flight path direction in relation to the wall. Other evidence shows the plane's path made a 52 degree angle with the wall.

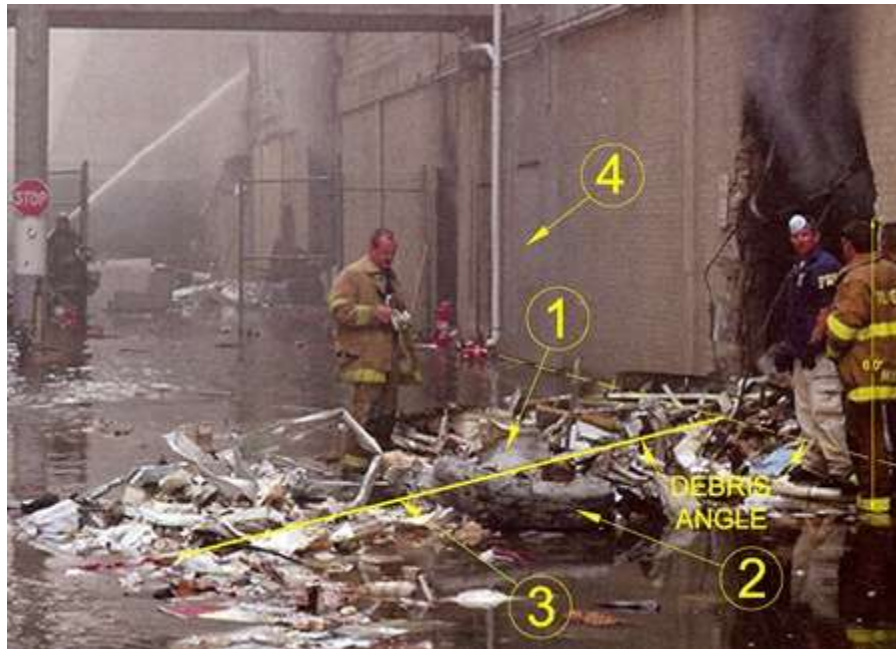
Figure AppE-5 Plane parts and debris angle

In the following photograph, Figure AppE-5, is a large remnant of a tire (2). Also shown is a wheel rim (1). The debris angle (3) is also clearly visible. A single doorway lies in the direction pointed to by (4). Note the black smoke residue on the wall above. Beyond, on the other side of a fence partition is so-called "exit hole" number 2, a large doorway.

Note the spacing of the ribs on the tire fragment (2), which are similar to the ribs found on Michelin aircraft tires shown in the following picture.

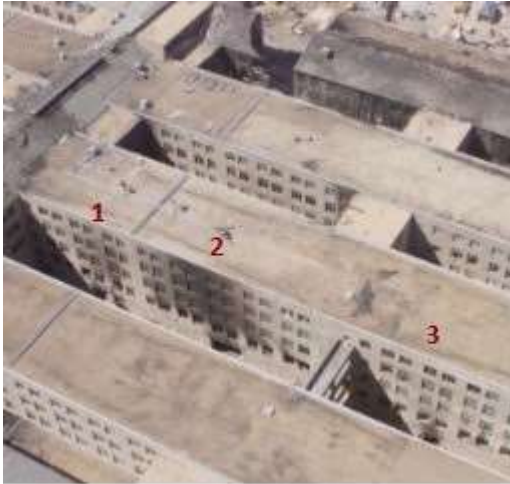
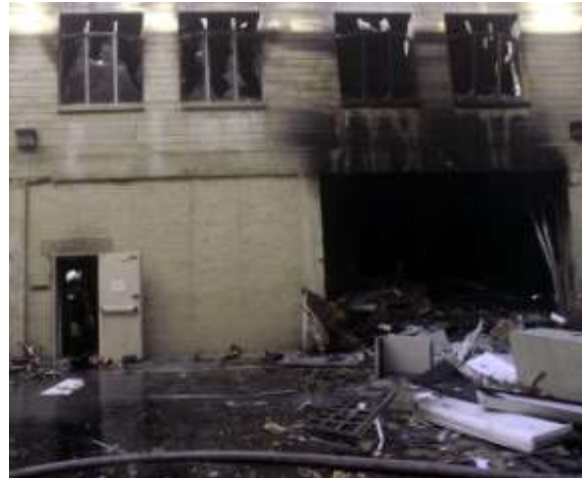
Figure AppE-7

and 3. Two of these “exit holes,” numbered 1 and 2, are actually doors for entry and exit. Figure AppE-7(b) shows the large doorway that was numbered “exit hole” 2. There is only one true plane exit hole, the circular-appearing C ring hole numbered as 3. As previously noted, Figure G-6, showing one plane “exit hole” is a more accurate, corrected version of Figure G-5.

(a) The three so-called “exit holes”
1 and 2 are doorways, 3 is the plane exit hole
